PRODUCT CAMPAIGN BULLETIN

<p>APPLICABILITY: 2009-2013 model year Legacy 2009-2013 model year Outback 2009-2013 model year Forester 2009-2013 model year Tribeca 2009-2011 model year Impreza 2009-2013 model year WRX and STI</p> <p>SUBJECT: Takata Front Passenger Airbag Inflator Replacement (2018 Calendar year expansion)</p>	<p>NUMBERS: TKA-18R TKB-18R TKC-18R</p> <p>DATE: 02/09/18 REVISED: 12/21/22</p> <p>NHTSA ID: 18V-012 18V-013 18V-014</p>
---	---

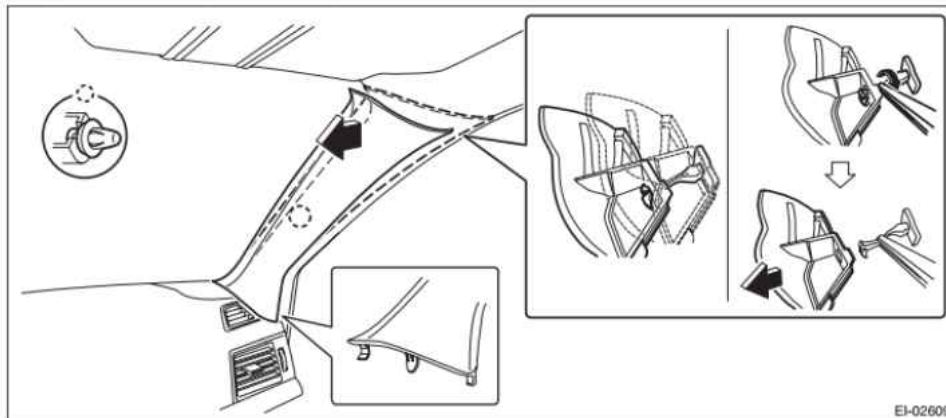
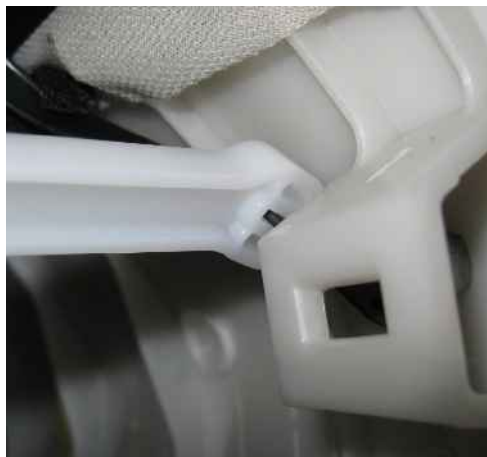
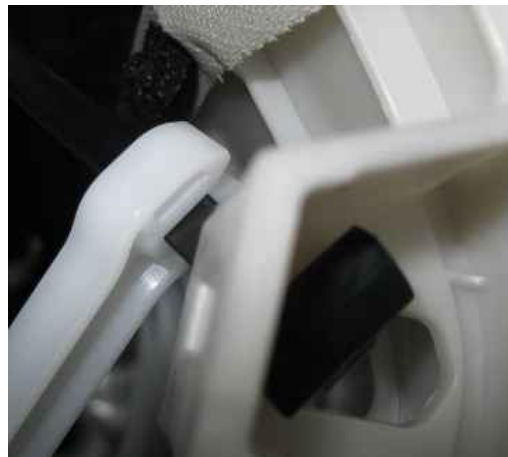
NOTE: Some models utilize a “tether clip” to secure the upper portion of the “A” pillar trim. The tether clip is located just below where the “A” pillar trim meets the head liner. If the tether clip becomes damaged, it **MUST** be replaced. The illustrations and photos below show the location of the tether clip and how to release it. It is **STRONGLY RECOMMENDED** to use the release tool (p.n. **SOA635147**) specifically designed for tether clip removal. Each Retailer has been supplied with 2 of these tools. If the tool is unavailable, a needle-nosed plier can be used to **CAREFULLY** release the tether clip as shown in the illustration below.
