2006 B-SERIES - PASSENGER AIR BAG SAFETY RECALL 2318A

March 6, 2026. Added video installation requirement and additional links

PASSENGER AIR BAG SAFETY RECALL 2318A
REPAIR PROCEDURE

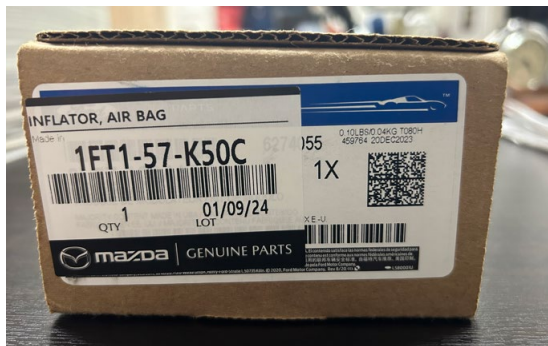
Inflator Part #1FT1-57-K50C

Inflator in box with warning label

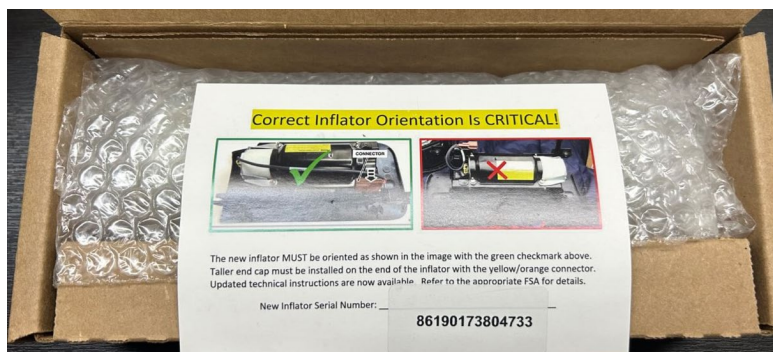
Inflator part box contents

1. Inflator – **DO NOT REMOVE END CAPS AND INSTALL PREASSEMBLED, WITH THE SHORTER CAP FIRST (TAIL END CAP) INTO THE MODULE**
2. Bracket
3. Nuts (4) and clip (1)
4. PLEASE READ THIS WARNING LABEL
