SAFETY RECALL BULLETIN

SUBJECT: DRIVE BELT AUTO TENSIONER – SAFETY RECALL CAMPAIGN			No: SR-18-001
			DATE: March 2018
			MODEL: See Below
CIRCULATE TO:	<input checked="" type="checkbox"/> GENERAL MANAGER	<input checked="" type="checkbox"/> PARTS MANAGER	<input checked="" type="checkbox"/> TECHNICIAN
<input checked="" type="checkbox"/> SERVICE ADVISOR	<input checked="" type="checkbox"/> SERVICE MANAGER	<input checked="" type="checkbox"/> WARRANTY PROCESSOR	<input checked="" type="checkbox"/> SALES MANAGER

This campaign bulletin instructs dealers to inspect and, if necessary, replace the drive belt auto tensioner with a countermeasure part.

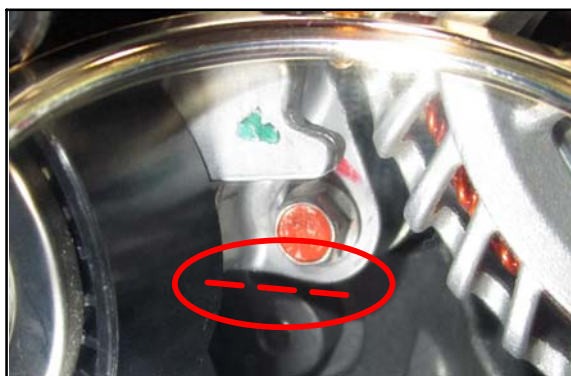
3. Check the auto tensioner and note the flange shape.
 - a. If the flange is straight, as illustrated in figures A and B, **leave as is** and go to **step 4**.
 - b. If the flange is concave, as illustrated in figure C, proceed to **Auto Tensioner Removal** process.

4. Reinstall the radiator condenser tank. **Repair is now complete.**

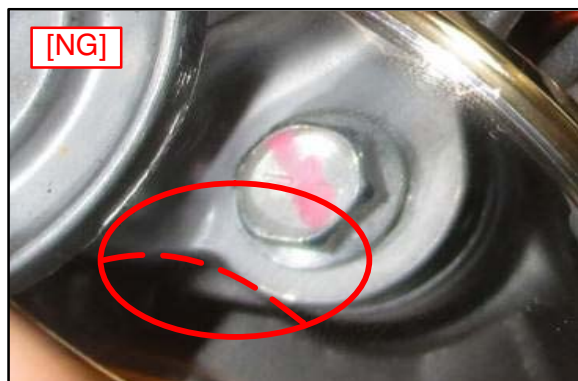
If the flange is concave, proceed with the repair.
