SAFETY RECALL

AA9Q0 CONVENTIONAL VALVETRAIN
ADJUSTMENT SCREW LOCK NUT
INSPECTION/REPAIR

RECALL NO: AA9Q0
DATE: 3-15-2018
REFERENCE: QA-180314-N1

SUBJECT VEHICLES: 18MY-19MY Conventional Trucks equipped with a J08 engine

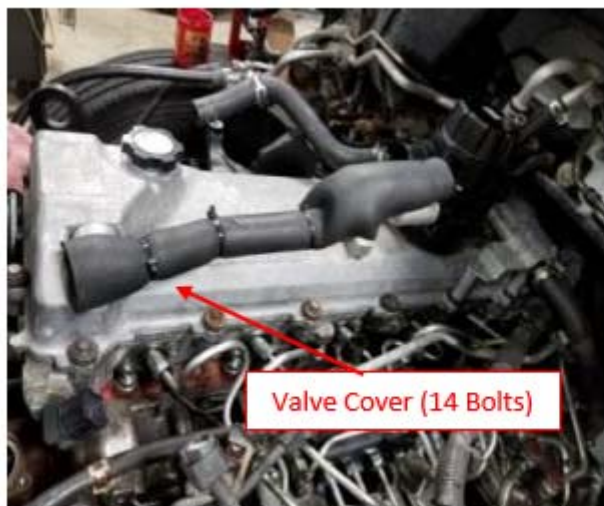
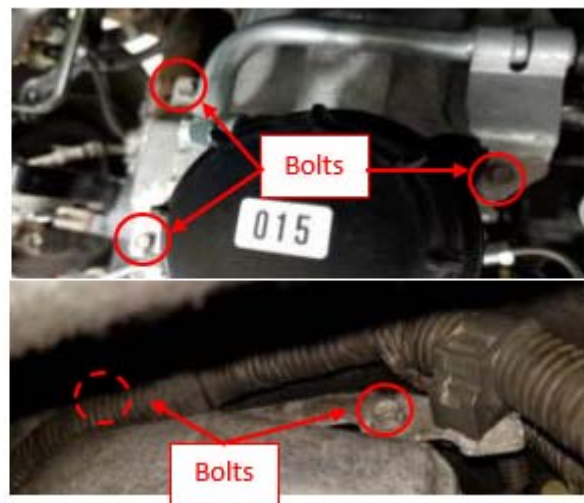
8. Inspect the 12 cross head screw lock nuts (2 nuts per cylinder). If any of the nuts have fallen off, attempt to locate the nut. **If the nut cannot be found, or engine damage is identified, contact Tech Assist for further direction.**

If all 12 nuts are present, use a torque wrench to check the torque of each of the 12 cross head screw lock nuts. Were any of the nuts found to be under tightened, below the specified torque?

Yes - Proceed to the Lash Adjustment Procedure

No - Proceed to the Assembly Procedure

Specified Torque: 18 lb-ft (25Nm)
