November 2018 FL766A-C NHTSA #18V-191 Transport Canada #18-190 REVISED NOTICE

#### Subject: Western Star Power Cable Studs

Models Affected: Specific Western Star 4700, 4900, 5700, and 6900 model vehicles manufactured September 12, 2016, through February 6, 2018.

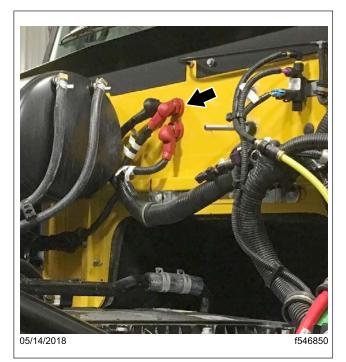
Fig. 1, Power Cable Stud Connector Location

- 1. Open the hood and locate the three or four power cable stud connectors on the front wall. See Fig. 1.
- 2. Pull back the covers on the power cable stud connectors. See Fig. 2. Inspect each cable stud to make sure at least one thread protrudes past the plastic nut. See Fig. 3 and Fig. 4.

- 1. Disconnect the batteries.
- 2. If not already done, open the hood and locate the three or four power cable stud connectors on the front wall, and pull back the cover on the power cable stud connector. See Fig. 1 and Fig. 2.
- 3. Loosen the dash, and move it back enough to access the front-wall power terminals. Refer to *Western Star Workshop Manual*, **Section 60.06**, **Subject 110**.

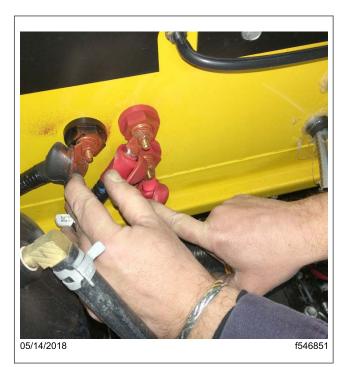
Fig. 2, Removing Connector Protective Cover

If at least one thread does **NOT** protrude past the plastic nut, the installation is **INCORRECT**. Proceed to "Power Cable Stud Replacement."
