May 2018
INT FL766-01
NHTSA #18V-191
Transport Canada #18-190
INTERIM RECALL BULLETIN

Subject: Western Star Power Cable Studs

Models Affected: Specific Western Star 4700, 4900, 5700, and 6900 model vehicles manufactured September 12, 2016, through February 6, 2018.

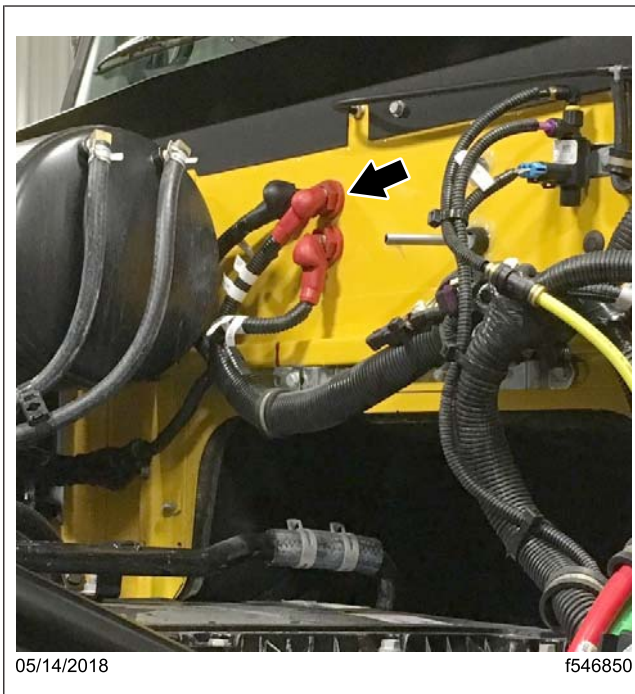
Fig. 1, Bulkhead Connector Location

On certain vehicles, the bulkhead pass through power stud with an attached gasket seal may not protrude through the bulkhead adequately. If improperly installed, the power stud may contact the bulkhead, resulting in potential arcing, which may increase the risk of a fire.

1. Check OWL prior to performing the interim recall to ensure the vehicle is involved and the campaign has not been previously completed. **DO NOT** use a completion sticker for the interim inspection or repair. Attaching a recall completion sticker may prevent the customer from getting the final recall repair.
2. Park the vehicle on a level surface, shut down the engine, and set the parking brake. Chock the tires.
3. Open the hood and locate the three battery bulkhead connectors on the front wall. See [Fig. 1](#).
4. Pull back the covers on the battery bulkhead connectors. See [Fig. 2](#). Inspect the bulkhead studs to make sure at least one thread protrudes past the plastic nut. See [Fig. 3](#) and [Fig. 4](#).
