Safety Recalls

Codes: 1902 / 19N4

Subject	After-Run Coolant Pump
Release Date	February 15, 2018
REVISION SUMMARY	<p>1902 – Updated claiming and work instructions to allow Pierburg pump installation on vehicles built after December 31 2012.</p> <p>19N4 – No changes.</p>
IMPORTANT! DO NOT PERFORM BOTH Safety Recall 1902 and Safety Recall 19N4	<p>All vehicles in Safety Recall 1902 are also in Safety Recall 19N4.</p> <p><u>Only one recall should be completed on each vehicle.</u></p> <ul style="list-style-type: none"> ➤ Perform Safety Recall 1902 only if a replacement after-run coolant pump is available. ➤ Perform Safety Recall 19N4 only if a replacement after-run coolant pump is <u>NOT</u> available. <p>Enter your recall claim as soon as possible. A SAGA claim for one of these recalls will automatically close the other. This automatic closure is normally completed within one week but may take up to two weeks.</p>
Affected Vehicles	<p>U.S.A.: Certain 2012-2017 MY Audi vehicles with a 2.0L TFSI gasoline engine</p> <p>CANADA: Certain 2013-2017 MY Audi vehicles with a 2.0L TFSI gasoline engine</p> <p><i>Check Campaigns/Actions screen in Elsa on the day of repair to verify that a VIN qual

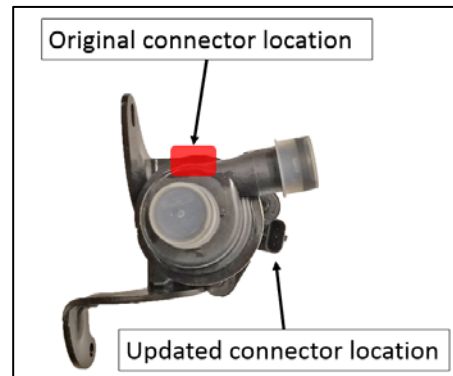
Due to the new location of the connector on the new pumps, the after-run coolant pump wiring harness <arrow> may have to be routed so it does not come into contact with the pump coolant hose.
