Safety Recalls

Codes: 19O2 / 19N4

<p>Subject After-Run Coolant Pump</p> <p>Release Date December 13, 2018</p>	
<p>IMPORTANT!</p> <p><u>DO NOT PERFORM BOTH</u></p> <p>Safety Recall 19O2 and Safety Recall 19N4</p>	<p>All vehicles in Safety Recall 19O2 are also in Safety Recall 19N4.</p> <p><u>Only one recall should be completed on each vehicle.</u></p> <ul style="list-style-type: none"> ➤ Perform Safety Recall 19O2 only if a replacement after-run coolant pump is available. ➤ Perform Safety Recall 19N4 only if a replacement after-run coolant pump is <u>NOT</u> available. <p>Enter your recall claim as soon as possible. A SAGA claim for one of these recalls will automatically close the other. This automatic closure is normally completed within one week but may take up to two weeks.</p>
<p>Affected Vehicles</p>	<p>U.S.A.: Certain 2012-2017 MY Audi vehicles with a 2.0L TFSI gasoline engine</p> <p>CANADA: Certain 2013-2017 MY Audi vehicles with a 2.0L TFSI gasoline engine</p> <p><i>Check Campaigns/Actions screen in Elsa on the day of repair to verify that a VIN qualifies for repair under this action. Elsa is the <u>only</u> valid campaign inquiry & verification source.</i></p> <ul style=

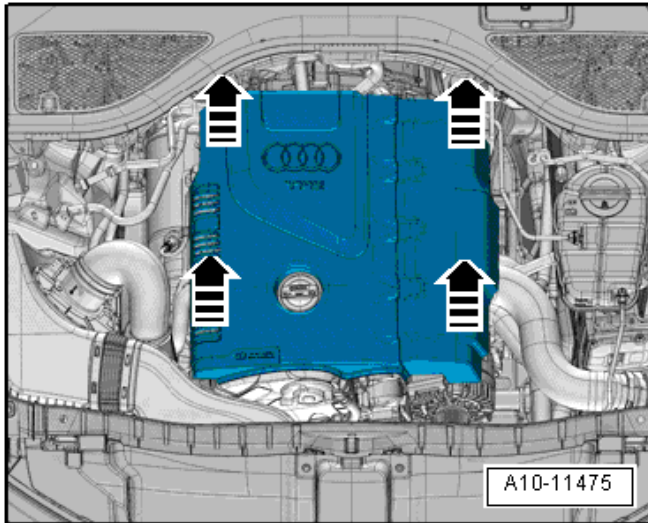
Remove engine cover:

- Carefully pull the engine cover off the ball pins one after the other in direction of <arrows>. Do not pull sharply on the engine cover or pull it to one side.

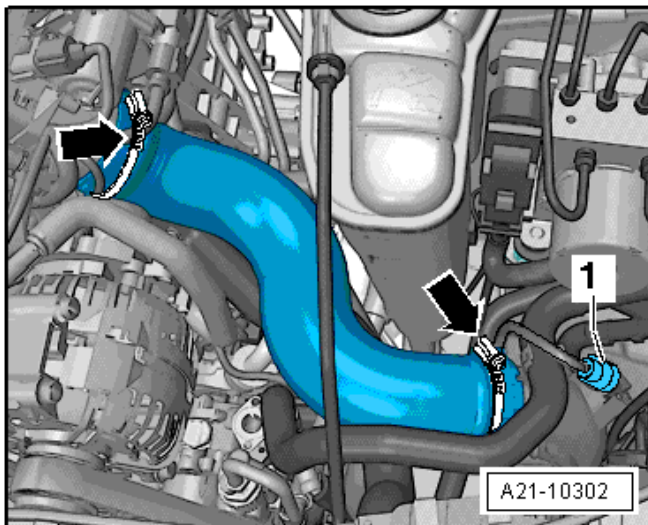
Remove intake air hose:

- Loosen the hose clamps <arrows> and remove the air duct hose.
