Safety Recall Code: 69Q8

TAKATA Driver Frontal Airbag Inflator

April 19, 2018

U.S.A. & CANADA: Certain 2006-2007 MY Volkswagen Passat Sedan & Passat Wagon vehicles equipped with a Takata driver frontal airbag

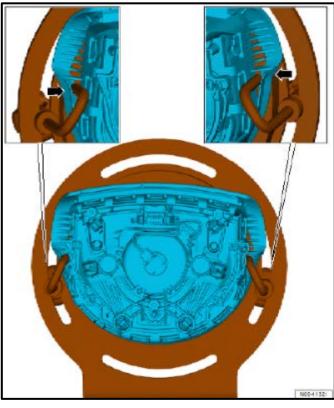
Clamp airbag centrally in airbag support. Securing points on the sides <arrows> and parallel opposite each other.

The clamps must be placed in the positions shown <arrows> to prevent damage to the airbag. Damage to the airbag is not covered under this action.

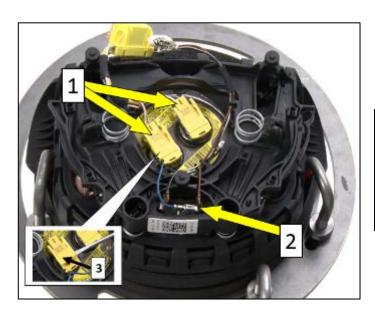
- Do not use a screwdriver to pry off connectors <1> or damage to the connectors could occur.
- Damage to the airbag connectors will not be covered under this action.

- Disengage connector locks <3> using a small flat bladed screwdriver.
- Remove connectors <1> using needle nose pliers.
- Remove ground cable <2>.

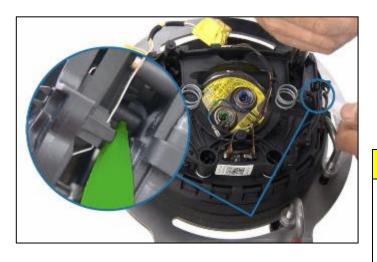
Use extreme care when removing the horn ring. If horn ring is damaged during removal, airbag replacement will be necessary. Replacement of the airbag due to damage during horn ring removal will not be covered under this action.

- When removing the horn ring, take care that the springs are not lost as they are not available separately.
- ONE replacement spring is included in the inflator kit in the event a spring is lost or damaged.
- If more than one spring is lost, replacement of the airbag is required. Replacement of the airbag is required if a spring is lost and is not covered under this action.

- Position the removal wedge -3409- on the plastic lugs to prevent damage to the conductor strip.
- Insert the removal wedge -3409- between the inflator and horn ring to prevent the horn ring from engaging again.
- Repeat work steps on other side.
