Safety Recall Code: 69Q8

TAKATA Driver Frontal Airbag Inflator

July 21, 2018

U.S.A. & CANADA: Certain 2006-2007 MY Volkswagen Passat Sedan & Passat Wagon vehicles equipped with a Takata driver frontal airbag

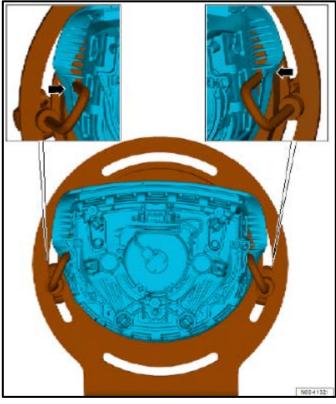
The clamps must be placed in the positions shown <arrows> to prevent damage to the airbag. Damage to the airbag is not covered under this action.

Clamp airbag centrally in airbag support. Securing points on the sides <arrows> and parallel opposite each other.

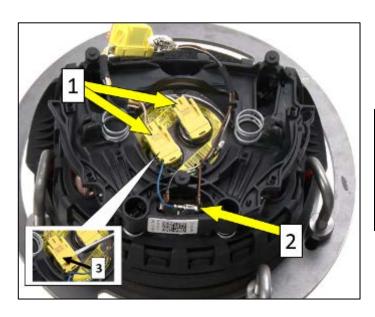
- Do not use a screwdriver to pry off connectors <1> or damage to the connectors could occur.
- Damage to the airbag connectors will not be covered under this action.

- Disengage connector locks <3> using a small flat bladed screwdriver.
- Remove connectors <1> using needle nose pliers.
- Remove ground cable <2>.

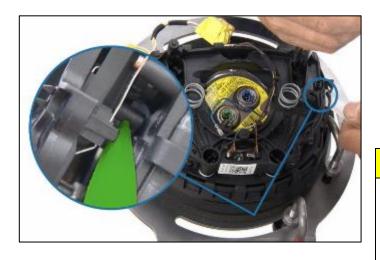
Use extreme care when removing the horn ring. If horn ring is damaged during removal, airbag replacement will be necessary. Replacement of the airbag due to damage during horn ring removal will not be covered under this action.

- Position the removal wedge -3409- on the plastic lugs to prevent damage to the conductor strip.
- Insert the removal wedge -3409- between the inflator and horn ring to prevent the horn ring from engaging again.
- Repeat work steps on other side.
