Safety Recall Code: 69X1

Subject	Second Row Bench Seat Safety Belt Buckles	
Release Date	June 21, 2018	
Affected Vehicles	U.S.A. & CANADA: Certain 2018 MY Volkswagen Atlas with second row bench seat	
	Check Campaigns/Actions screen in Elsa on the day of repair to verify that a VIN qualifies for repair under this action. Elsa is the <u>only</u> valid campaign inquiry & verification source.	
	✓ Campaign status must show "open."	
	✓ If Elsa shows other open action(s), inform your customer so that the work can also be completed at the same time the vehicle is in the workshop for this campaign.	
Problem Description	If a child restraint with a larger than recommended base is installed in the center position of the second row bench seat, it may damage both the center and adjacent outboard safety belt buckles. A damaged safety belt buckle can release unexpectedly, increasing the risk of injury to vehicle occupants in a crash.

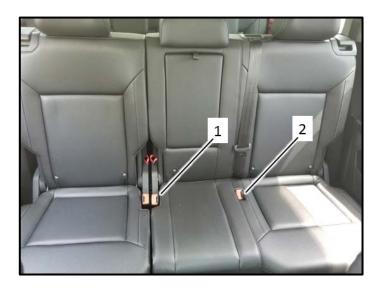
- When replacing an affected seat belt buckle, a VTA WEB ticket <arrow> must be created to order the seat • belt buckle(s). Do not call VTA.
- Attach a photo showing damage to the seat belt buckle(s) to the VTA WEB ticket.

- When creating the WEB ticket, be sure to enter a contact phone number at the bottom of the Technician's Questionnaire.
- Ground the vehicle until parts arrive.
