L73X-R.02.18

Engine SW Update

Aventador

**To: Official After Sales Network**  
**Subject: Engine SW Update**  
**Date: 05 October 2018**  
**Pages 10**

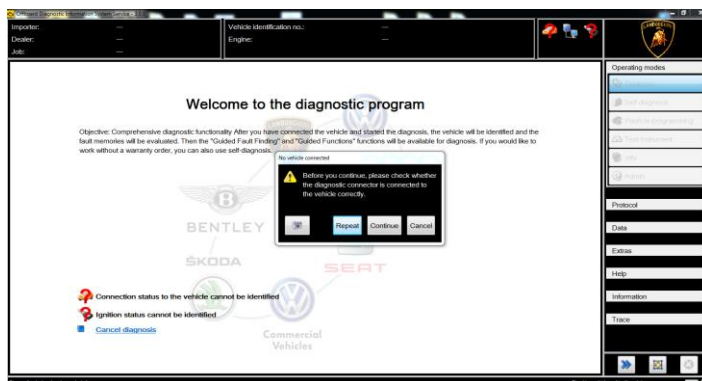
- A. If there are any connection problems with the VAS 6154 diagnostic interface and MY 12 vehicles, check the technical documentation in the Lamborghini HUB / Service / Service&Recall Campaigns-Technical Communication / Technical Communication / Aventador.
- B. If the error message regarding the diagnostic interface and the two icons for status of on board connection and key ON are shown as in the picture below:
  - Click “Cancel”;
  - Repeat the diagnostic interface installation following the procedure in the Lamborghini HUB / Service / Diagnosis / ODIS.
