SAFETY RECALL 18V-408 Retrofitting Bearing Support for Side Stand

SI 46 002 18R2

**G 310 R (K03, 0G11),
G 310 GS (K02, 0G12)**

Service Information No. SI 46 002 18R2

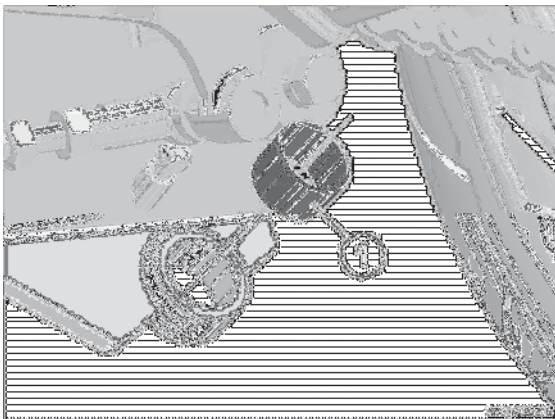
5

- ◆ Check the bearing bush **(1)** for cracks and deformation.

Bearing bush has cracks or is deformed/drilling template does not fit.

Bearing bush is damaged or deformed.

- ◆ Create a Puma case, do not carry out any repairs.

- ◆ Retrofit the bearing support for the side stand.

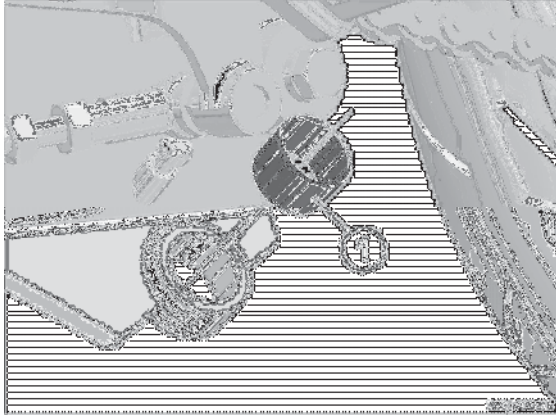
6

- Check the bearing bush (1) for cracks and deformation.

Distance is not there (bolts/footrest bracket have contact) or the bearing bush is damaged/deformed.

- Create a Puma case, do not carry out any repairs.
