Safety Recall

Code: 60D1

| Subject | Panoramic Sunroof Ambient Light Bar (LED Module) |
| Release Date | February 14, 2019 |

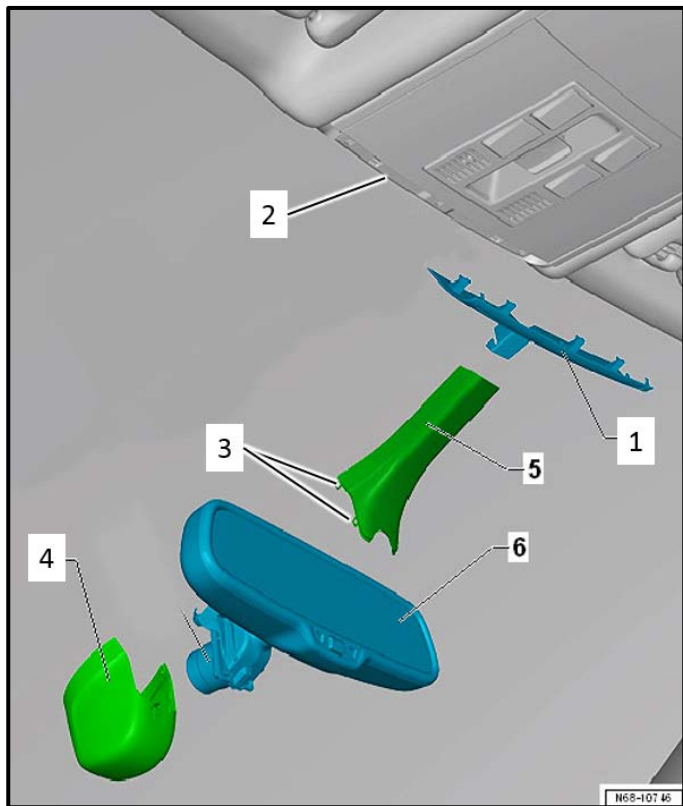
Remove rear view mirror base cover (versions without front camera):

- Using -3409-, unclip retaining plate <1> from the headliner frame <2>.
- Disengage clips <3> from front cover <4>.
- Remove retaining plate <1> with cover <5>.

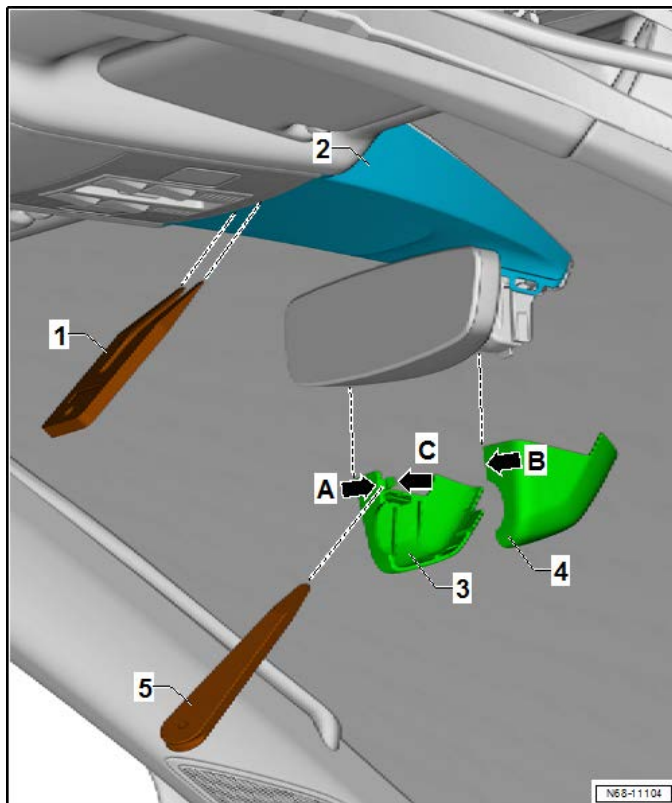
Remove rear view mirror base cover (versions with front camera):

- Using the -T10383/1- <1> unclip the cover for the front camera <2> from the retainer in the front area of the roof console.
- Using the wedge <1> push the cover of the front camera <2> slightly downward carefully.
- A gap will be built between the installed mirror covers <3 and 4>, <arrow A and arrow B>.
- Using the -3409- push the locking tab <C> of the left mirror cover <3>.
- First remove the right mirror cover <4>.
- Then remove the left mirror cover <3>.
- Remove the cover of the front camera <2>.

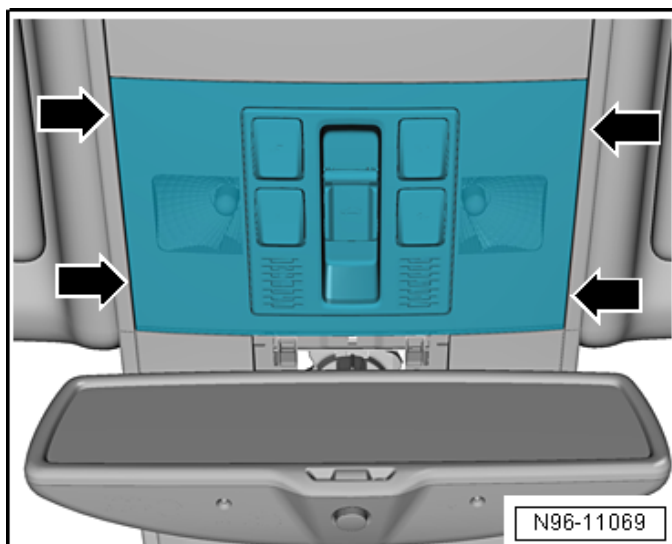
Remove overhead light switch assembly:

- Using the -3409-, pry the diffusion lens from the light switch assembly in the areas marked by <arrows>.
- If equipped, release and disconnect the connectors.

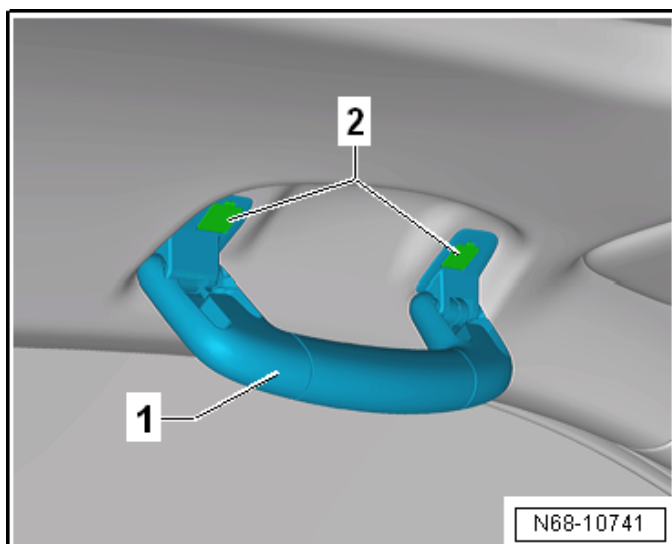
Remove all four roof grab handles:

- Fold the roof grab handle <1> downward and remove the caps <2> using an angled screwdriver, 90° pick or similar tool.

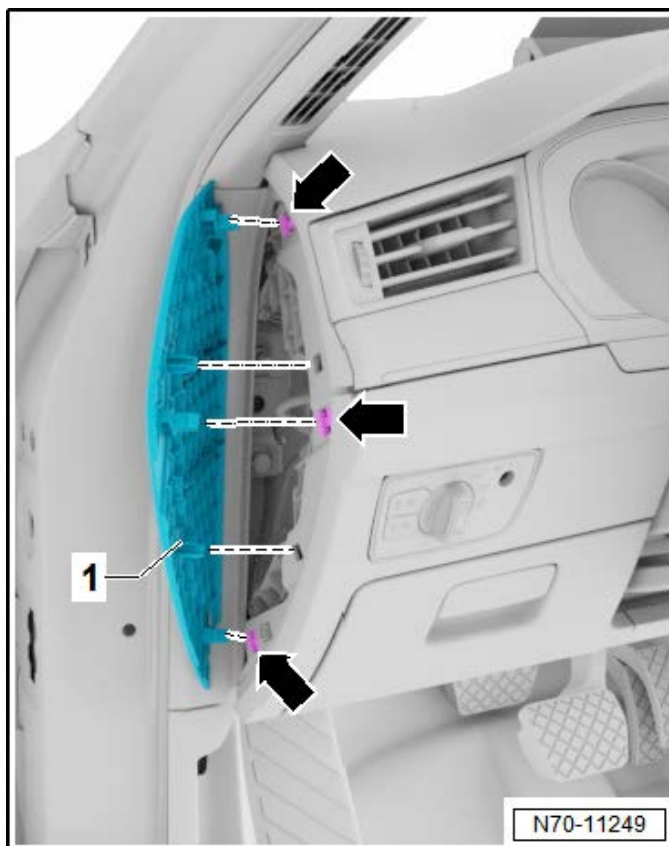
Remove both instrument panel side covers:

- Loosen the instrument panel side cover <1> with the -3409- in the area of the catches <arrows>.
- Remove the cover rearward from the A-pillar gap cover.

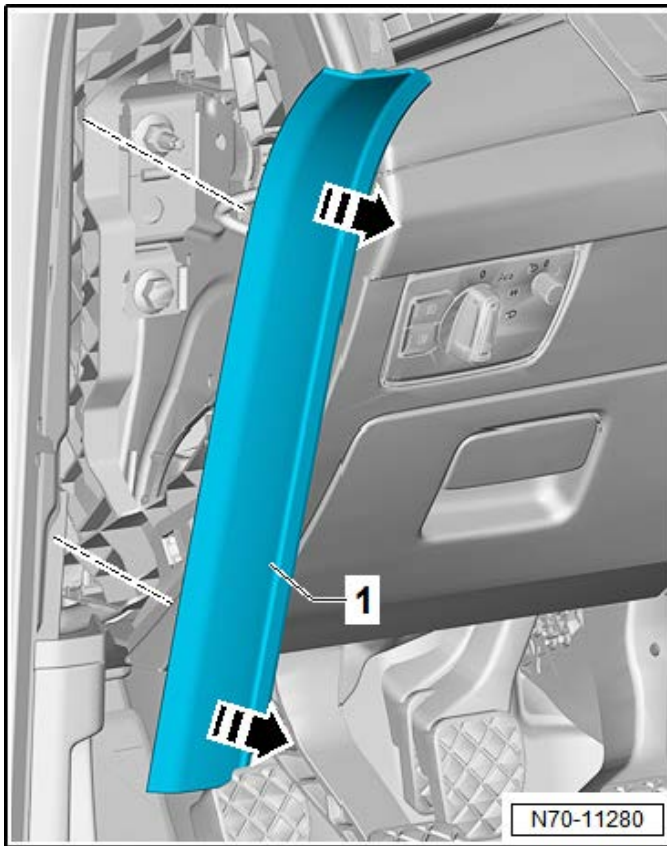
Remove both A-pillar gap covers:

- Unclip the A-pillar gap cover <1> from the A-pillar upper trim panel and A-pillar lower trim panel <arrows>.
- Loosen and remove the A-pillar gap cover <1> from the door seal molding.

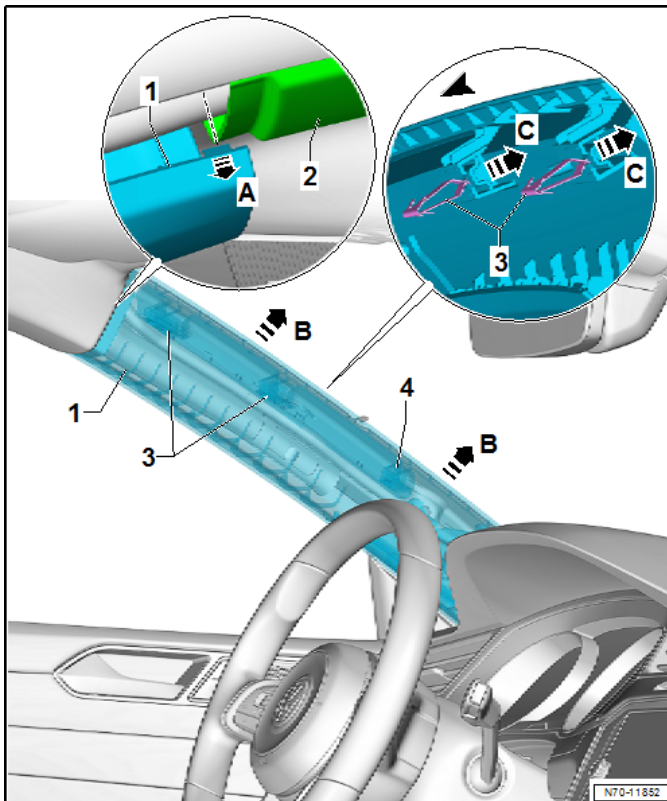
Remove both A-pillar trims:

- The holes for clips <3> on the A-pillar are slotted to allow the clips to slide out of the mounts on the A-pillar trim.
- The clips <3> will be replaced>.
- Remove A-pillar trim in direction of <arrows B>.

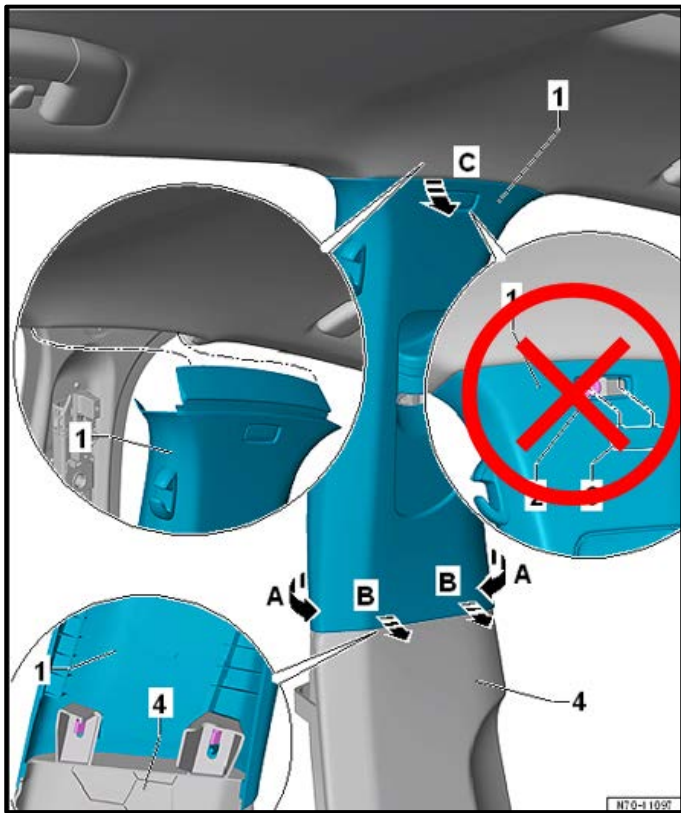
Disengage both upper B-pillar trims:

- Move seat belt height adjuster to the lowest position.
- Starting at the bottom, disengage the B-pillar upper trim panel <1> at the door seal <arrow A> by placing the -T10383- on the front edge of the trim panel.
- Unclip the B-pillar upper trim panel <1> from the B-pillar lower trim panel <4> <arrows B> by placing the -T10383- on the lower edge of the trim panel.
- Remove the B-pillar upper trim panel <1> from the mount on the body <arrow C> by pivoting the trim panel slightly inward and pulling it downward.

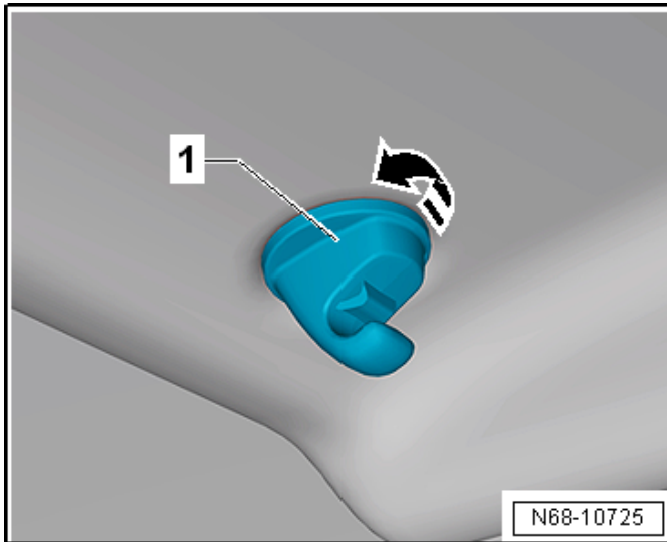
Remove both sun visor center supports:

- Disengage the sun visor at the sun visor center support and fold to the side.
- Turn the sun visor center support <1> approximately 90° (1/4 of a turn) counter-clockwise <arrow>.
- Remove the sun visor center support <1> downward.

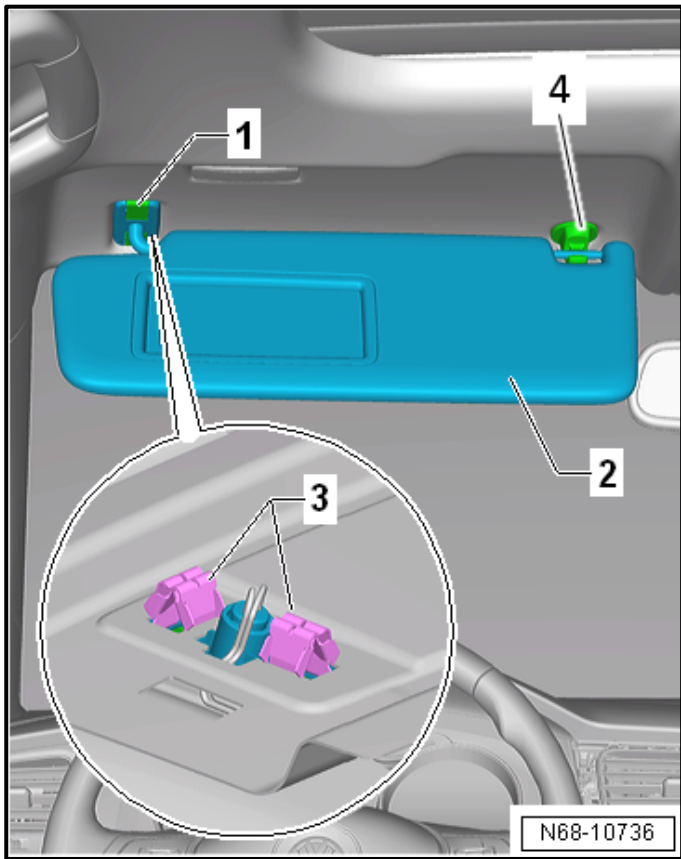
Remove both sun visors:

- Remove caps <1> from the sun visor mount.
- Using the -T10558-, loosen the front retainer <3> in the sun visor mount <1> from the body mount.
- Keep tension on the sun visor to prevent the retainer from unintentionally locking again.
- Using the -T10558-, loosen the rear retainer <3> in the sun visor mount <1> from the body mount.

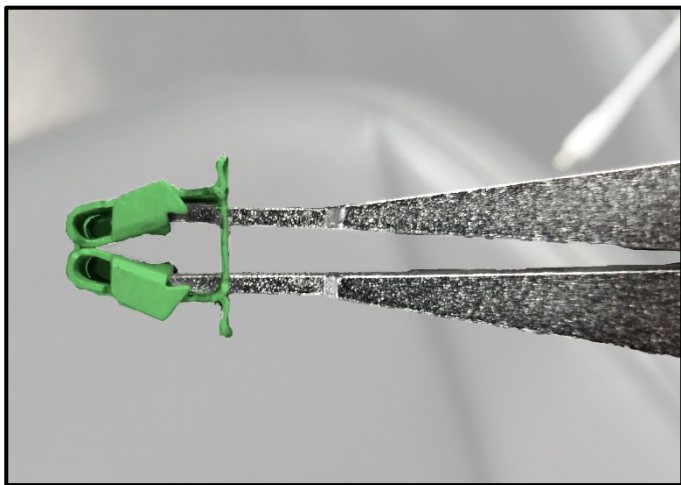
When removing clips for the sun visor mounts and the headliner mounts, the pliers -T10558- must be centered in the clip and fully inserted in the clip as shown.

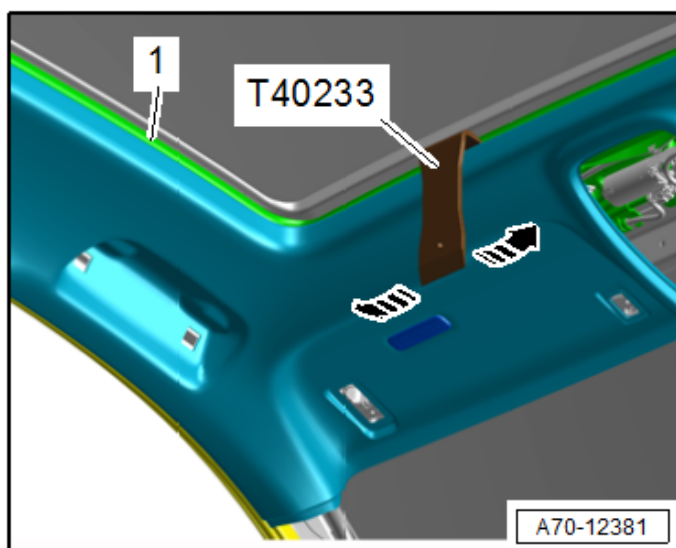
Separate headliner from sunroof trim:

- To avoid dirtying the headliner, clean the -T40233-.
- At the front of the headliner, push the -T40233- between the sunroof frame <1> and the headliner and loosen the front of the headliner.

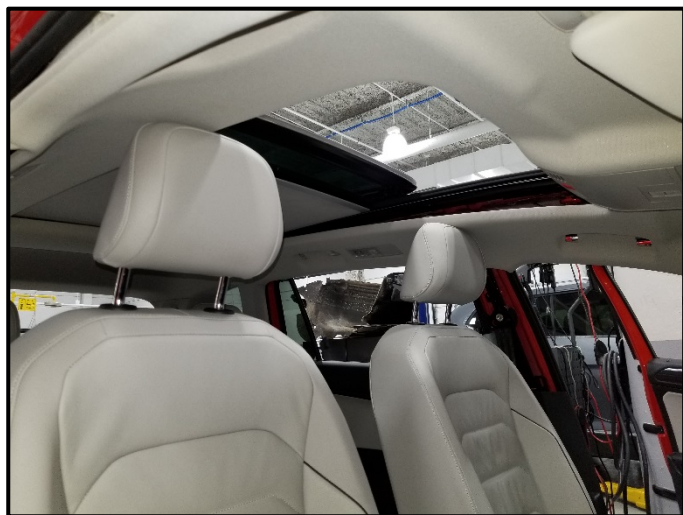
Position front seats and headrests:

- Raise front seats and headrests to their highest position.

The headliner does not need to be completely removed from the vehicle. Allowing the headliner to rest on the front seat headrests will allow enough room to install the in-line fuses. Doing so will also prevent damage to the headliner.

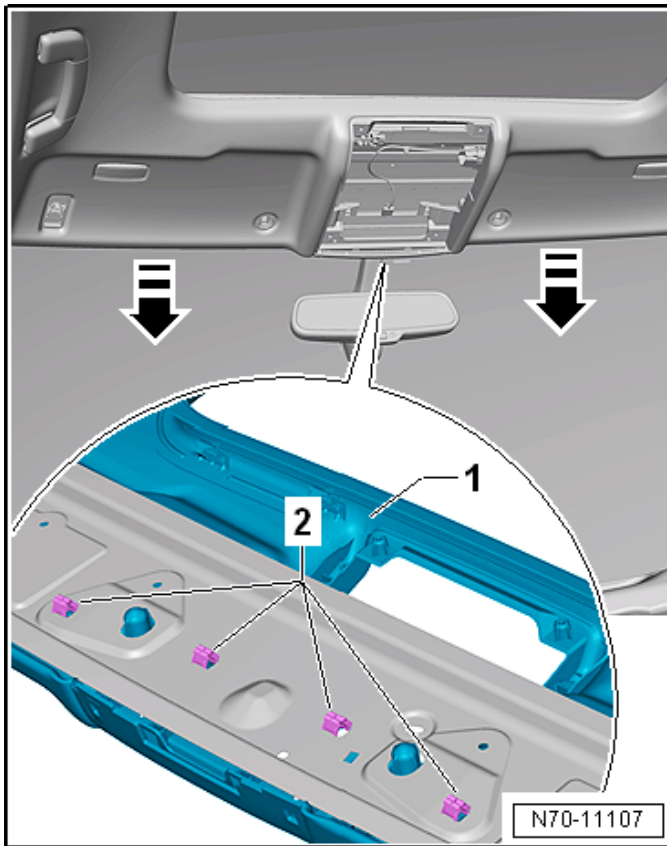
Releasing headliner clips:

- Release headliner clips <2> using -T10558- and lower the front of the headliner.

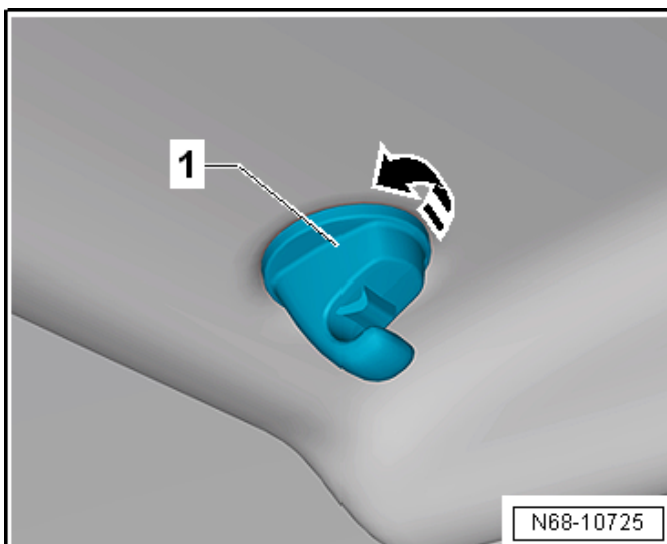
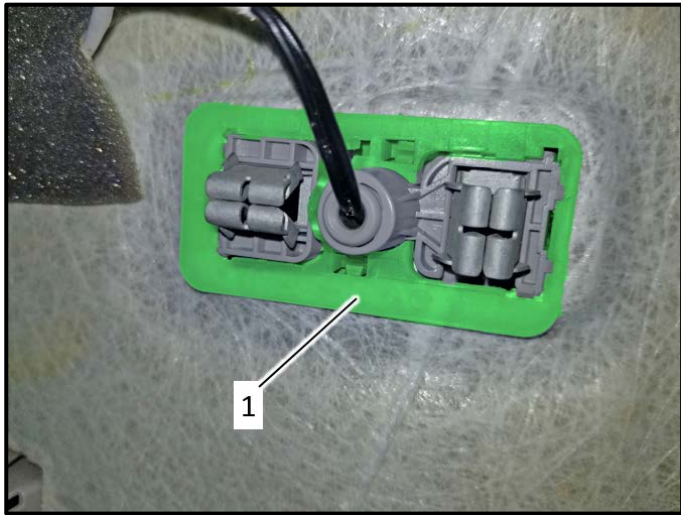
Reinstall both sun visor supports:

- Turn the sun visor center support <1> approximately 90° (1/4 of a turn) clockwise in opposite direction of <arrow>.
