## A. VEHICLE INSPECTION PROCEDURE

2009 Mazda6 (HP) and 2010 Mazda6 (HZ) vehicles, which were originally sold in, or currently or previously registered in Salt Belt States listed below.

### B. CROSS MEMBER INSPECTION PROCEDURE 2009-2010 MAZDA6

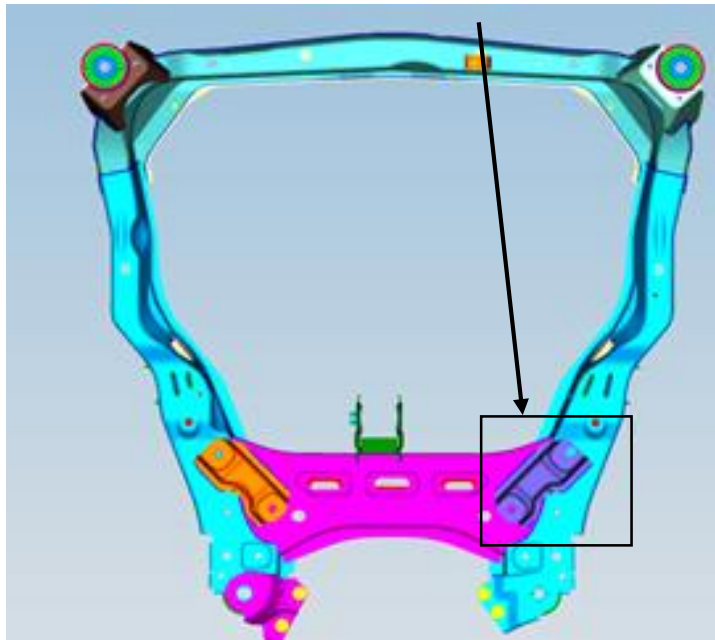
Top View – Area affected (Right Top Side)

# Zone 1 Inspection – Upper Surface/Top side

Look for holes or cracks along the top surface in these areas. If a hole or crack is present, the cross member needs to be replaced. This cross member fails inspection as there is perforation

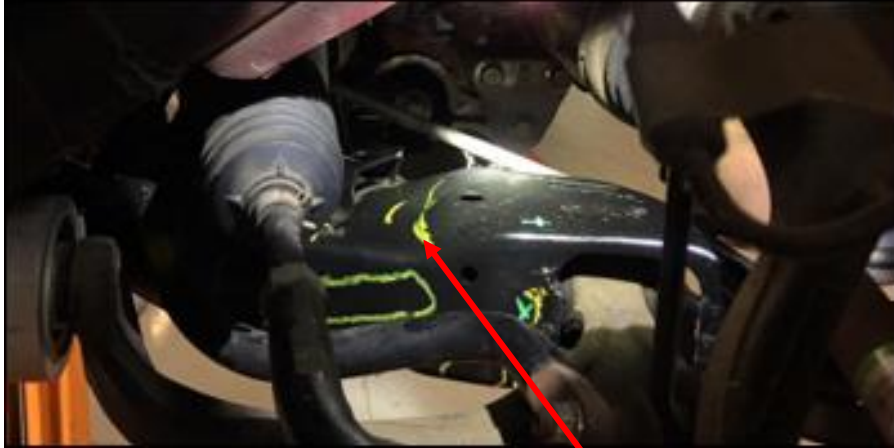
Top Side View: Non-Damaged Cross Member

## Zone 1 inspection Area: Top Surface

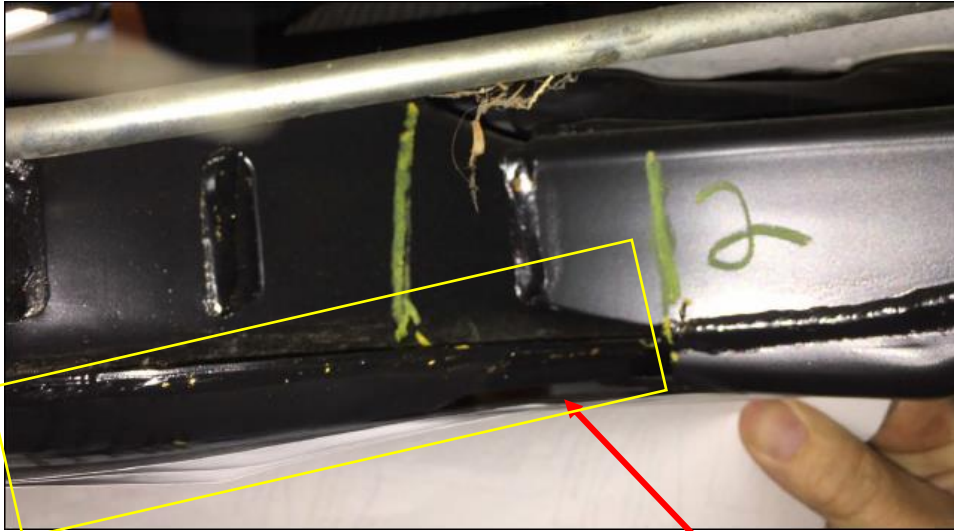
Inside View: Non-Damaged Cross member

Zone 2 inspection Area:

Look for perforation or crack along the flange in this area. If a crack or perforation is present, replace the cross member.

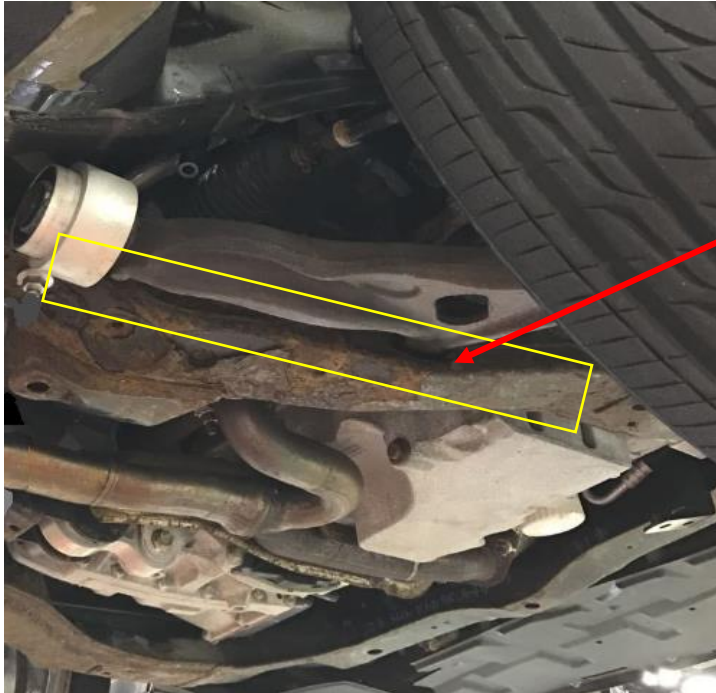
Side View: Non-Damaged Cross member

Zone 3 inspection Area:  
Look for perforation especially along the bottom corner ridge line (this area). If perforation or a crack is present the cross member needs to be replaced.
