GROUP  
**Safety Recall Campaign**

MODEL  
**2018MY  
Stinger (CK)**

NUMBER  
**SC170 (Rev 1, 02/04/2019)**

SUBJECT: **FRONT WIRING HARNESS INSPECTION/REPLACEMENT  
AND GROMMET INSTALLATION (SC170)**

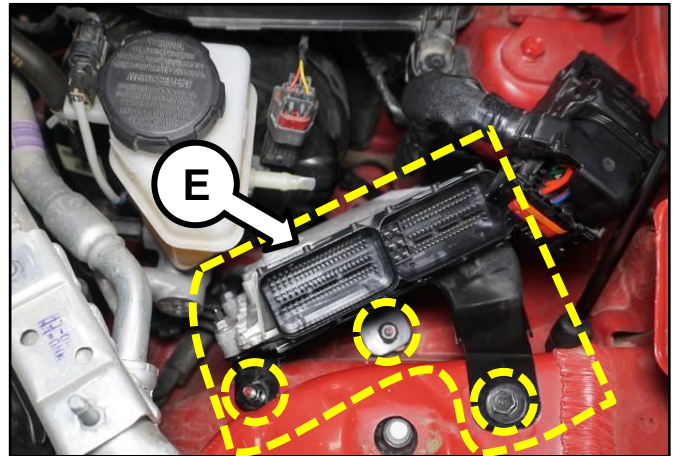
7. Visually inspect the harness for interference.
- If the harness is touching the left fender apron panel () , proceed to the next step.
  - If the harness is not touching the panel () , proceed to step 13 on page 5.

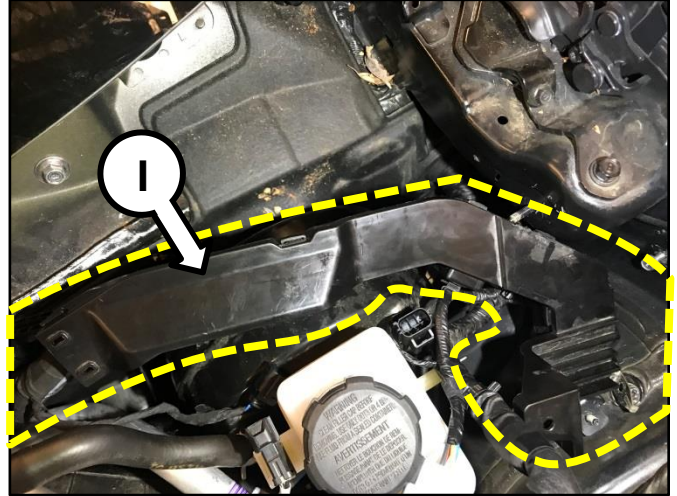
11. Carefully move the harness and protector (I) away from the firewall enough to allow access to the lower area of the harness.

12. Reach behind the hood and into the well area to slightly pull up the harness. Thoroughly inspect the harness for any damage.

- If there is damage to the harness, open a Techline case online and **do not proceed** with claim submission until wire harness replacement approval or denial is determined. See page 6 for the Front Wiring Harness Replacement procedure.
- If there is no damage to the harness, proceed to the next step.
