SIB 11 17 18

## RECALL CAMPAIGN 18V-755: EXHAUST GAS RECIRCULATION (EGR) COOLER INSPECTION (V8)

## Inspecting the EGR Cooler

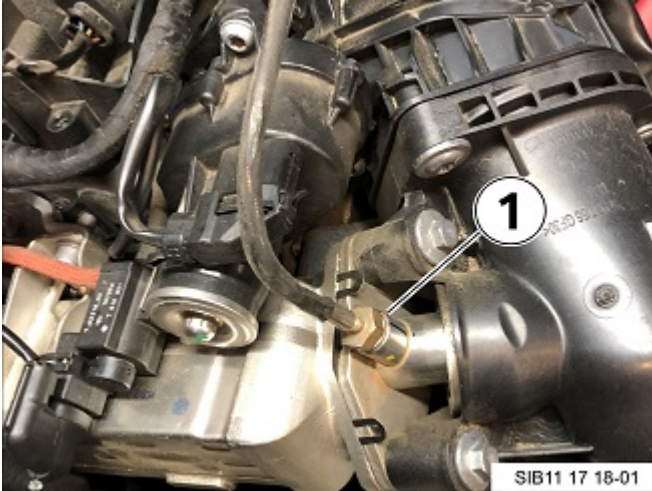
- Measure the temperature at the EGR cooler outlet pipe (1).

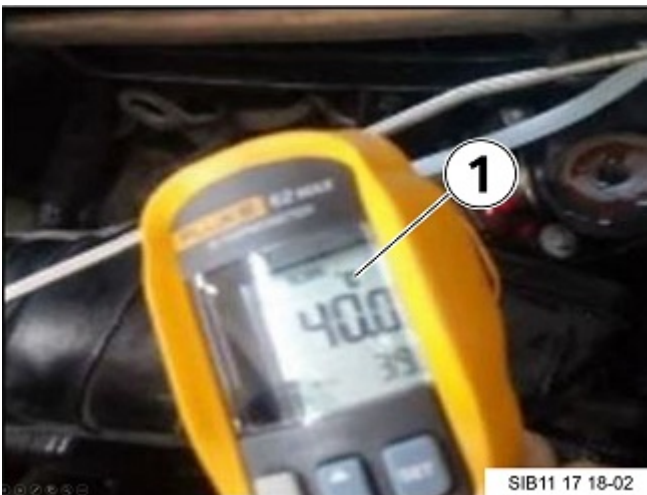
- The temperature of the cooler needs to be below 50°C (1) before the probe of the digital video scope can be safely inserted to inspect the cooler.

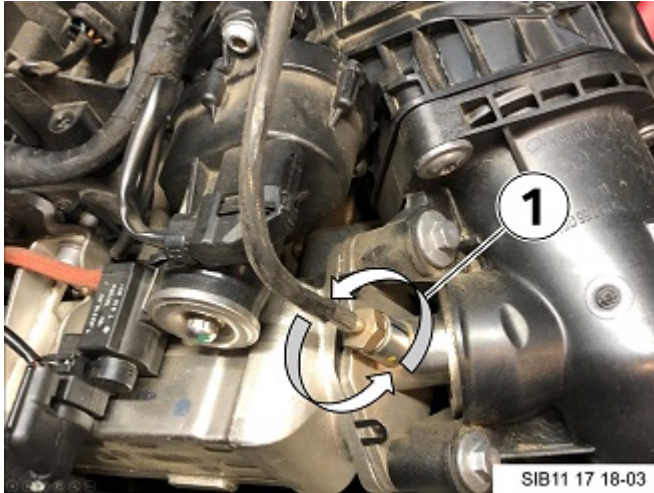
- Remove the EGR temperature sensor (1). **NOTE:** Count the number of revolutions (turns) required to remove the temperature sensor.
- **NOTE:** During installation, Pre-wind the temp sensor counterclockwise the number of turns it took to remove the sensor. This will keep the wires from twisting when reinstalled. Tightening torque 21Nm.

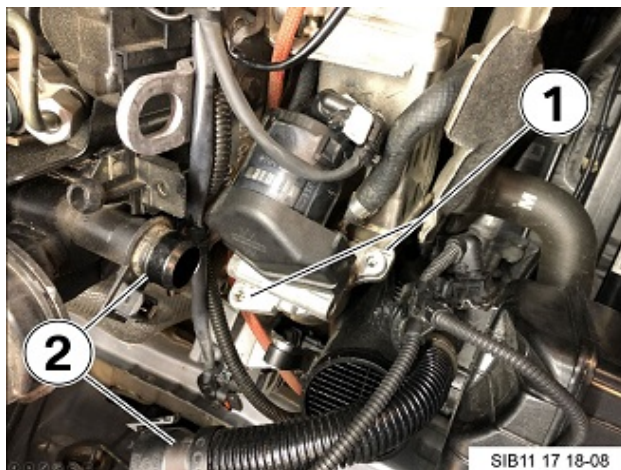
- Loosen the tamperproof T30 screws (1) on the EGR valve and remove the valve from the EGR cooler. **NOTE:** The valve only needs to be removed from the cooler far enough to inspect the inside of the cooler. Do not disconnect the cooling lines from the EGR valve.

**NOTE:** (F25 is pictured) It is necessary to disconnect the crankcase breather line to access the EGR valve (2).

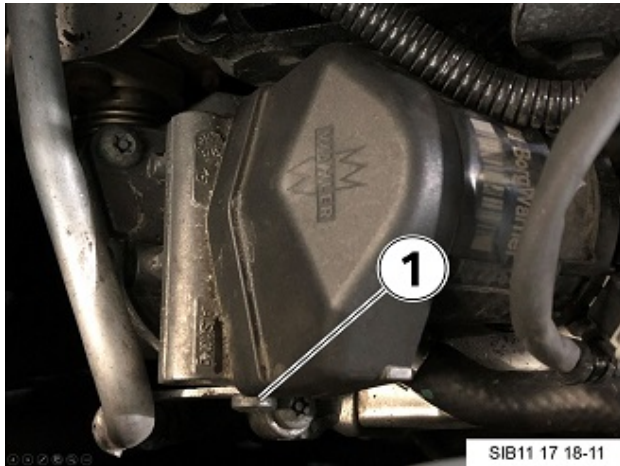
- **NOTE:** (F15 is pictured) Remove the T30 screw (1) before removing EGR valve.

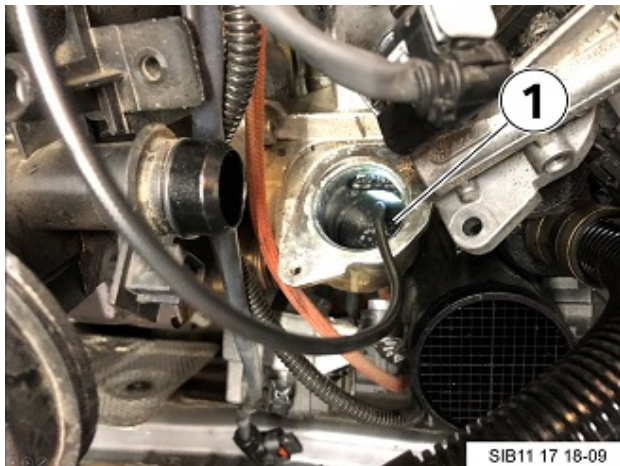
- Insert the probe for the borescope and inspect the fins on the inlet side of the EGR cooler for any build up or contamination (1).
