**SIB 11 17 18**

## RECALL CAMPAIGN 18V-755: EXHAUST GAS RECIRCULATION (EGR) COOLER INSPECTION

This Service Information Bulletin (Revision #9) replaces SI B11 17 18 **dated January 2020**.

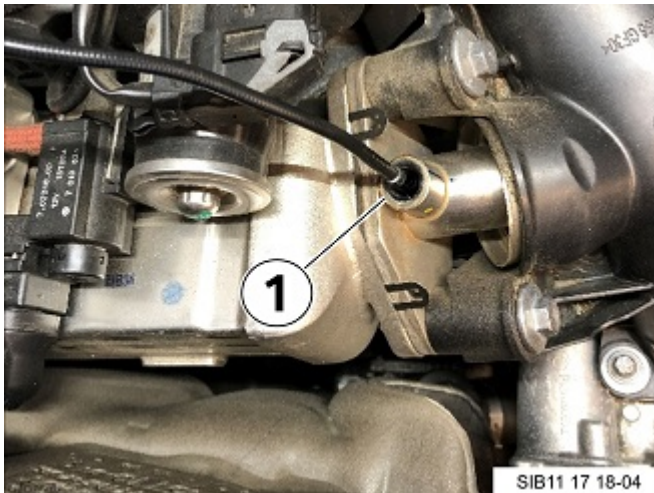
- Set the borescope to the 90° setting and install in the port temperature sensor (1).

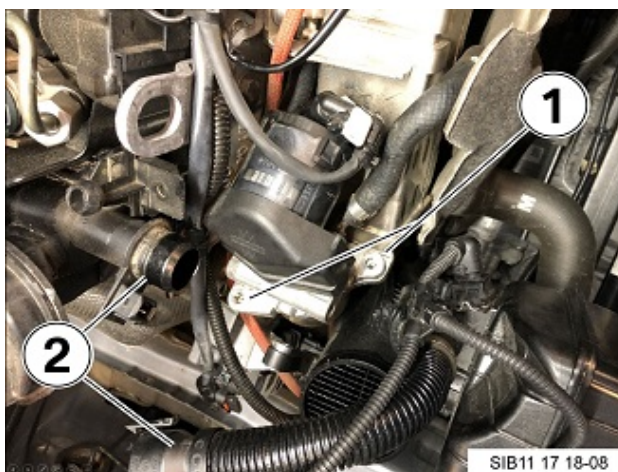
- Loosen the tamperproof T30 screws (1) on the EGR valve and remove the valve from the EGR cooler. **NOTE:** The valve only needs to be removed from the cooler far enough to inspect the inside of the cooler. Do not disconnect the cooling lines from the EGR valve.

**NOTE:** (F25 is pictured) It is necessary to disconnect the crankcase breather line to access the EGR valve (2).
