SIB 11 17 18

2019-10-29

RECALL CAMPAIGN 18V-755: EXHAUST GAS RECIRCULATION (EGR) COOLER INSPECTION (VS7)

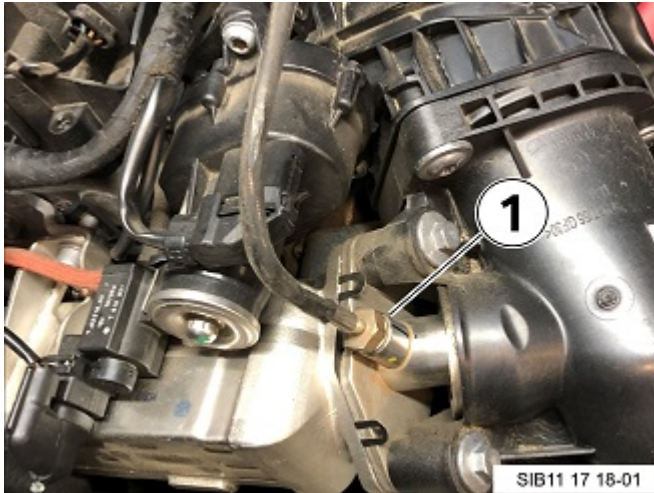
- Measure the temperature at the EGR cooler outlet pipe (1).

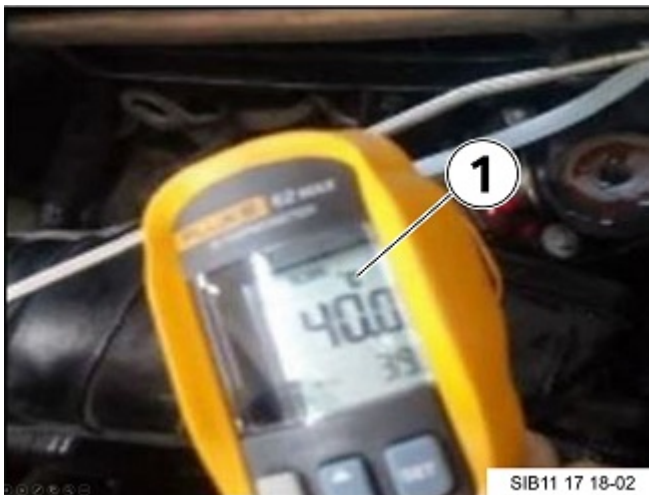
- The temperature of the cooler needs to be below 50°C (1) before the probe of the digital video scope can be safely inserted to inspect the cooler.

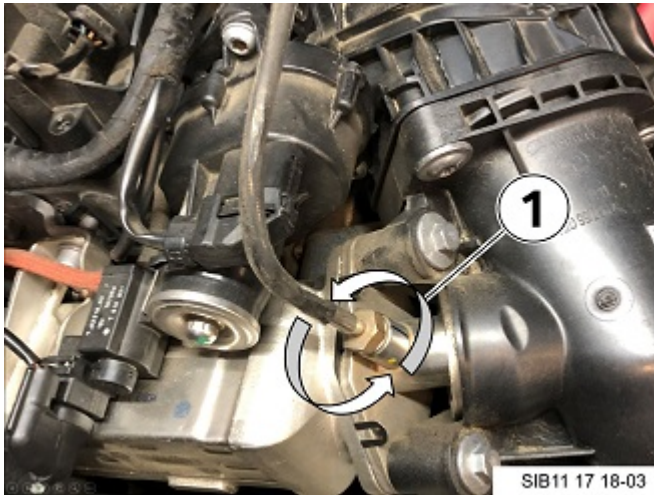
- Remove the EGR temperature sensor (1).
NOTE: Count the number of revolutions (turns) required to remove the temperature sensor.
- **NOTE:** During installation, Pre-wind the temp sensor counterclockwise the number of turns it took to remove the sensor. This will keep the wires from twisting when reinstalled. Tightening torque 21Nm.

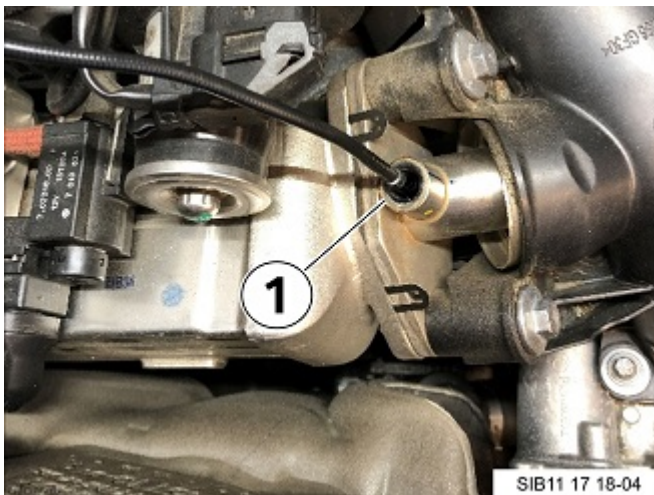
- Set the borescope to the 90° setting and install in the port temperature sensor (1).

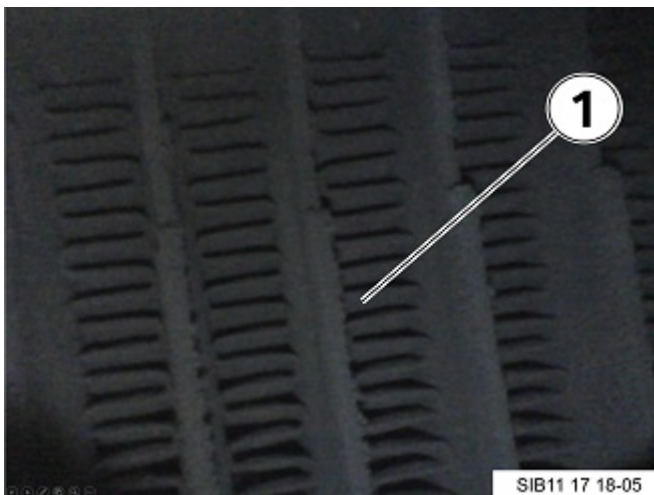
- Inspect the fins on the EGR cooler for any build up or contamination. Black dry soot is a normal byproduct of the EGR system. An internally failed cooler will have a mix of soot and coolant which creates a moist “sludge” build-up.

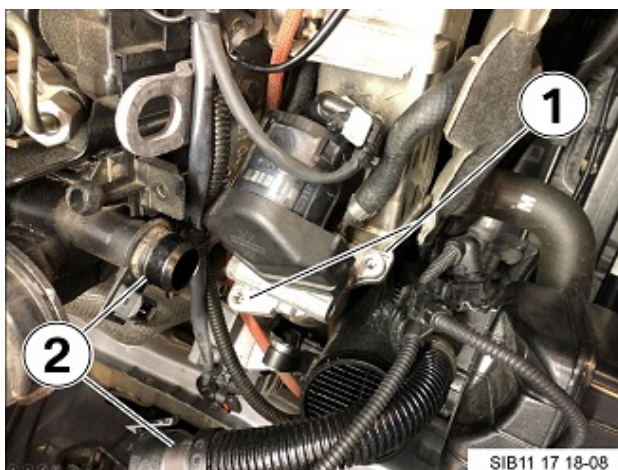
- Loosen the tamperproof T30 screws (1) on the EGR valve and remove the valve from the EGR cooler. **NOTE:** The valve only needs to be removed from the cooler far enough to inspect the inside of the cooler. Do not disconnect the cooling lines from the EGR valve.

NOTE: (F25 is pictured) It is necessary to disconnect the crankcase breather line to access the EGR valve (2).

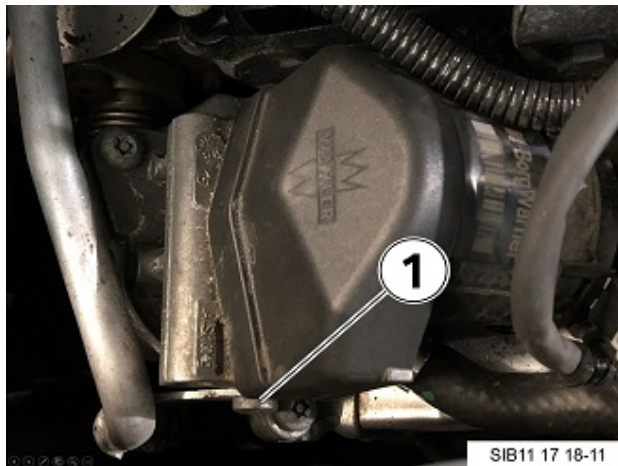
- **NOTE:** (F15 is pictured) Remove the T30 screw (1) before removing EGR valve.

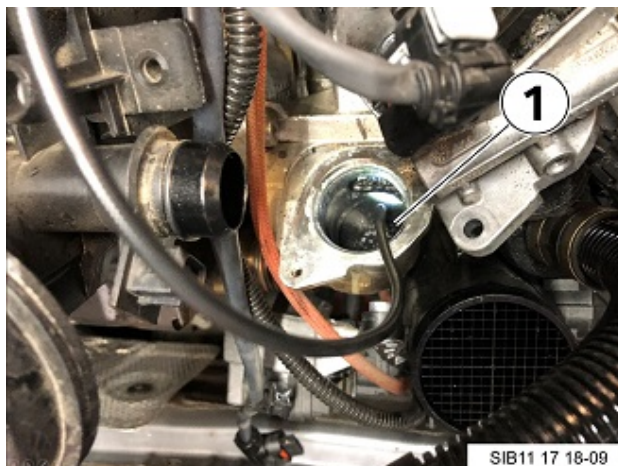
- Insert the probe for the borescope and inspect the fins on the inlet side of the EGR cooler for any build up or contamination (1).
