L614-
R.01.18

To: **Official After Sales Network**
Subject: **Engine Software Update Coupè**
Date: **21 December 2018**
Pages: **18**

Engine SW Update Coupè

Gallardo Coupè

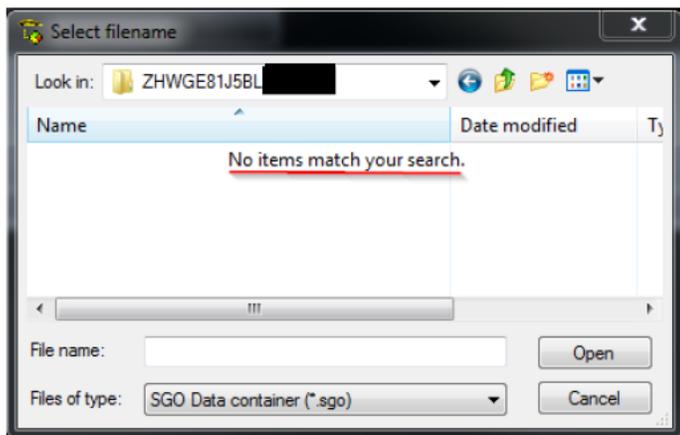
If no file is present in the folder as shown in the picture below, follow the troubleshooting chapter from step 68 of this bulletin.

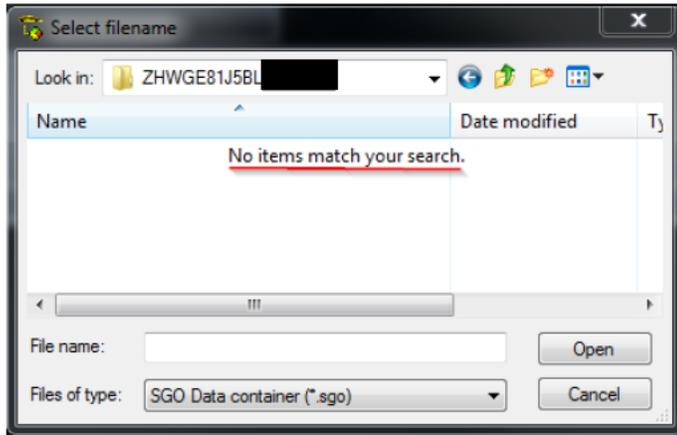
If no file is present in the folder as shown in the picture below, follow the troubleshooting chapter from step 68 of this bulletin.

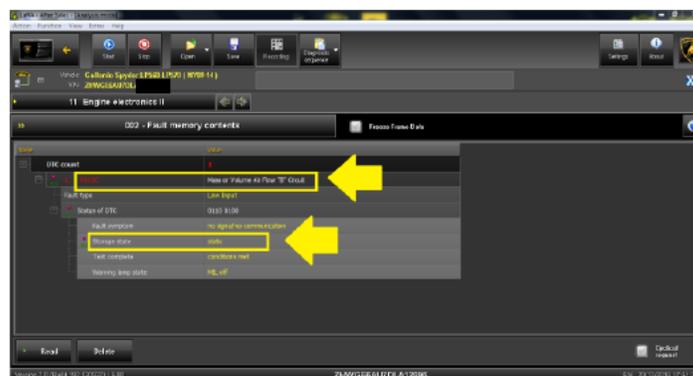
42. Click on the “Start” and verify that it is memorised the fault code “P010C” in the “static” state, as shown in the figure.

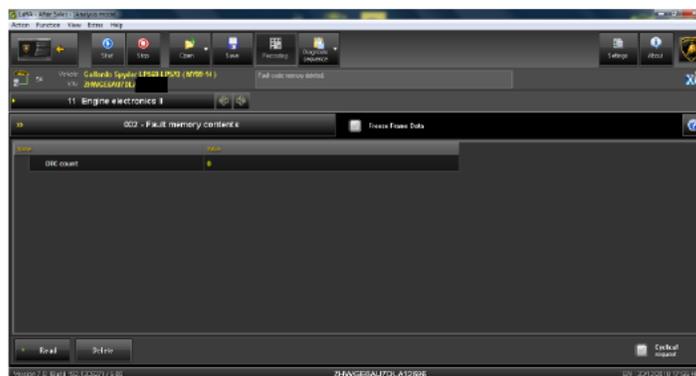
48. Verify that the fault code “P010C” does not appear in the list, as shown in the figure.

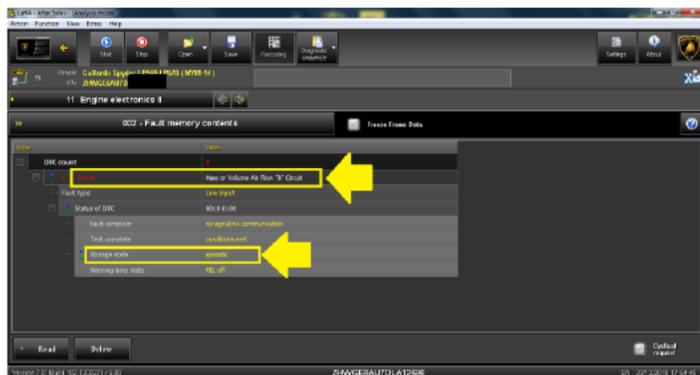
46. Click on the “Start” and verify that the fault code “P010C” has the “sporadic” state, as shown in the figure.

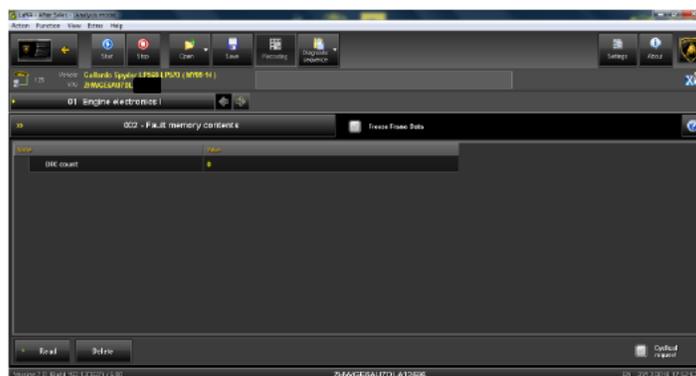
49. Check that no error code is saved in the “01 Engine electronics I” control unit, as shown in the figure.
