TECHNICAL INSTRUCTIONS

SAFETY RECALL JSL

PASSENGER AIRBAGS COULD DEACTIVATE

CERTAIN 2008 – 2019 LX 570

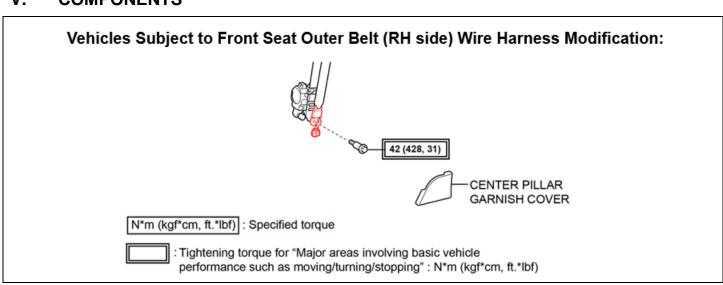
V. COMPONENTS

The front passenger occupant classification system has a seatbelt tension sensor that could malfunction over time and could cause the airbag warning light and the passenger airbag "OFF" indicator to illuminate. In addition, the front passenger airbag, passenger knee airbag, and the passenger seat-mounted side airbag may be deactivated. If these airbags are deactivated, there is an increased risk of injury to the occupant in the event of a crash.
