TECHNICAL INSTRUCTIONS

SAFETY RECALL JSL

PASSENGER AIRBAGS COULD DEACTIVATE

CERTAIN 2008 - 2019 LX 570

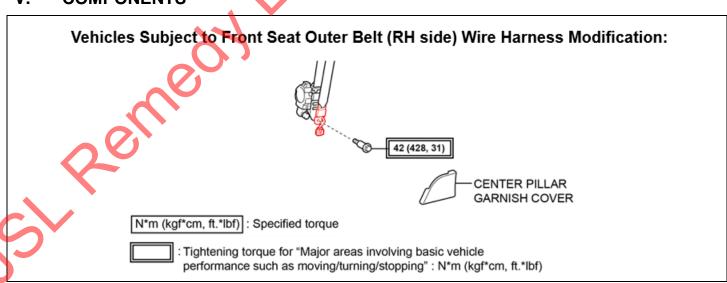
V. COMPONENTS

The front passenger occupant classification system has a seatbelt tension sensor that could malfunction over time and could cause the airbag warning light and the passenger airbag "OFF" indicator to illuminate. In addition, the front passenger airbag, passenger knee airbag, and the passenger seat-mounted side airbag may be deactivated. If these airbags are deactivated, there is an increased risk of injury to the occupant in the event of a crash.
