GROUP  
Safety Recall Campaign

NUMBER  
SC172 (Rev 3, 08/30/2019)

SUBJECT: HIGH PRESSURE FUEL PUMP OUTLET  
INSPECTION (SC172)

This bulletin provides the procedure to inspect the connections of the High Pressure Fuel Pipe to the fuel pump outlet for fuel leaking and, if necessary, replace the fuel pipe with a new one on certain vehicles listed below that received an engine replacement under Recall No. 17V224 (SC147), under Product Improvement Campaigns (PI1802 / PI1803) or under warranty. The previous engine replacement may not have been properly performed, and in some cases, the high pressure fuel pipe may have been damaged, misaligned or improperly torqued during the engine replacement procedure, allowing fuel to leak. Leaking fuel increases the risk of fire.

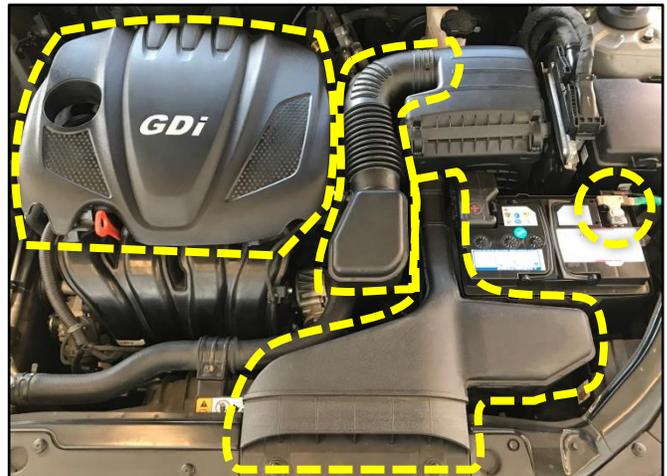
1. Record the customer's radio presets before proceeding to the next step.
2. Disconnect the negative (-) battery cable and then remove the engine cover, air duct, and air intake hose assembly.
3. Using regulated shop air, gently blow and clean the areas around the flare nut (A) at both ends of the high pressure fuel pipe to remove any debris or foreign substance.

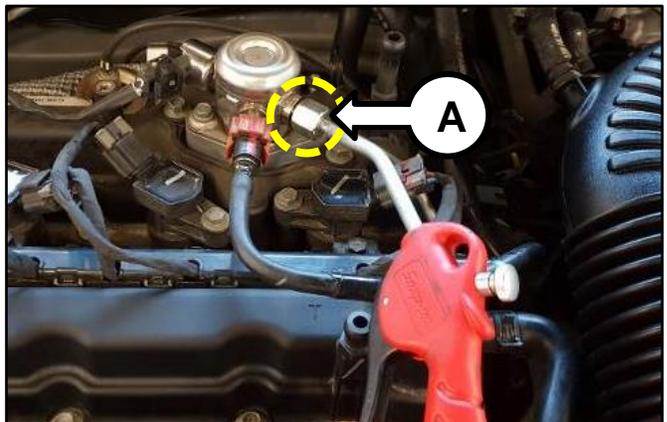
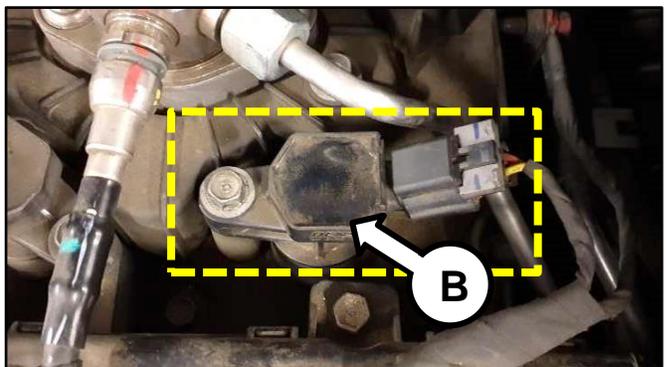
4. Disconnect and remove cylinder 4's ignition coil (B). Use a clean shop rag to cover the spark plug tube and ensure no foreign substance falls into the tube.

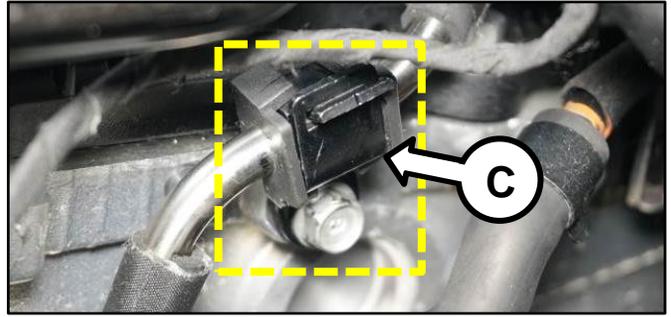
5. Ensure the high pressure fuel pipe retaining bracket (C) is torqued. If the bracket and bolt are missing\*, install a new bracket and bolt as necessary, prior to performing the next step.

\* **2.4L JF, JFa, UMa, & QL:** if the bracket and bolt (C) are missing, the high pressure fuel pipe must be replaced (pg. 5) as the bracket is not available separately (bolt is available separately).

**Tightening torque (bracket):**  
**5.8 – 8.7 lb.ft (7.8 – 11.8 N.m,**  
**0.8 – 1.2 kgf.m)**

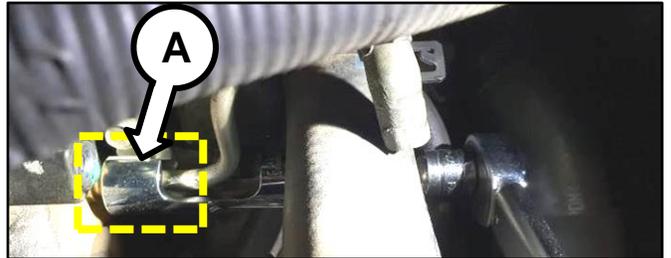
7. If the SST socket rotates, **DO NOT RE-TORQUE**. Proceed to the 2.4L GDI High Pressure Fuel Pipe Replacement procedure on page 5.

If the SST socket did not rotate, proceed to the step 8.

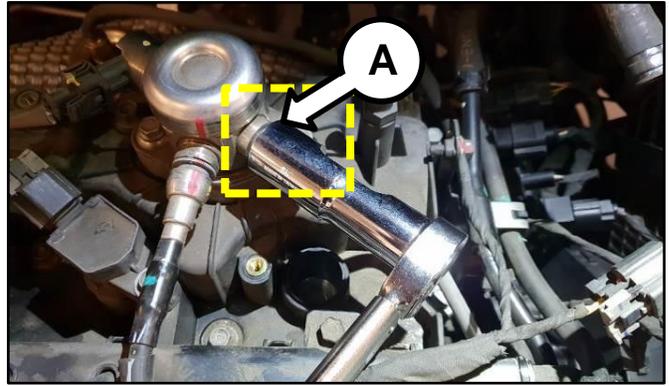
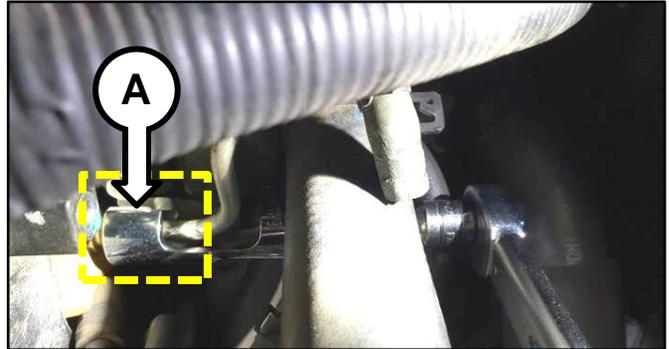
5. Using SST 09314-3Q100, carefully loosen the upper and lower high pressure pipe flare nuts (A). Remove and discard the high pressure fuel pipe.

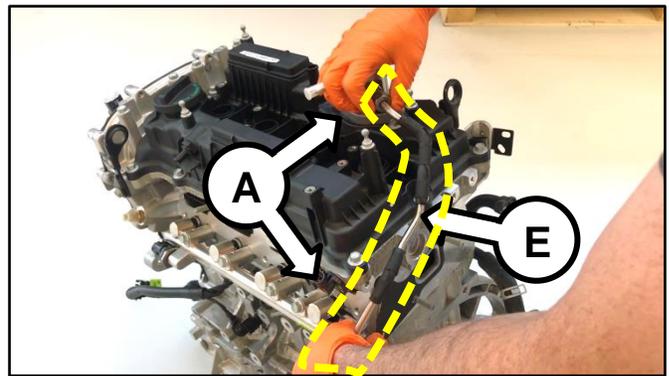
6. Properly position the new fuel pipe (E) and then hand-tighten both flare nuts (A).

Installation of fuel pipe was performed on a removed engine for demonstration purposes only.

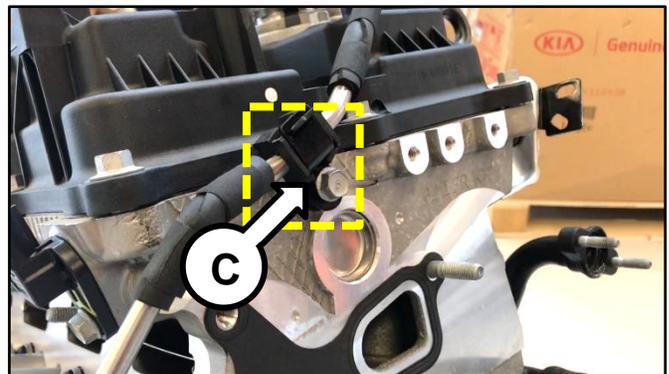
7. Install the pipe retaining bracket and bolt (C) and torque to specifications.

**2.4L TF, QF, XMa, & SL:** If the bracket and bolt are missing, order and install a new bracket and bolt.

**2.4L JF, JFa, UMa, & QL:** If the bolt is missing, order and install a new bolt.

5.8 – 8.7 lb.ft (7.8 –11.8 N.m,  
0.8 – 1.2 kgf.m)

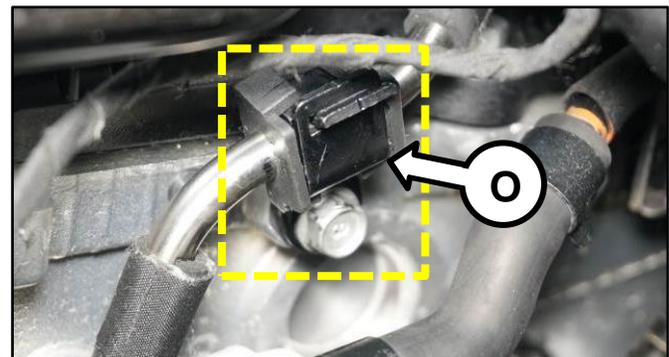
14. Ensure the high pressure fuel pipe retaining bracket (O) is torqued.

If the bracket and bolt are missing, order and install a new bracket and bolt.

**Tightening torque:**  
5.8 – 8.7 lb.ft (7.8 –11.8 N.m,  
0.8 – 1.2 kgf.m)

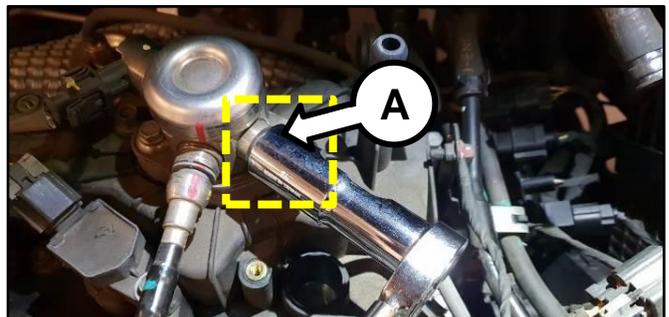
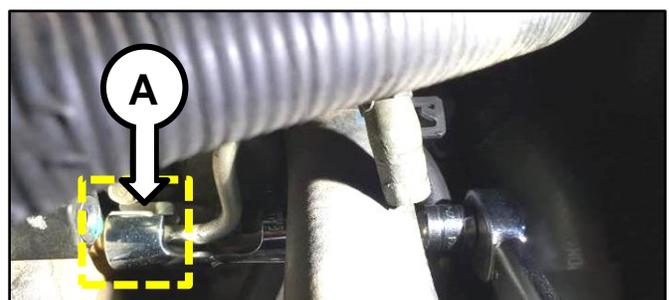
3. Using SST 09314-3Q100, carefully loosen the upper and lower high pressure fuel pipe flare nuts (A). Remove and discard the high pressure fuel pipe.

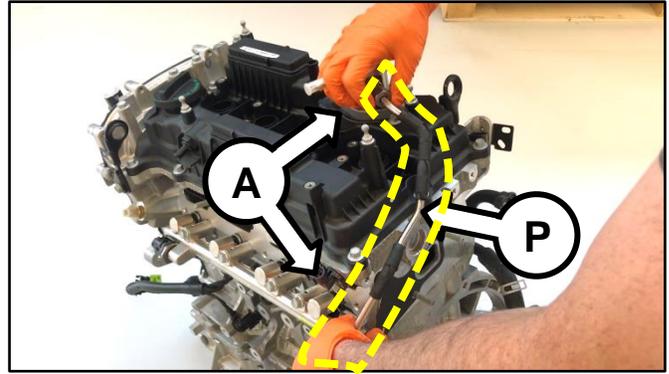
4. Properly position the new fuel pipe (P) and then hand-tighten both flare nuts (A).

Installation of fuel pipe was performed on a removed engine for demonstration purposes only.

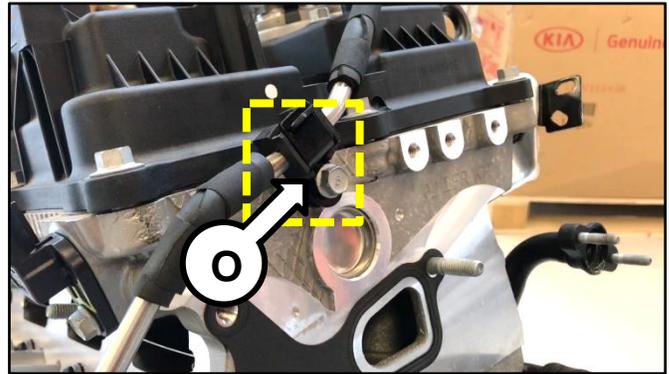
5. Install the pipe retaining bracket and bolt (O) and torque to specifications.

If the bracket and bolt are missing, order and install a new bracket and bolt.

**Tightening torque:**  
 5.8 – 8.7 lb.ft (7.8 – 11.8 N.m,  
 0.8 – 1.2 kgf.m)

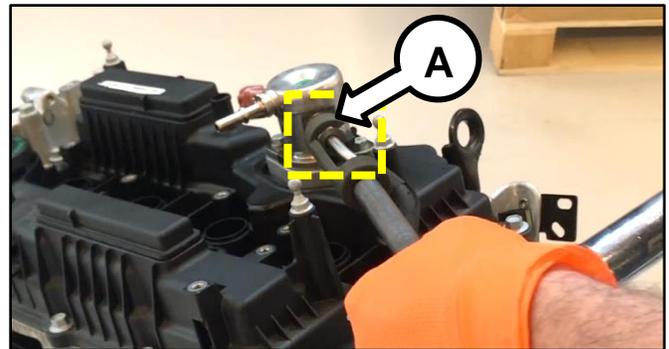
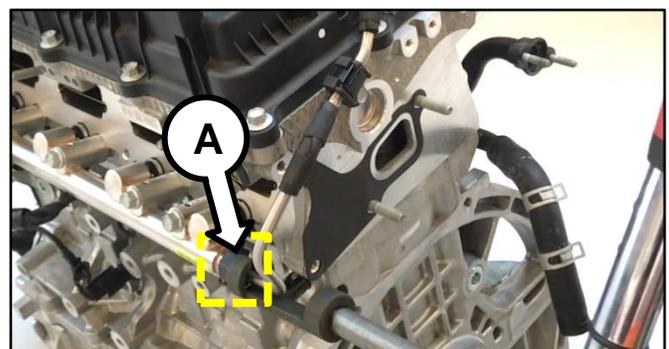
6. Using a click-type/electronic torque wrench and SST 09314-3Q100, torque both flare nuts (A) to specifications.

**Tightening torque:**  
 19.5 – 23.9 lb.ft (26.5 – 32.4 N.m,  
 2.7 – 3.3 kgf.m)

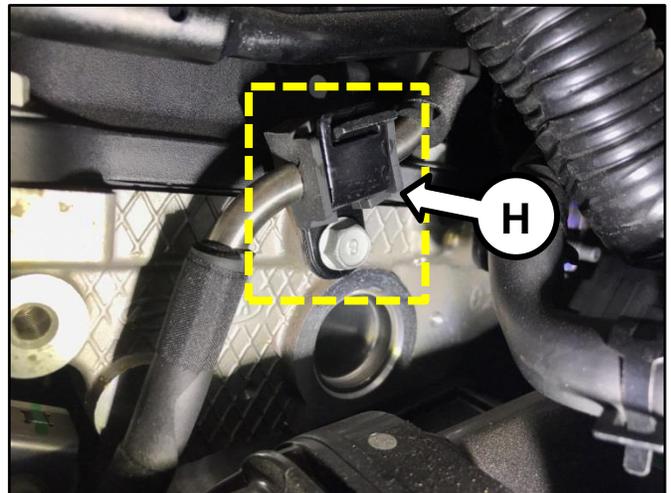
10. Ensure the high pressure fuel pipe retaining bracket (H) is torqued.

- If the bracket and bolt are missing, proceed to the "JFa/UMa/QL 2.0T GDI High Pressure Fuel Pipe Replacement Procedure" on page 19 (bracket is not available separately).
- If only the bolt is missing, order and install a bolt.

**Tightening torque (bracket):**

**5.8 – 8.7 lb.ft (7.8 –11.8 N.m,  
0.8 – 1.2 kgf.m)**

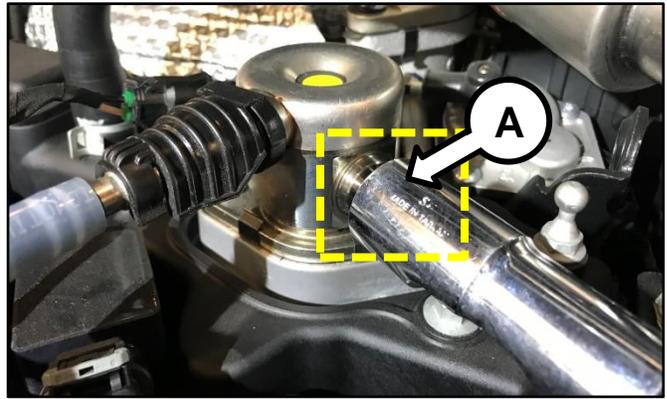
11. Using a click-type/electronic torque wrench and SST 09314-3Q100, verify and ensure the flare nuts (A) at both ends of the high pressure fuel pipe are torqued to specifications.

**Tightening torque (flare nuts):**  
**19.5 – 23.9 lb.ft (26.5 – 32.4 N.m,**  
**2.7 – 3.3 kgf.m)**

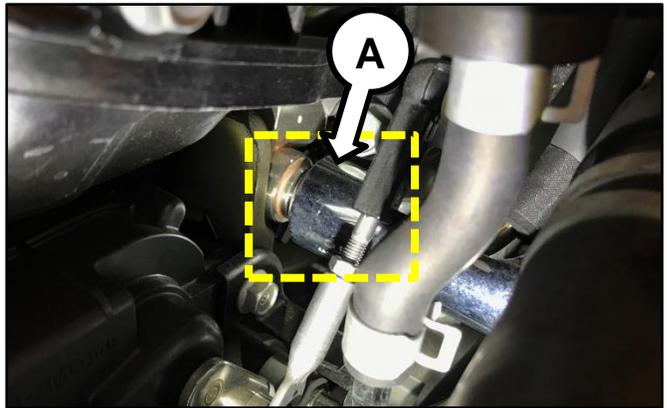
12. If the SST socket rotates, **DO NOT RE-TORQUE.** Proceed to the “JFa/UMa/QL 2.0T GDI High Pressure Fuel Pipe Replacement Procedure” on page 19.

If the SST socket did not rotate, proceed to the step 13.
