GROUP
Safety Recall Campaign

NUMBER
SC172 (Rev 1, 02/18/2019)

SAFETY RECALL CAMPAIGN

SUBJECT: HIGH PRESSURE FUEL PUMP OUTLET
INSPECTION (SC172)

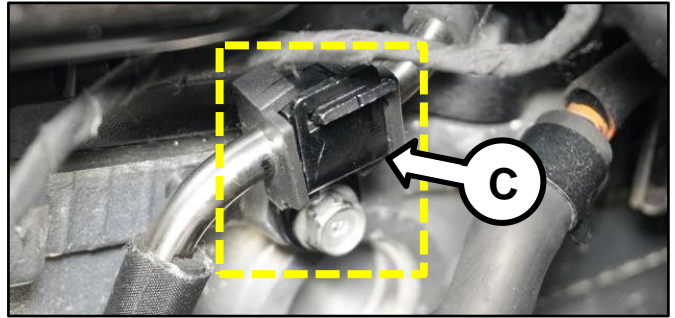
5. Ensure the high pressure fuel pipe retaining bracket (C) is torqued. If the bracket and bolt are missing*, install a new bracket and bolt as necessary, prior to performing the next step.

* **2.4L JF, JFa, UMa, & QL:** if the bracket and bolt (C) are missing, the high pressure fuel pipe must be replaced (pg. 5) as the bracket is not available separately (bolt is available separately).

Tightening torque (bracket):
5.8 – 8.7 lb.ft (7.8 – 11.8 N.m,
0.8 – 1.2 kgf.m)

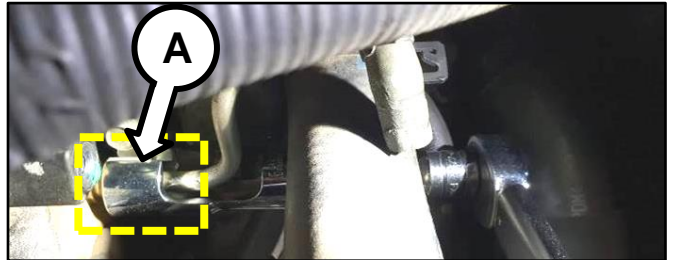
7. If the SST socket rotates, **DO NOT RE-TORQUE**. Proceed to the 2.4L GDI High Pressure Fuel Pipe Replacement procedure on page 5.

If the SST socket did not rotate, proceed to the step 8.

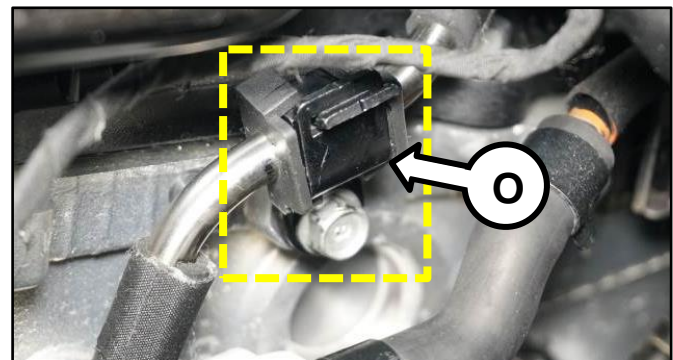
14. Ensure the high pressure fuel pipe retaining bracket (O) is torqued.

If the bracket and bolt are missing, order and install a new bracket and bolt.

Tightening torque:
 5.8 – 8.7 lb.ft (7.8 –11.8 N.m,
 0.8 – 1.2 kgf.m)

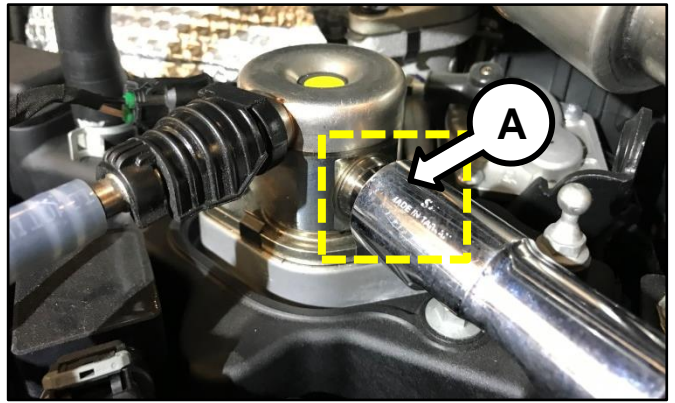
12. If the SST socket rotates, **DO NOT RE-TORQUE.** Proceed to the “JFa/UMa/QL 2.0T GDI High Pressure Fuel Pipe Replacement Procedure” on page 19.

If the SST socket did not rotate, proceed to the step 13.
