GROUP Safety Recall Campaign	MODEL 2011-2014MY Optima (QF/TF) 2012-2014MY Sorento (XMa) 2011-2013MY Sportage (SL)
	NUMBER SC172	DATE January 2019
SAFETY RECALL CAMPAIGN		
SUBJECT: HIGH PRESSURE FUEL PUMP OUTLET INSPECTION (SC172)

This bulletin provides the procedure to inspect the connections of the High Pressure Fuel Pipe to the fuel pump outlet for fuel leaking and, if necessary, replace the fuel pipe with a new one on certain 2011-2014 MY Kia Optima, 2012-2014 MY Kia Sorento, and 2011-2013 MY Kia Sportage vehicles **that received an engine replacement under Recall No. 17v224 (SC147)**. The remedy for the previous recall may not have been properly performed, and in some cases, the high pressure fuel pipe may have been damaged, misaligned, or improperly torqued during the engine replacement procedure, allowing fuel to leak. Leaking fuel increases the risk of fire.

HIGH PRESSURE FUEL PUMP OUTLET INSPECTION (SC172)

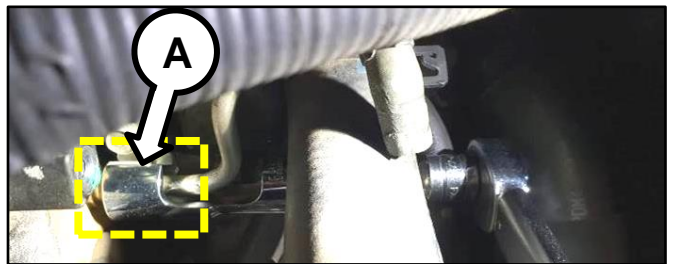
7. If the SST socket rotates, **DO NOT RE-TORQUE**. Proceed to the 2.4L GDI High Pressure Fuel Pipe Replacement procedure on page 5. If the SST socket did not rotate, proceed to the step 8.
