GROUP  
Safety Recall Campaign

NUMBER  
SC172 (Rev 2, 03/08/2019)

SUBJECT: HIGH PRESSURE FUEL PUMP OUTLET  
INSPECTION (SC172)

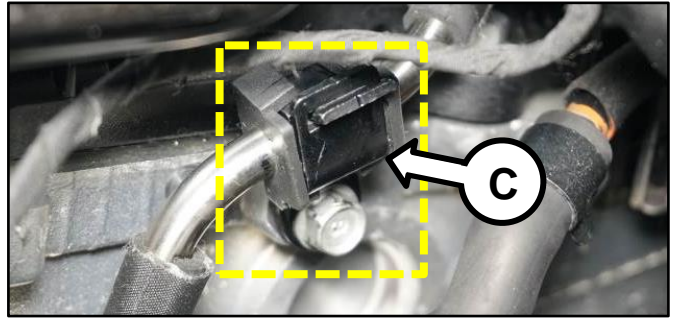
5. Ensure the high pressure fuel pipe retaining bracket (C) is torqued. If the bracket and bolt are missing\*, install a new bracket and bolt as necessary, prior to performing the next step.

\* **2.4L JF, JFa, UMa, & QL:** if the bracket and bolt (C) are missing, the high pressure fuel pipe must be replaced (pg. 5) as the bracket is not available separately (bolt is available separately).

**Tightening torque (bracket):**  
**5.8 – 8.7 lb.ft (7.8 – 11.8 N.m,**  
**0.8 – 1.2 kgf.m)**

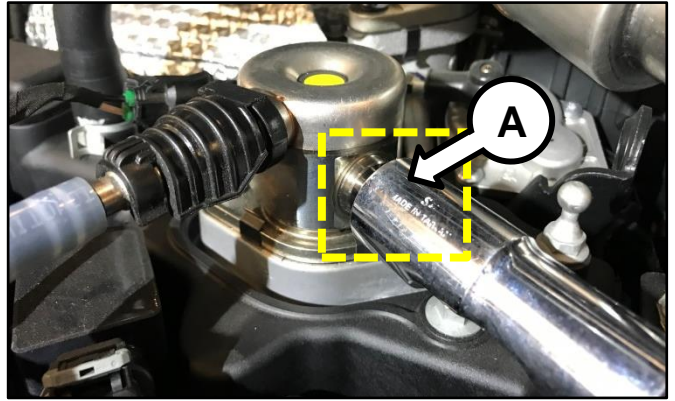
12. If the SST socket rotates, **DO NOT RE-TORQUE**. Proceed to the “JFa/UMa/QL 2.0T GDI High Pressure Fuel Pipe Replacement Procedure” on page 19.

If the SST socket did not rotate, proceed to the step 13.

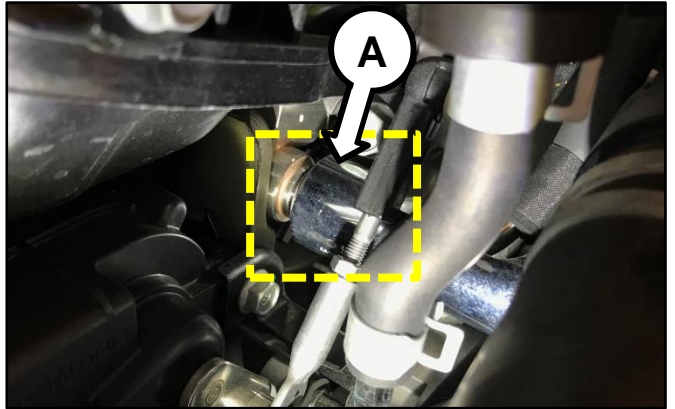
15. With the engine idling, use one strip of oil test paper and wipe the areas around the high pressure fuel pipe flare nuts (A) and the gap between the flare nut and pipe.

- If the wiped section of the oil test paper becomes a darker shade, proceed to the “JFa/UMa/QL 2.0T GDI High Pressure Fuel Pipe Replacement Procedure” on page 19.
- If the oil test paper color does not change, reinstall all removed components in the reverse order of removal and reprogram the customer’s radio presets. No further action is required.

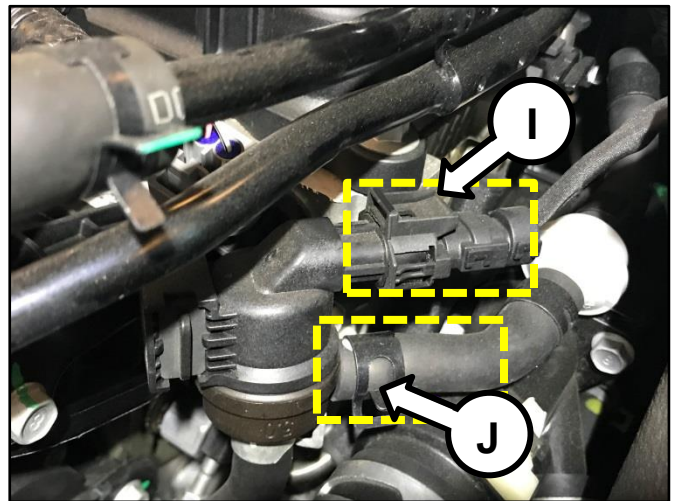
2. Perform steps 2 through 9 of the 2.0T High Pressure Fuel Pipe Inspection procedure as necessary and then disconnect the PCSV connector (I) and upper hose (J).

3. Remove the high pressure fuel pipe retaining bracket bolt and bracket (H). **DO NOT DISCARD THE RETAINING BRACKET BOLT.**

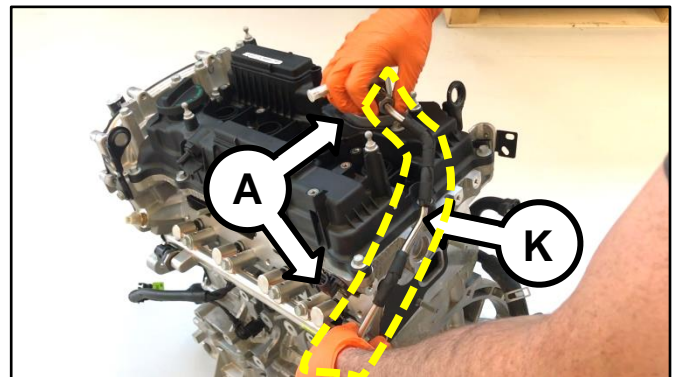
Installation of fuel pipe was performed on a removed engine for demonstration purposes only.

- Properly position the new fuel pipe (K) and then hand-tighten both flare nuts (A).
