GROUP	NUMBER
RECALL	19-01-001H
DATE	MODEL(S)
MARCH 2019	APPLICABLE VEHICLES BELOW

HIGH PRESSURE FUEL PIPE INSPECTION AND REPLACEMENT (RECALL CAMPAIGN 180)

Description: The high pressure fuel pipe may have been damaged, misaligned, or improperly torqued during prior engine replacement allowing fuel to leak, increasing the risk of a fire. This bulletin describes the procedure to confirm the high pressure fuel pipe is properly installed.

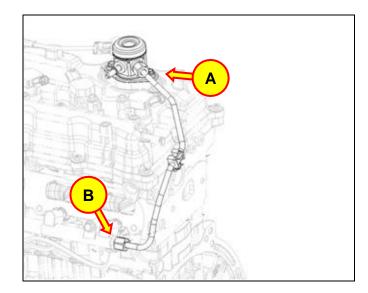
3. Remove debris on the high pressure fuel pump and the high pressure fuel pipe nuts at (A) and (B) using compressed air.

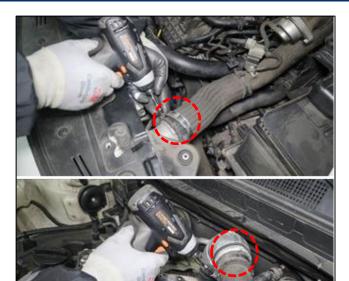
4C. **For 2.0L Turbo vehicles**, loosen the intercooler inlet hose clamps and remove the intercooler inlet hose.

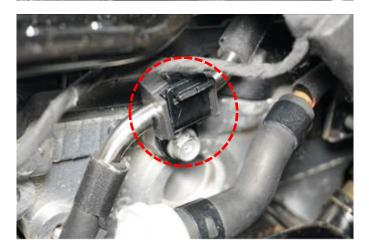
15. Remove the fuel pipe clamp bolt and bracket.

Tightening Torque: 7.8 ~11.8 Nm (0.8 ~ 1.2 kgf.m, 5.8 ~ 8.7 lb-ft)

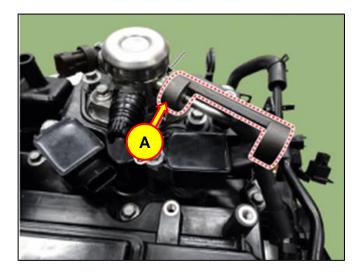
16. Remove the high pressure fuel pipe nut (A) from the high pressure fuel pump **using the SST**.

26.5 ~32.4 Nm (2.7 ~ 3.3 kgf.m, 19.5 ~ 23.9 lb-ft)

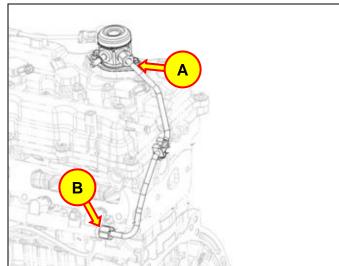
17. Remove the high pressure fuel pipe nut (B) from the delivery pipe **using the SST**.

26.5 ~32.4 Nm (2.7 ~ 3.3 kgf.m, 19.5 ~ 23.9 lb-ft)

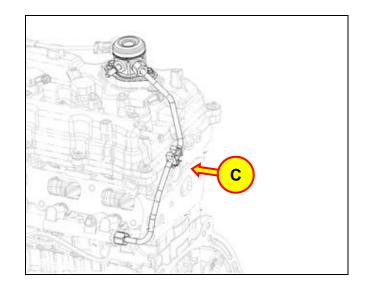
18. Loosen the function block nut (C) and remove and discard the old high pressure fuel pipe. Transfer the center bracket from the old pipe to the new pipe if needed.

7.8 ~11.8 Nm (0.8 ~ 1.2 kgf.m, 5.8 ~ 8.7 lb-ft)

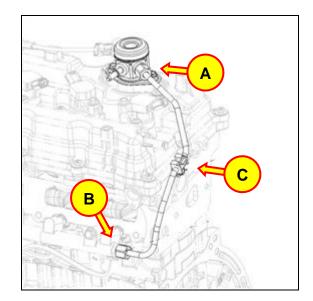
Do NOT fully tighten.
Do NOT use a power tool.
