BLUE BIRD

R18ZE

DATE: July 31, 2019
TO: Blue Bird Owners
Subject: Recall R18ZE, Intermittent Air Gauge Operation (Noncompliance)

Intermittent Air Gauge Operation

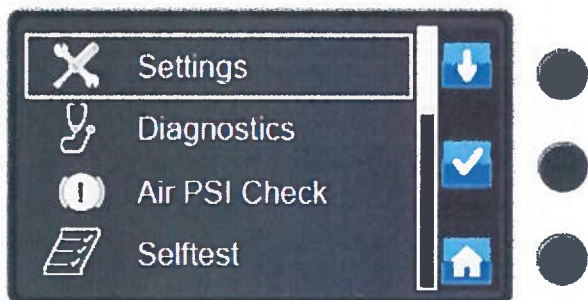
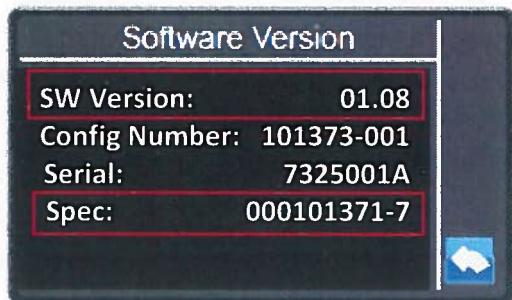
Verify software version is correct for applicable Spec number.

Note: The "SW Version" number displayed is the software version level currently installed.

Note: The "Spec" number displayed is the Ametek part number listed on the Vantage website and below.

If yes, update procedure is complete. If no, verify software version being installed and reflash.
