BLUE BIRD

R18ZE

DATE: February 11, 2019
TO: Blue Bird Owners
Subject: Recall R18ZE, Intermittent Air Gauge Operation (Noncompliance)

Intermittent Air Gauge Operation

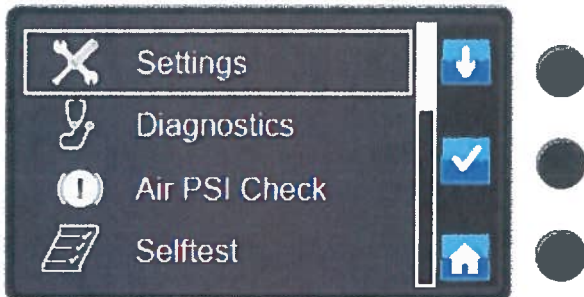
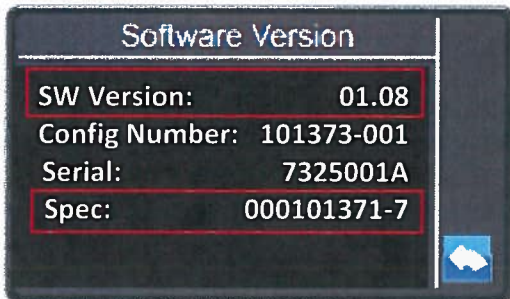
Verify software version is correct for applicable Spec number.

Note: The "SW Version" number displayed is the software version level currently installed.

Note: The "Spec" number displayed is the Ametek part number listed on the Vantage website and below.

If yes, update procedure is complete. If no, verify software version being installed and reflash.

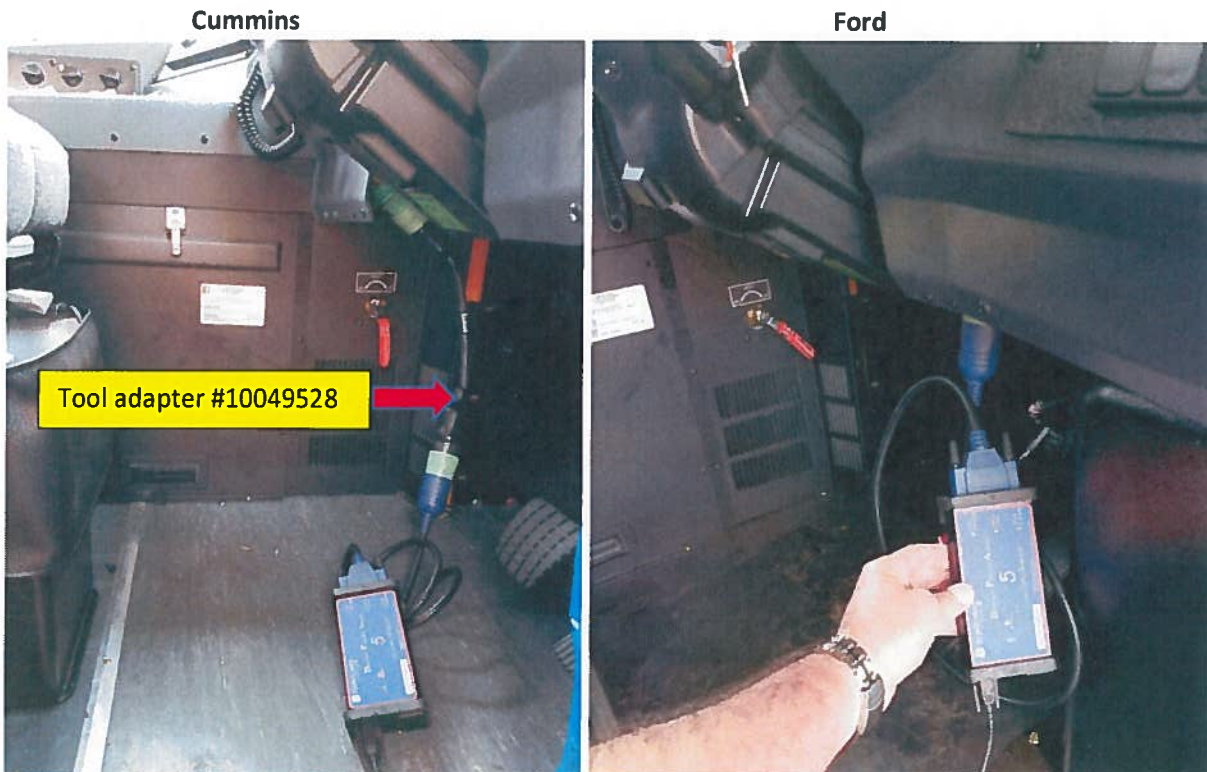
Example: Vision bus diagnostic port connections shown below:

Note: Tool adapter #10049528 is ONLY required with Cummins (Bus has Green Diagnostic Port).

To update the Ametek cluster software version on a bus, connect Dearborn DPA-5 or equivalent RP1210 communication adapter to the laptop using the USB connection and then connect to the J1939 diagnostic port of the bus. Note: Based on year model, engine model, J1939 diagnostic port will be located on lower left or right side of the steering column. Cummins diesel engines that are EPA/CARB certified (Built on or after 01/18/2016) will require service tool adapter #10049528, reference Service Memorandum SM1603.
