Product Safety Recall

17477 Front Passenger Air Bag Inflator

Reference Number: N161644421

Release Date: March 2018

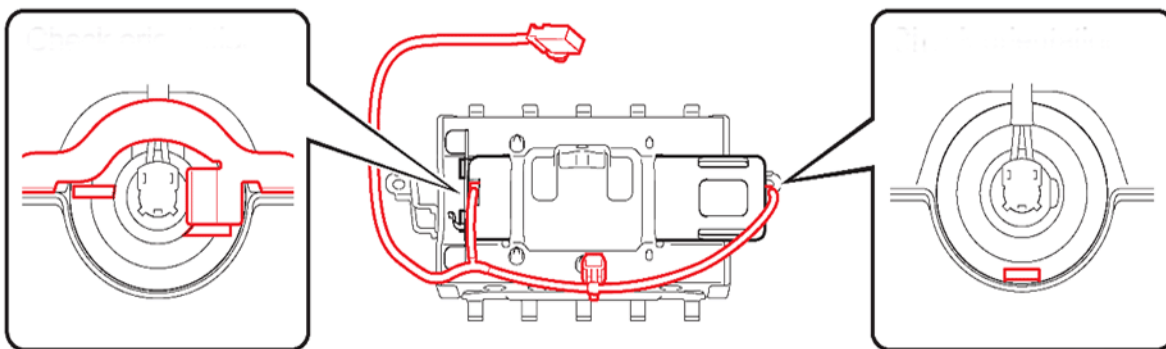
4751081

6. Insert the inflator fully with the correct orientation as shown. DO NOT pinch the wire.
