Terex Utilities	
SAFETY NOTICE	SN-669

Models Affected: Digger Derricks

SUBJECT: Pole Guide Bar 450543

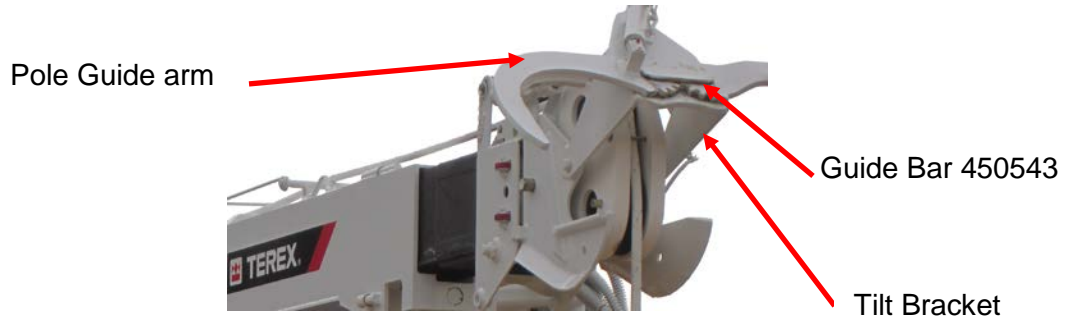
Identify Guide Bar:

Identification of affected 450543 Guide Bar: (See graphics below)

1. The grease zerk will be on the upper side above the pole guide arms and the surface is flat.
2. The top surface of the bar will be nearly flat with a milled counterbore (recessed area) for the grease zerk.
