Product Safety Recall

17478 Front Passenger Air Bag Inflator

Reference Number: N161644422

Release Date: December 2018
Revision: 00

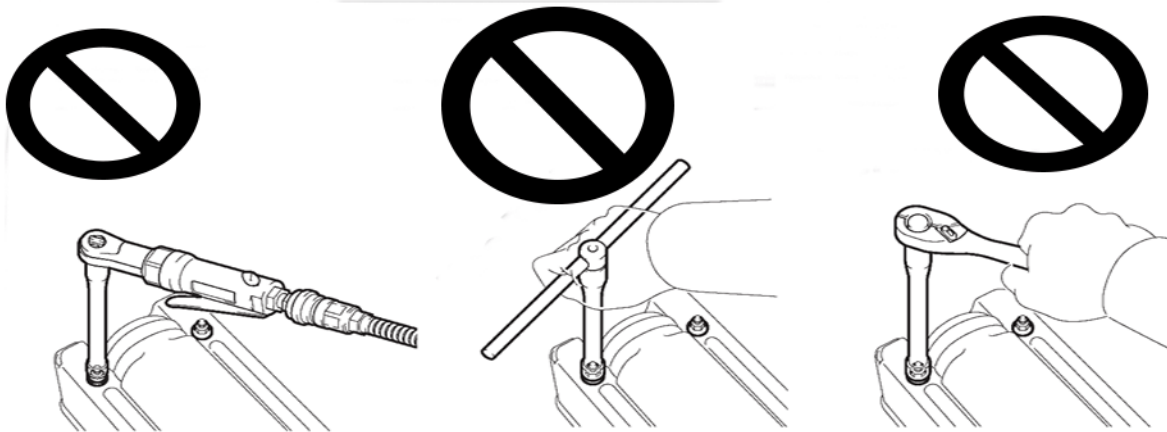
4751084

Important: If any gap exists, the aligned flats may move apart, resulting in failure in normal deployment of the air bag.

8. Remove the 3 remaining old self-locking nuts and install temporarily 3 NEW self-locking nuts by hand. Store the removed self-locking nuts in a replacement part box or the like.
9. Push the inflator and plate towards the position determining plate to eliminate any gap.

Important: The tightening torque is low (3.9 N·m). Use of an air ratchet wrench or tightening strongly with a T-handle wrench or a ratchet handle may cause deformation of the stud bolt.
