A. INTERIM VEHICLE INSPECTION PROCEDURE UNTIL PARTS ARE AVAILABLE

2009 Mazda6 (HP) and 2010 Mazda6 (HZ) vehicles, which were originally sold in, or currently or previously registered in Salt Belt States listed below.

B. CROSS MEMBER INSPECTION PROCEDURE 2009-2010 MAZDA6

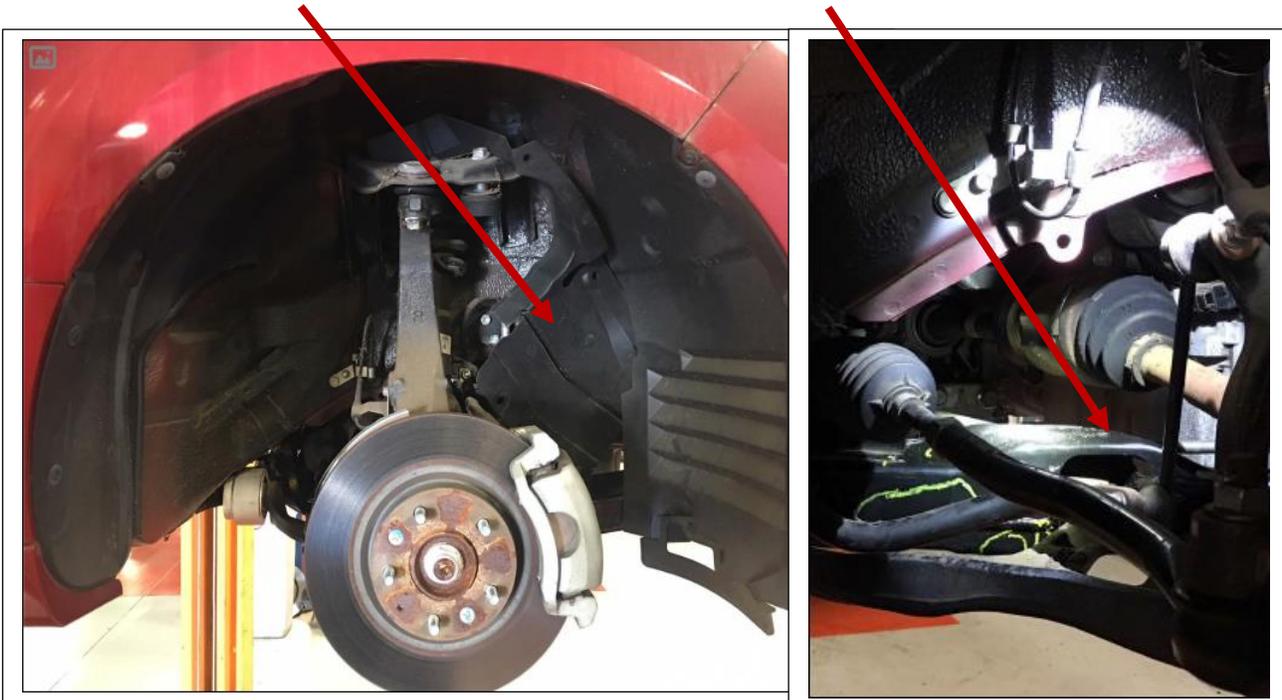
1. Remove the right front tire.
2. Remove **visible** clips of side cover of right front tire house.
Then bend the side cover so that Inspection point Zone No.1: Upper surface of the cross member can be seen

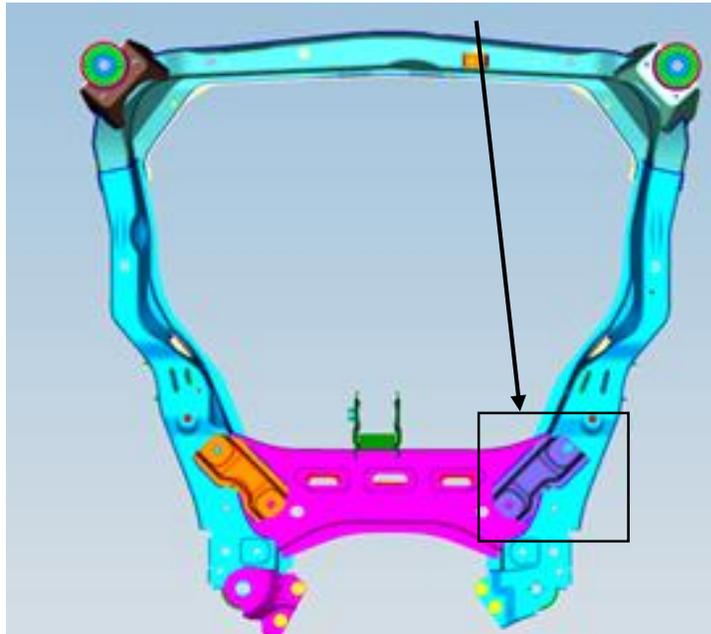
Top View – Area affected (Right Top Side)

On certain subject vehicles in salt belt states, it is possible that the front cross member may be corroded due to possible insufficient paint coating. Corrosion may be more severe on the portion just under the air conditioner drain, causing a perforation.

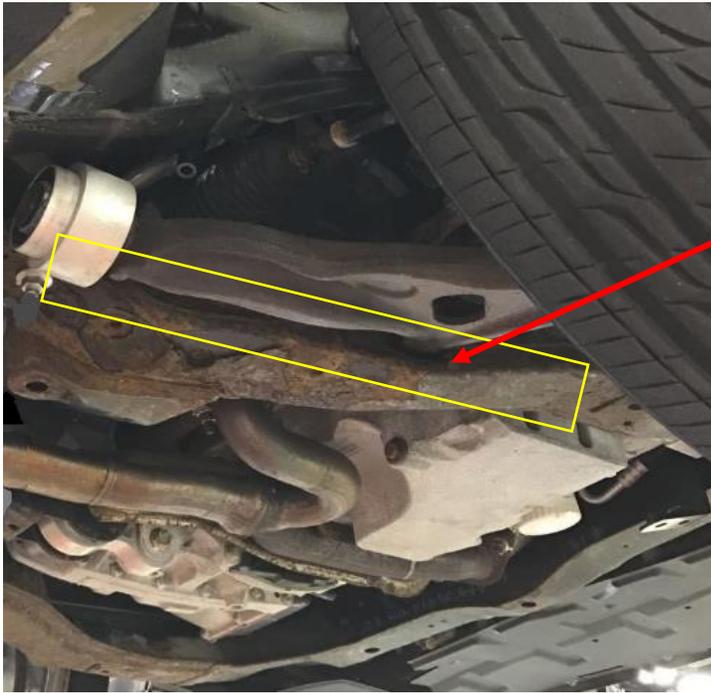
Side View: Non-Damaged Cross member

Zone 3 inspection Area:
Look for perforation especially along the bottom corner ridge line (this area). If perforation or a crack is present the cross member needs to be replaced.
