A. VEHICLE INSPECTION PROCEDURE

2009 Mazda6 (HP) and 2010 Mazda6 (HZ) vehicles, which were originally sold in, or currently or previously registered in Salt Belt States listed below.

B. CROSS MEMBER INSPECTION PROCEDURE 2009-2010 MAZDA6

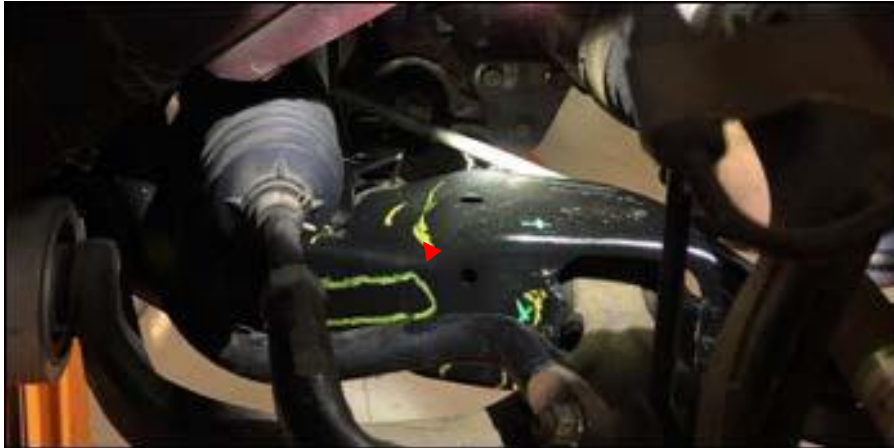
Top Side View: Non-Damaged Cross Member

Zone 1 Inspection – Upper Surface/Top side

There are bolt holes and other holes which are drilled at manufacturing production. Do not mistake those for holes made by corrosion.

Look for holes or cracks along the top surface in these areas. If a hole or crack is present, the cross member needs to be replaced. This cross member fails inspection as there is perforation

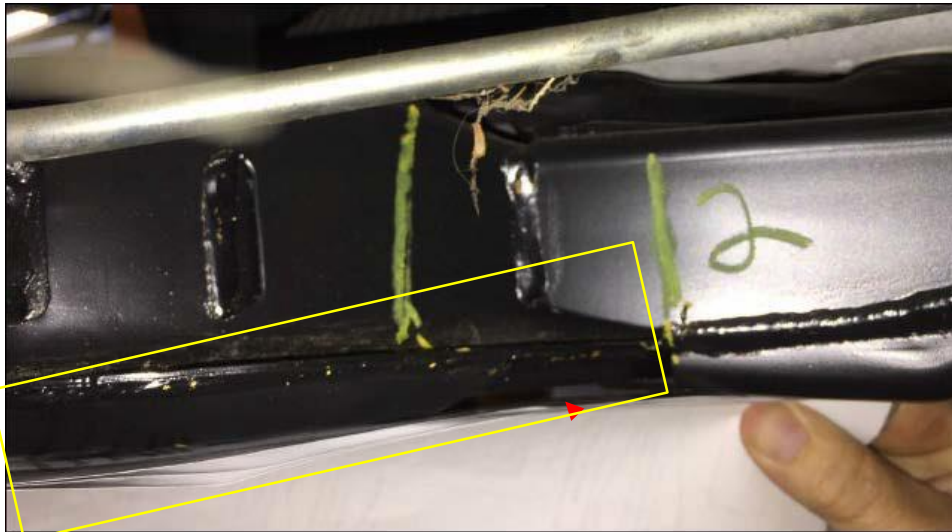
Inside View: Non-Damaged Cross member

Zone 2 Inspection - Inside Corner/Flange Weld

Look for perforation or crack along the flange in this area. If a crack or perforation is present, replace the cross member.

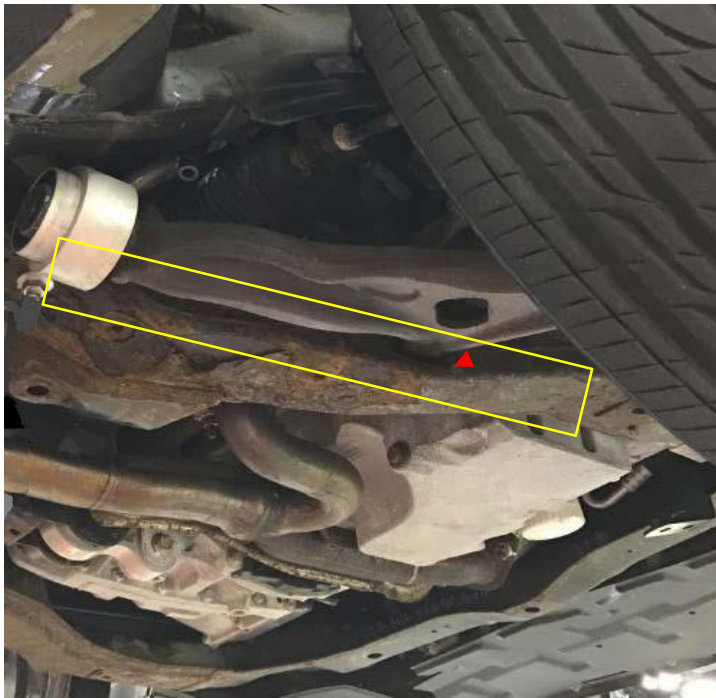
Side View: Non-Damaged Cross member

Zone 3 Inspection - Outer Area

Zone 3 inspection Area:
Look for perforation especially along the bottom corner ridge line (this area). If perforation or a crack is present the cross member needs to be replaced.
