Quality Bulletin

**Recall R19931: Front Seat Rail Flange Nuts
Model Year 2018 - 2019 XC60 & S90**

CAT/NO:
R19931

QB Instruction VCC-516729-1

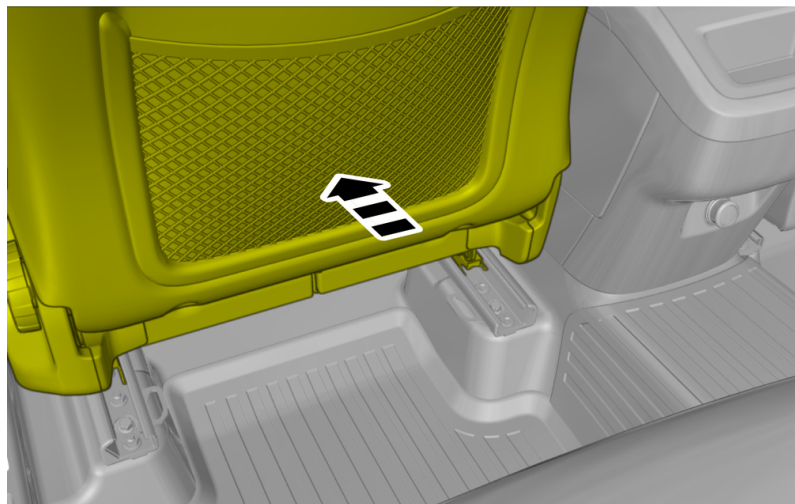
On both front seats

Volvo has identified that the drivers and passengers front seat rail rear flange nuts may be missing. This condition can compromise the front seat structure and position, and increase the risk of injury to the seat occupants in a crash.

Adjust the seats to the front position.

Inspect and install nut/nuts if missing.
