SAFETY BULLETIN

Communication #: T-19-01

Model Year(s): 2015-2019

SUBJECT: BATTERY FUSE BLOCK INSPECTION / CHASSIS FUSE RELOCATION

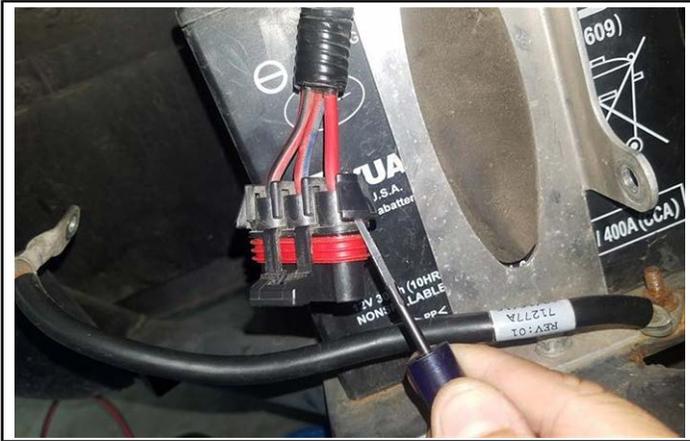
1. Disconnect the secondary locking clip from the battery fuse block connector.
2. Using a small screwdriver, remove secondary locking clip from back of the connector.

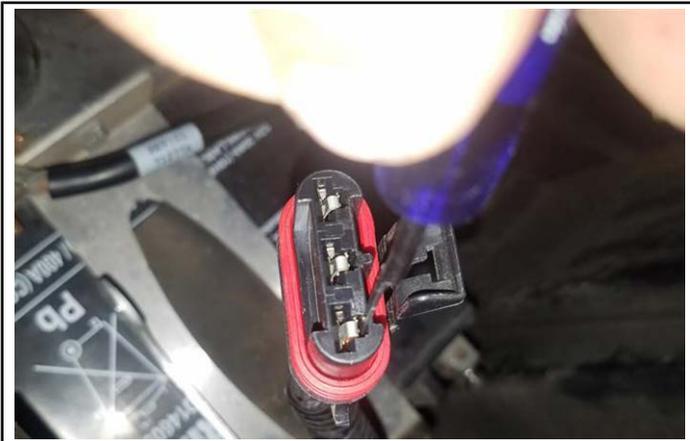
3. Using a pin removal tool, remove the red wire from "Position C". Insert the pin removal tool into the small, round release slot of the associated terminal until it releases the terminal retainer. Gently pull the wire out of the connector.

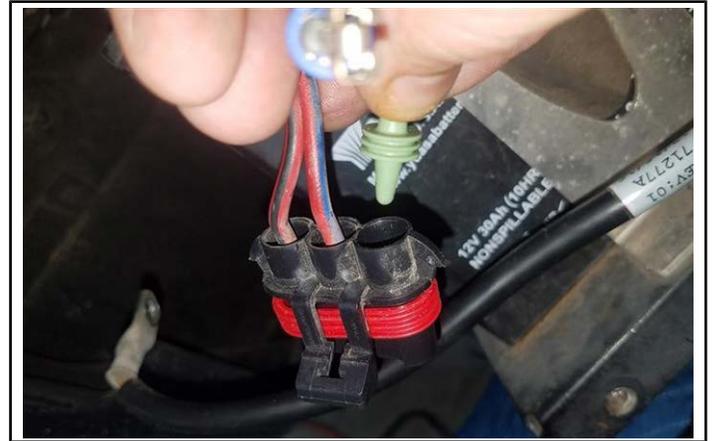
4. Install cavity plug into "Position C" and reinstall the rear secondary locking clip cover to the back of the connector.

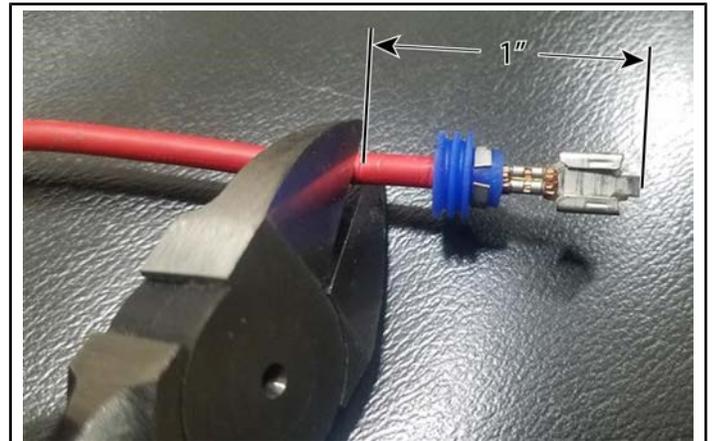
5. Measure roughly ONE inch (1") from the end of the connector. Using a Wire Cutter, snip off the connector end of the red wire that was removed from "Position C" as shown.

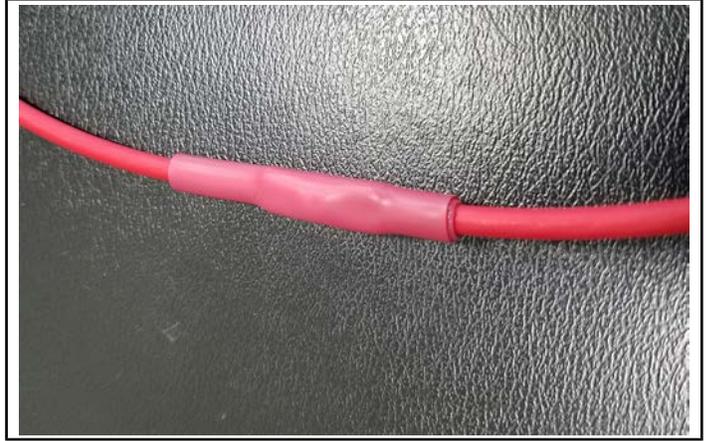
12. Using a heat gun, evenly apply approximately 250° F (120° C) to the heat shrink until the adhesive weeps out both ends as shown.

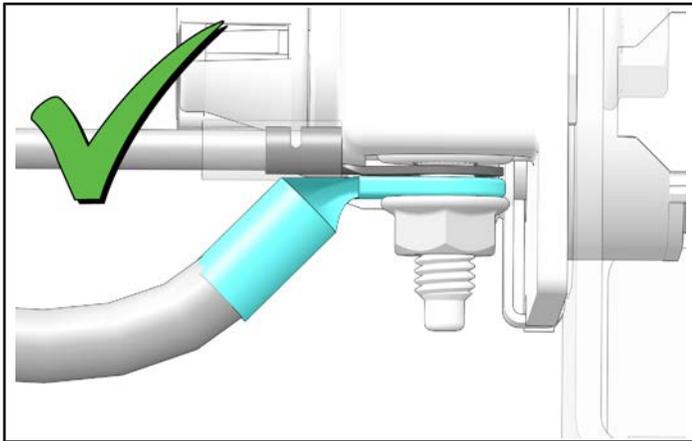
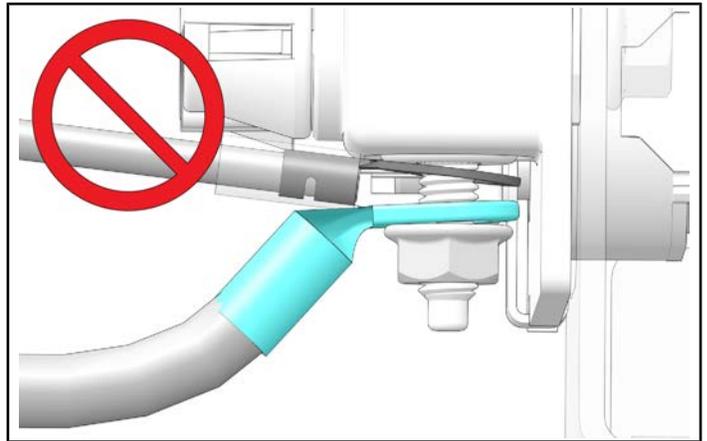
14. Orientate the new ring terminal so the flat sides of terminals are mated under the battery cable. Install both positive terminal rings to the battery fuse block.

Torque nut to specification. Slide the red terminal boot over the terminals.

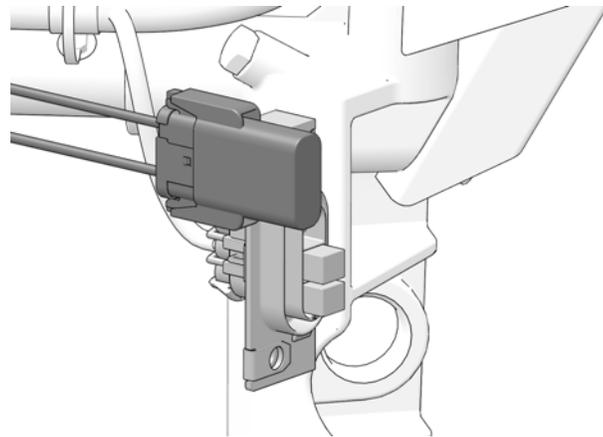
2015–2016

The base of the metal clip will need to be bent 90° to accommodate clearance for the battery fuse block cover installation.

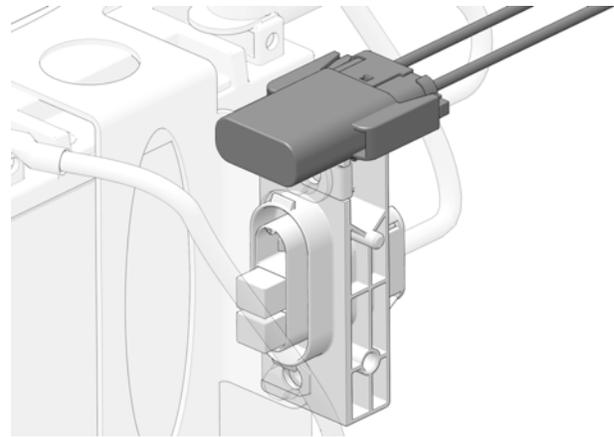
2017–2019

15. Mount new Maxi fuse holder to existing battery fuse block holder as shown.
