January 31, 2019

SUBJECT: **NEW VEHICLE DEMONSTRATION / DELIVERY HOLD -
 Safety Recall 19S43 – Supplement #2**
 Certain 2019 Model Year Ranger Vehicles
 Rear Tail Lamps

CERTAIN 2019 MODEL YEAR RANGER VEHICLES — REAR TAIL LAMP WIRING

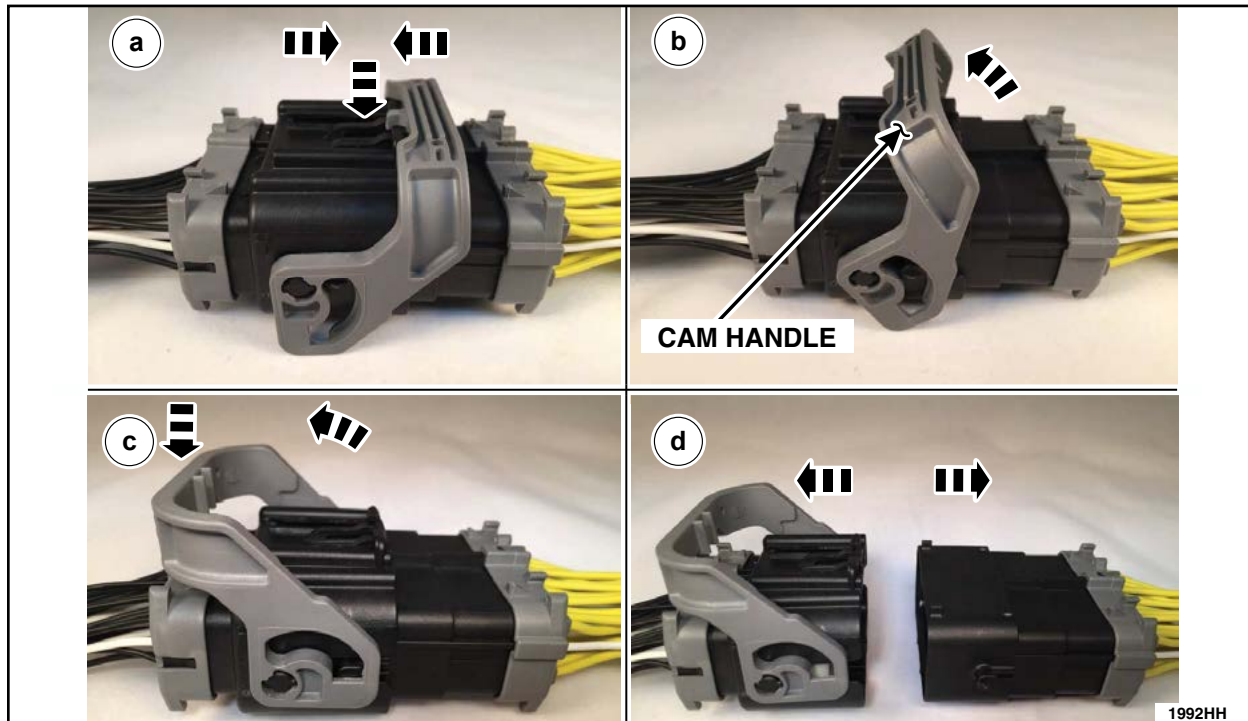
FIGURE 16

16. Release the connector lock and open the connector C422. See Figure 16.

- a. Push the connectors together and depress the primary lock.
- b. Once the primary lock releases the cam handle, rotate the cam handle as shown.
- c. Push the cam handle all the way back and seat the cam handle.
- d. Pull the male and female connectors apart.
