David J. Johnson
 Director
 Service Engineering Operations
 Ford Customer Service Division

November 22, 2019

**SUBJECT: NEW VEHICLE DEMONSTRATION / DELIVERY HOLD -
 Safety Recall 19S43**
 Certain 2019 Model Year Ranger Vehicles
 Rear Tail Lamps

CERTAIN 2019 MODEL YEAR RANGER — REAR TAIL LAMP WIRING

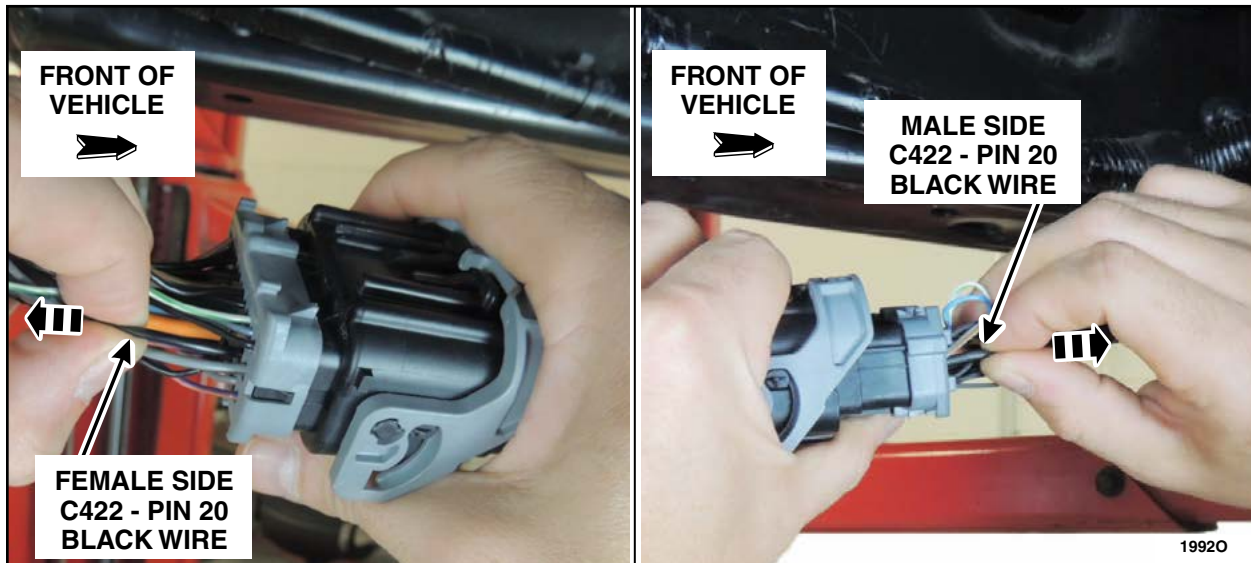
FIGURE 10

10. At connector C422, using your fingers pull outward on pin 20 (BK wire) on both sides of the C422 connector. Only apply enough pulling force to ensure the terminal is locked into the connector. Listen for the volt/ohm meters audible tone to either stop or intermittently break up as you pull on pin 20 (BK wire). If the terminal pulled out of the connector hard shell or the meters audible tone stop or intermittently broke up, record the side of the connector and the pin number on the repair order. Whether or not the terminal pulled out of the connector hard shell proceed to the next Step. See Figures 10, 11 and 12.

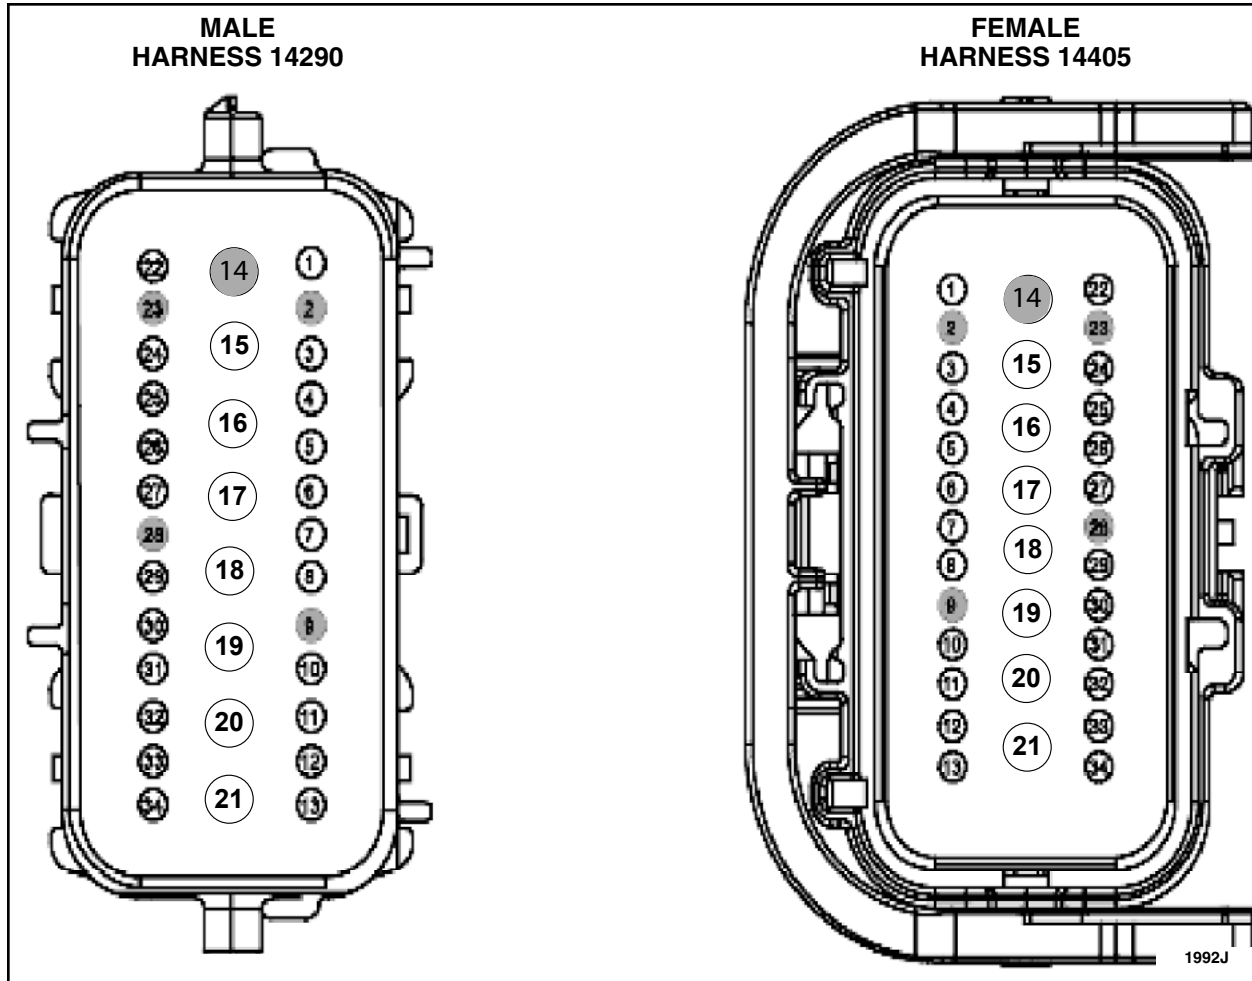
FIGURE 11

13. At connector C422, using your fingers pull on the remaining wires in the center row of terminals wires (cavities 14-19 and 21) on both male and female connector sides, checking for any terminals that may be push out of the connector hard shell. See Figures 11, 12 and 13.
