December 2019

Dealer Service Instructions for:

Equipment Safety Recall VB9 / NHTSA 19E-077 Electric Power Steering Gear

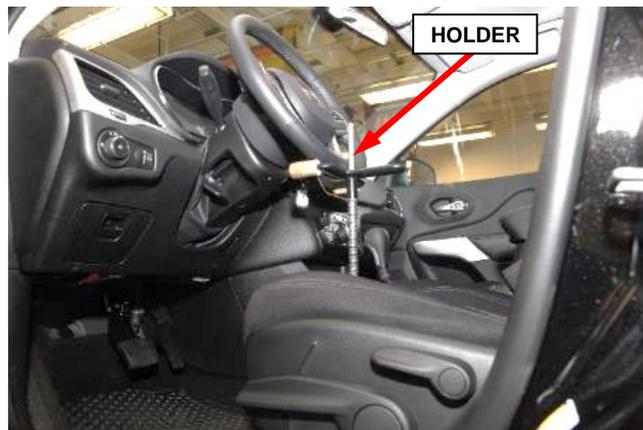
Figure 3 – Steering Wheel Holder

3. Using a steering wheel holder, lock the steering wheel at the 12 o'clock center position to keep it from rotating. This keeps the clockspring in the proper orientation (Figure 3).

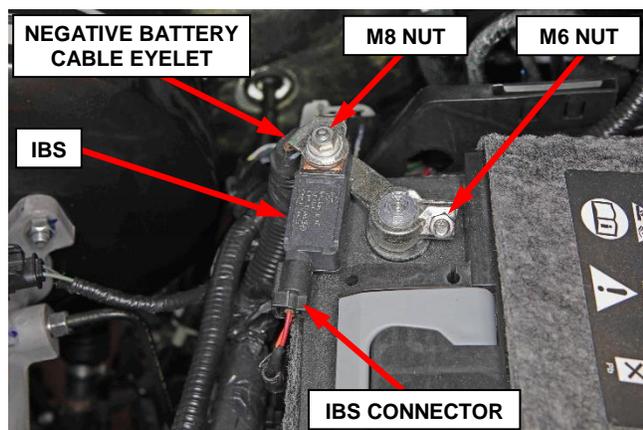
Figure 2 – Vehicle Battery

4. Open the hood.
5. Disconnect the Intelligent Battery Sensor (IBS) wire harness connector (Figure 2).
6. Remove the M8 negative battery cable eyelet nut (Figure 2).
7. Remove the negative battery cable eyelet and isolate the negative battery cable away from the IBS negative cable terminal (Figure 2).

8. Loosen the M6 battery cable clamp with IBS captive nut (Figure 2).

NOTE: Do not remove the M6 captive nut, doing so may cause the M6 stud on the battery cable clamp with IBS to break (Figure 2).
