**PRODUCT CAMPAIGN BULLETIN**

<p><b>APPLICABILITY:</b> 2010-2014 MY Legacy          2010-2014 MY Outback          2010-2013 MY Forester          2010-2014 MY Tribeca          2010-2011 MY Impreza          2010-2014 MY WRX and STI</p> <p><b>SUBJECT:</b> Takata Front Passenger Airbag Module / Inflator Replacement (2019 Calendar year expansion)</p>	<p><b>NUMBERS:</b> TKA-19R          TKB-19R          TKC-19R</p> <p><b>DATE:</b> 01/14/19</p> <p><b>REVISED:</b> 12/28/23</p> <p><b>NHTSA ID:</b> 19V-007          19V-008          19V-009</p>
---	---

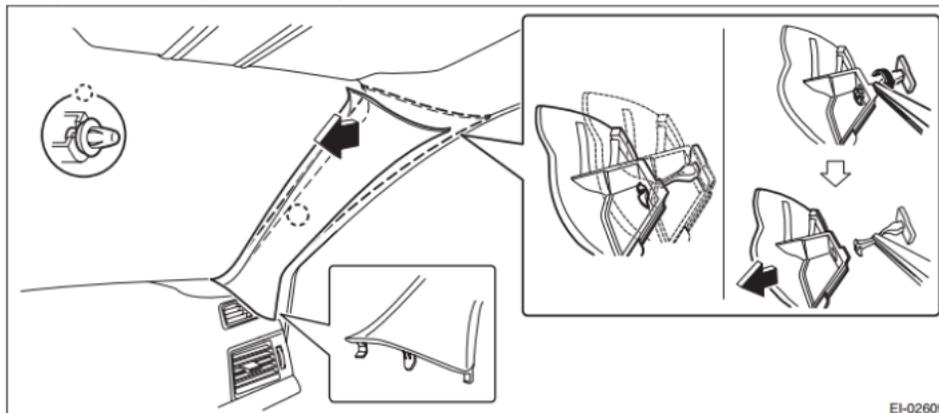
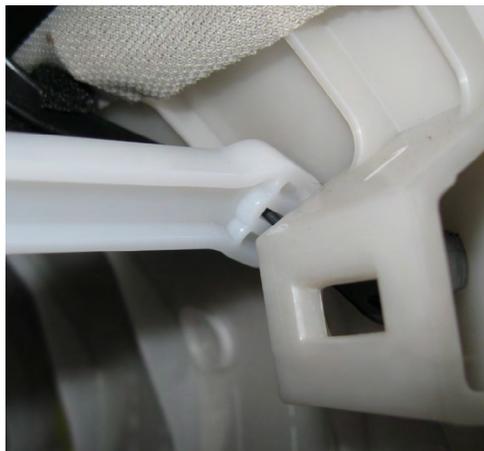
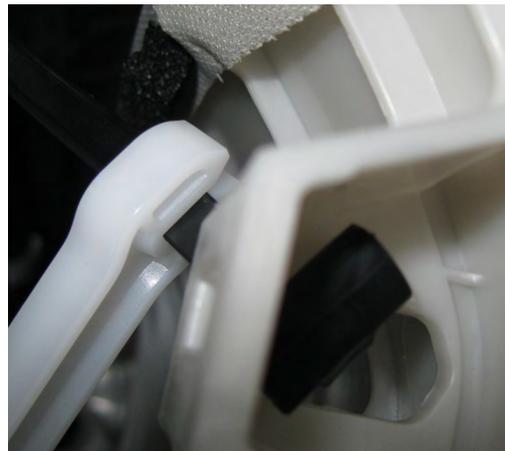
**NOTE:** Some models utilize a “tether clip” to secure the upper portion of the “A” pillar trim. The tether clip is located just below where the “A” pillar trim meets the head liner. If the tether clip becomes damaged, it **MUST** be replaced. The illustrations and photos below show the location of the tether clip and how to release it. It is **STRONGLY RECOMMENDED** to use the release tool (p.n. **SOA635147**) specifically designed for tether clip removal. Each Retailer has been supplied with 2 of these tools. If the tool is unavailable, a needle-nosed plier can be used to **CAREFULLY** release the tether clip as shown in the illustration below.

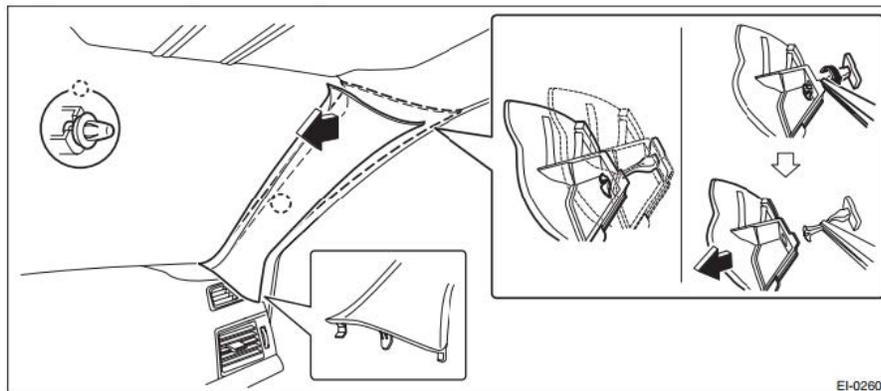
**NOTE:** When removing the “A” pillar trim, be **VERY CAREFUL** not to damage the upper trim retaining (tether) clip. The clip is located just below where the trim panel meets the head liner. If the tether clip becomes damaged, it **MUST** be replaced. The illustrations below show how to release the tether clip and remove the “A” pillar trim. It is **STRONGLY RECOMMENDED** to use the release tool (p.n. SOA635147) specifically designed for tether clip removal. See pg. 8 of this bulletin for more information.

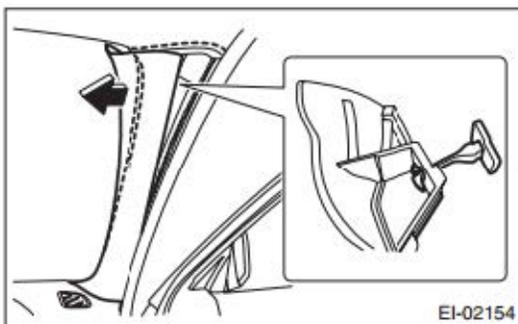
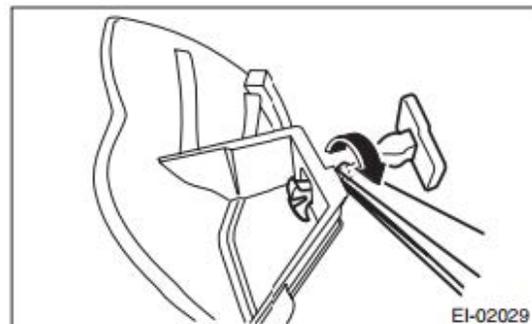
**NOTE:** On **FORESTER** models, when removing the “A” pillar trim, be **VERY CAREFUL** not to damage the upper trim retaining (tether) clip. It is **STRONGLY RECOMMENDED** to use the release tool (p.n. SOA635147) specifically designed for tether clip removal. See pg. 8 of this bulletin for more information. The clip is located just below where the trim panel meets the head liner. If the tether clip becomes damaged, it **MUST** be replaced. The illustrations below show how to release the tether clip and remove the “A” pillar trim.

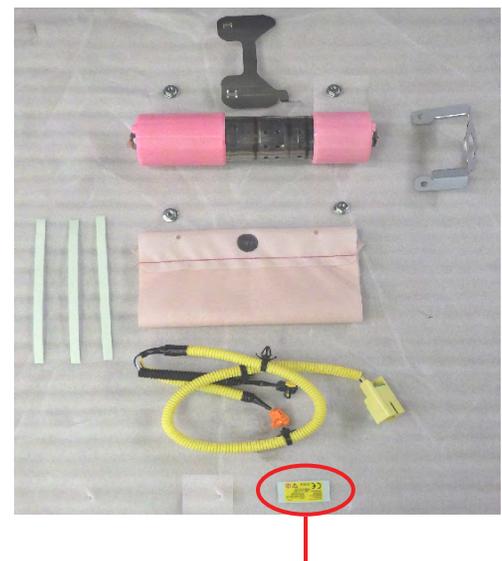
- New Self-Locking nuts (4)
- New Inflator (pink caps on both ends identify it as the replacement part)
- New Inflator Harness
- Electro-Tap (red shorting crimp connector, not shown)
- Black Thermal Insulator
- Stopper Plate
- Protective Sheet
- Anti-Wrinkling Tapes (3)
- Shipping Documentation

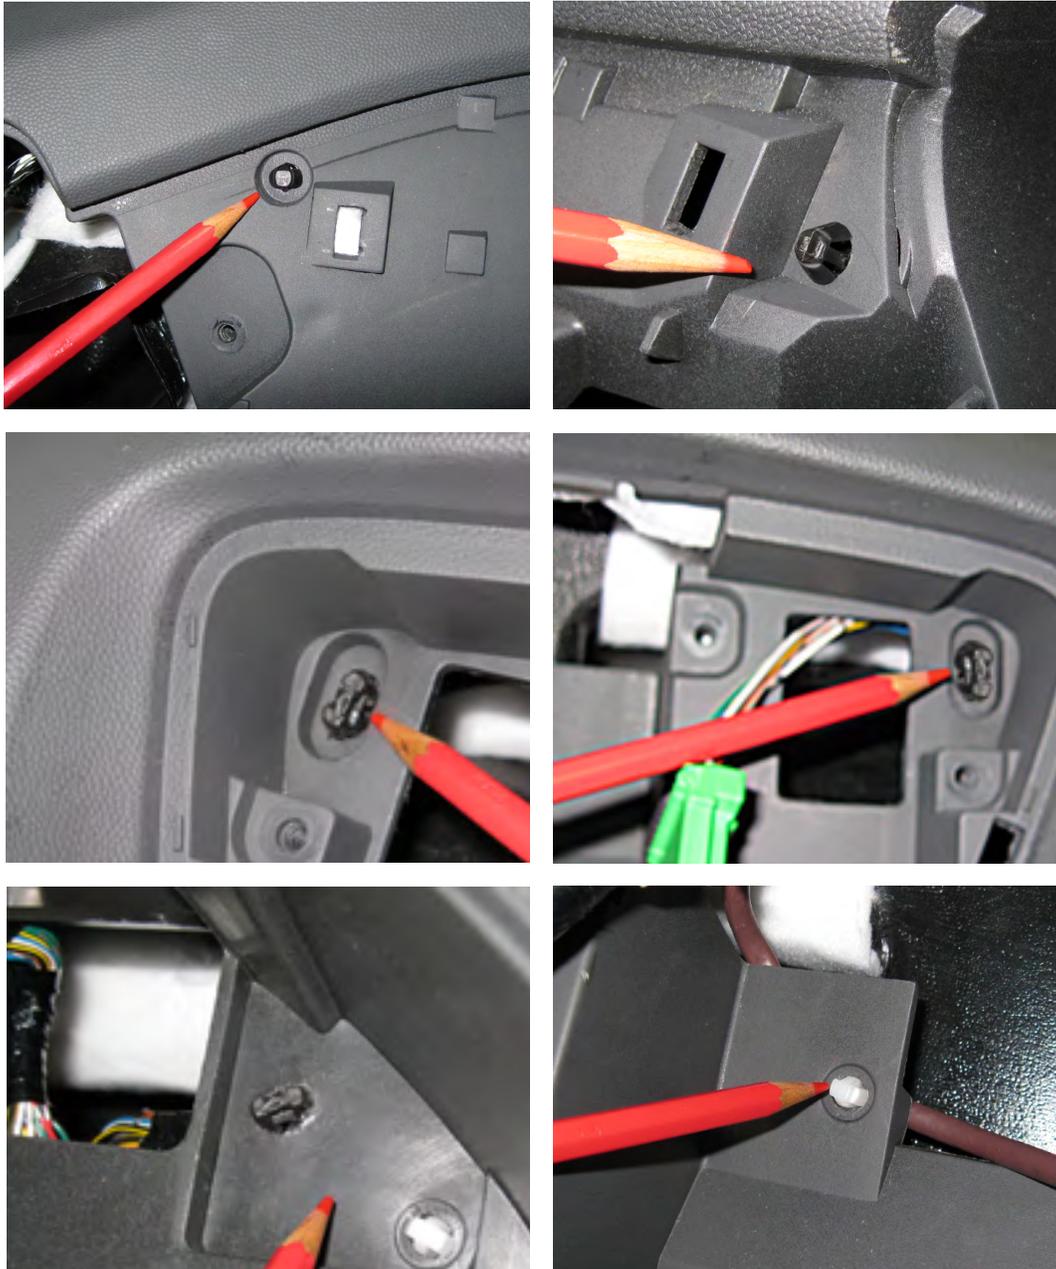
- Remove the harness connectors from components as needed to access the IP retaining screws as per the Service Manual. Release the harness retaining clips shown below using needle-nosed pliers and push them through to allow additional movement of the IP.

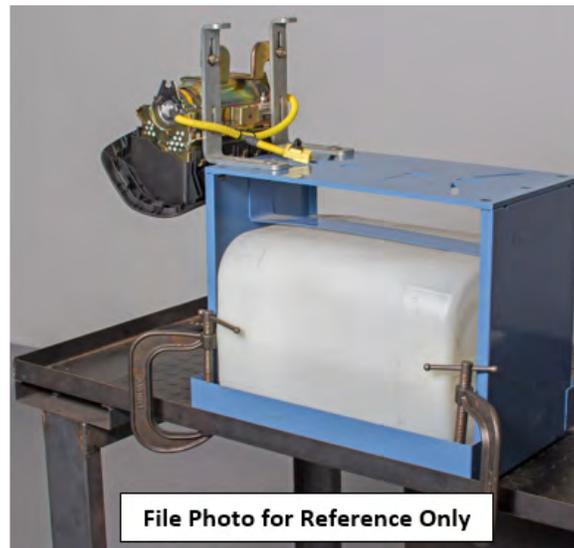
**REMINDER:** It is **STRONGLY RECOMMENDED** the removed airbag module **ALWAYS** be mounted to the Airbag Deployment Fixture (part number J-39401-B and file photo shown below) to better secure it during the inflator replacement procedure. When mounting the module to the fixture, pay close attention to the harness routing. Always perform this work in an area away from others to reduce chances of inadvertent injury should any deployment occur. Take your surroundings into account to avoid possible hazards should an inadvertent deployment occur or sources of static or other electricity that could potentially induce such a deployment.

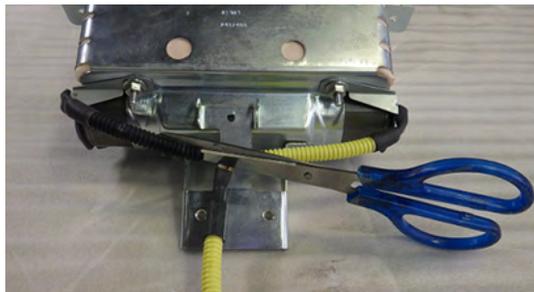
**STEP 4-** Using a scissor or wire cutter (no knives or razors) **CAREFULLY** cut the black harness cover tube (approximately 1 1/2 inches) enough to expose the blue and white wires inside. Provide enough room to install the Electro-Tap (shorting) connector.

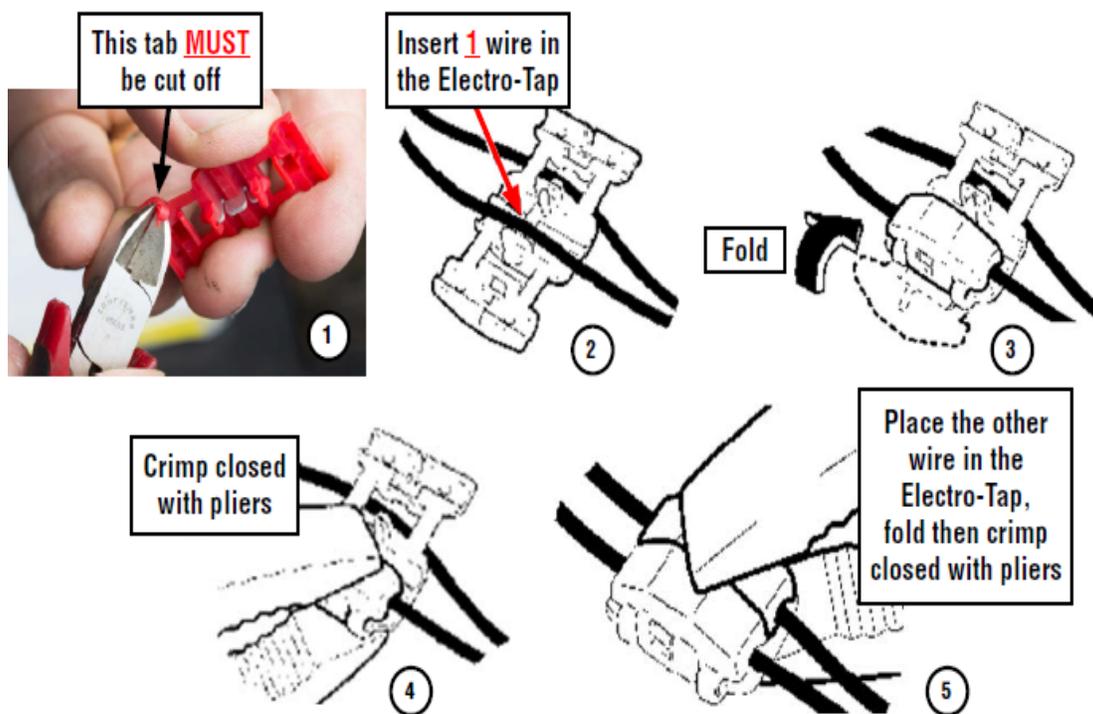
**STEP 5-** Short the blue and white wires together by installing the Electro-Tap connector. The connector creates a short circuit which acts as a safeguard to prevent against static discharge that may deploy the removed inflator. The tab portion of the Electro-Tap connector **MUST** be cut off prior to use to insure a good short-circuit is made as shown in the illustration below. **Follow the sequence below** for installing the Electro-Tap connector. Use pliers to squeeze closed the two sections of the connector together, **one section at a time**.

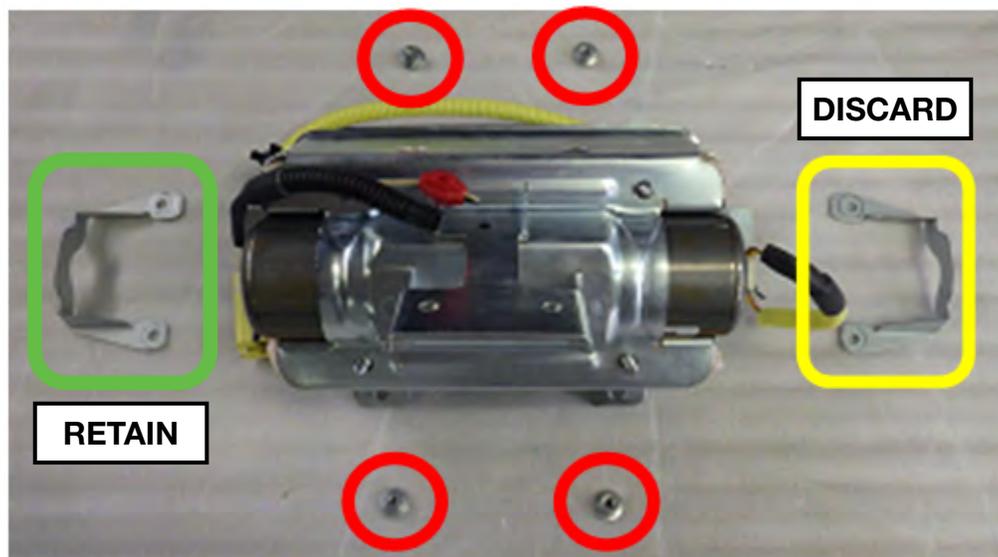
**STEP 7- USING HAND TOOLS ONLY**, loosen and remove the four (4) 10mm self-locking nuts along with both stopper plates. **RETAIN the stopper plate circled in GREEN** (Left-side bracket in image below) as it will be used during reassembly. Discard the removed stopper plate circled in **YELLOW** as it is no longer needed along with the 4 removed 10mm nuts.

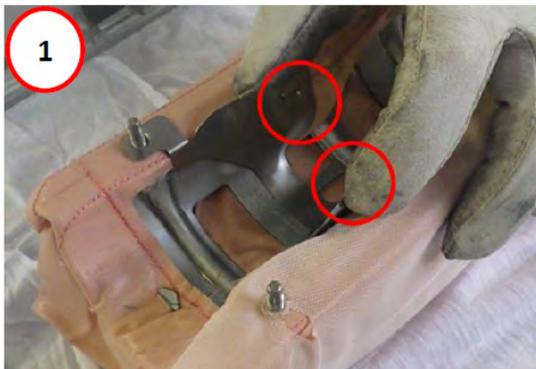
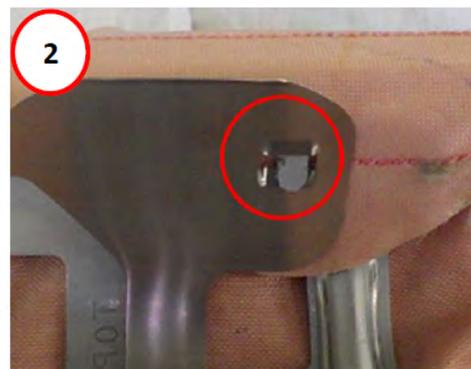
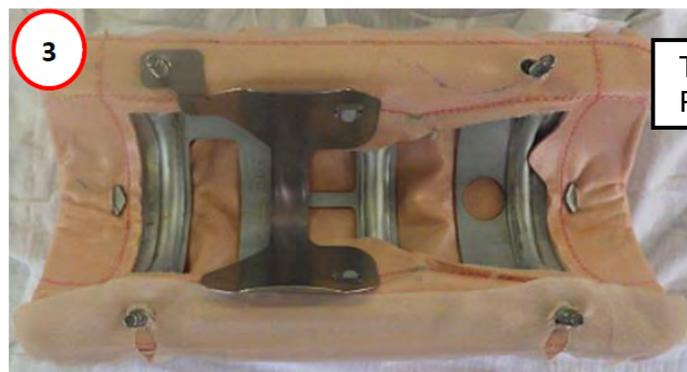
Thermal Insulator Properly Installed

**STEP 11-** CAREFULLY install the black thermal insulator into the back (inflator) side of the airbag as shown in photo 1 below. **CAUTION:** Gloves are recommended when doing this as edges of the thermal insulator can be very sharp. **TAKE YOUR TIME** and do not bend or twist the insulator any more than necessary to make it fit. The insulator can only be installed in one direction as shown in photo 3 otherwise, the airbag will not fit back into the module frame properly. Confirm both retaining claws come through the corresponding insulator holes like the example shown in photo 2.

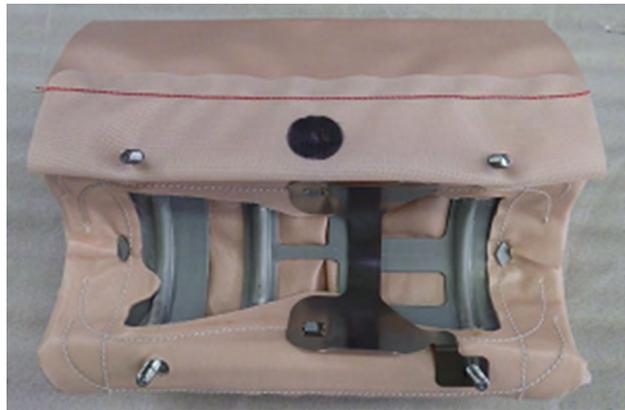
**STEP 12-** Install the protective sheet onto the studs of the airbag with the black mark in the position specified in the photo below. Due to the different spacing of the studs, the protective sheet will only fit properly when installed in this manner.

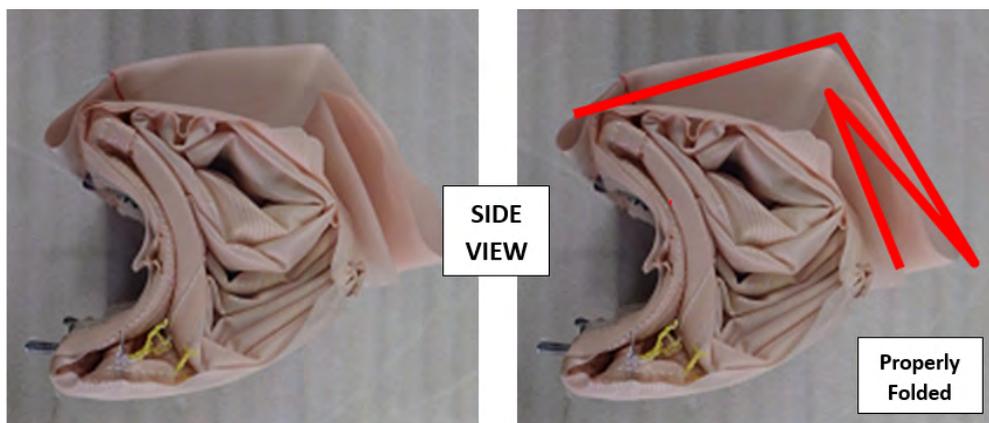
**STEP 13-** The protective sheet is properly installed when: **a)** it fits squarely on the studs, **b)** the black oval-shaped mark is facing up and **c)** the excess is laying over the top of the airbag and folded as shown in the side view photos below.

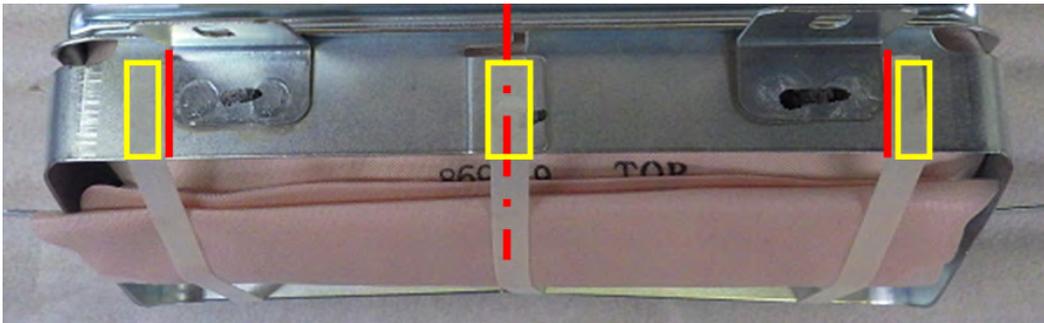
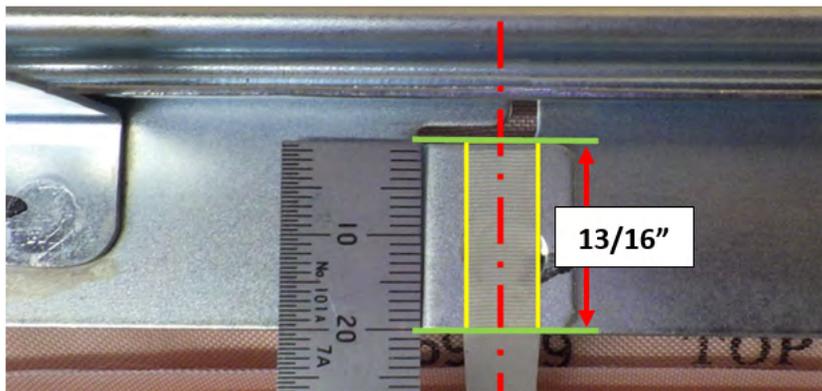
**STEP 15-** Apply the 3 anti-wrinkling tapes to the module frame as shown below to retain the protective sheet. The yellow rectangles represent the tapes and the red lines indicate where the tapes are to be positioned. Approximately 200mm (13/16") from each end of the 2tape should be applied to the module frame.

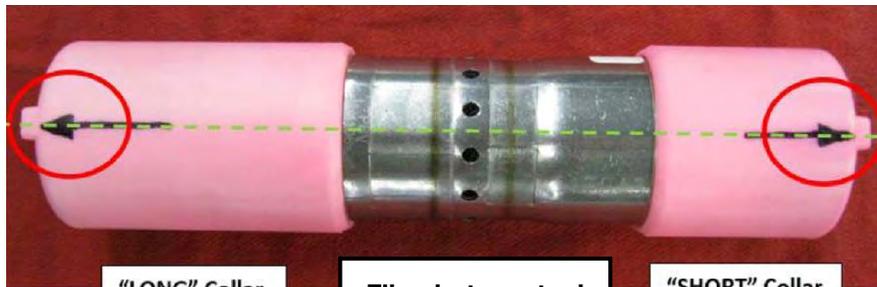
**STEP 16-** Inspect the new inflator to confirm the locating protrusions on each of the pink collars are aligned as shown below. The “short” collar can be rotated as needed to align it with the protrusion on the “long” collar if necessary.

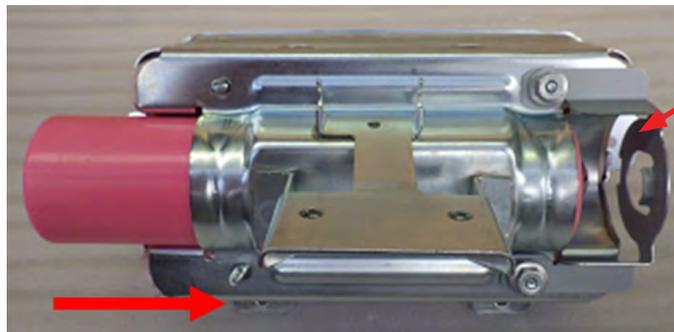
**New Stopper Plate Supplied with Kit.**

**STEP 18-** Slide the new inflator back into the mounting bracket, short collar end first. Align the tab on the new stopper plate with the notch on the end of the collar. When properly installed, the inflator will be tight against the stopper plate with no gap.

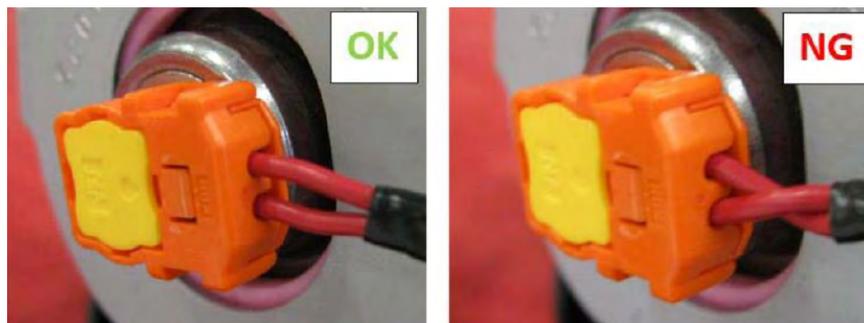
**BEFORE** connecting the harness to the inflator, make sure the harness is not twisted as shown below.

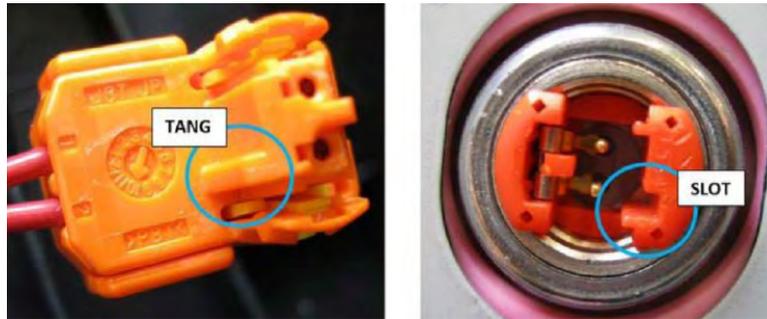
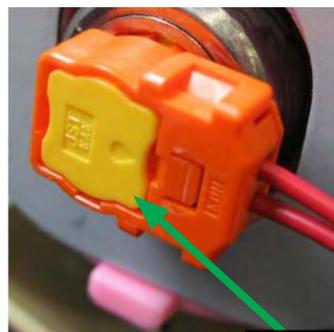
**CAREFULLY** align the tang of the inflator with the slot on the inflator harness connector as shown below. Push down firmly on the yellow lock tab to engage the connector's locking claws into the groove inside the connector boss on the inflator end. Confirm the connector is locked by prying up **LIGHTLY** with a small flat-blade screwdriver. Repeat the procedure on the opposite end.

Once alignment is confirmed, push down firmly to engage the connector. When fully seated, press down on the yellow tab locking the connector to the inflator.
