**PRODUCT CAMPAIGN BULLETIN**

<p><b>APPLICABILITY:</b> 2010-2014 MY Legacy          2010-2014 MY Outback          2010-2013 MY Forester          2010-2014 MY Tribeca          2010-2011 MY Impreza          2010-2014 MY WRX and STI</p> <p><b>SUBJECT:</b> Takata Front Passenger Airbag Module / Inflator Replacement (2019 Calendar year expansion)</p>	<p><b>NUMBERS:</b> TKA-19R          TKB-19R          TKC-19R</p> <p><b>DATE:</b> 01/14/19</p> <p><b>REVISED:</b> 12/28/22</p> <p><b>NHTSA ID:</b> 19V-007          19V-008          19V-009</p>
---	---

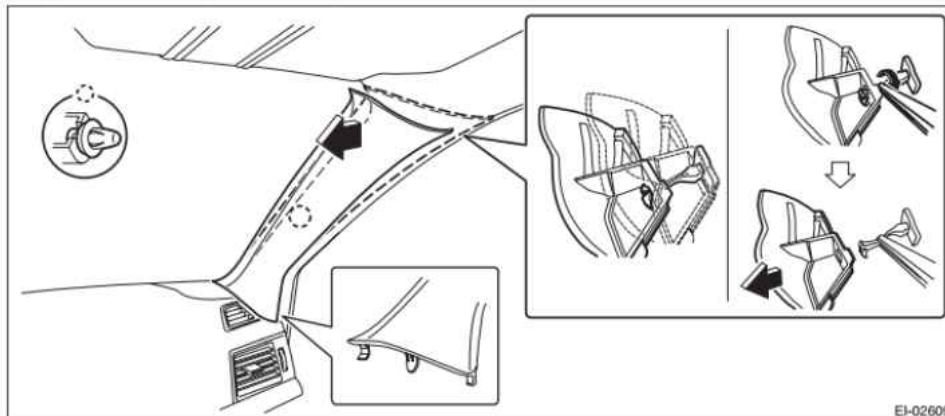
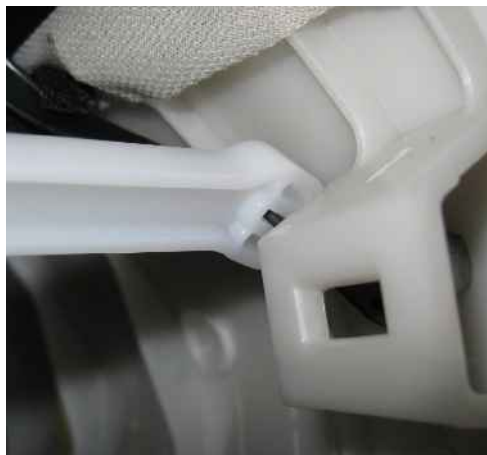
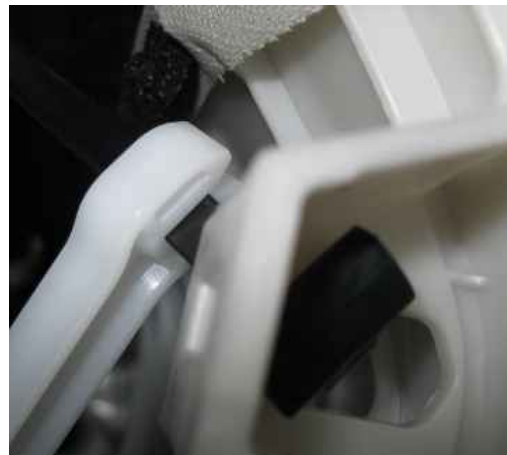
**NOTE:** Some models utilize a “tether clip” to secure the upper portion of the “A” pillar trim. The tether clip is located just below where the “A” pillar trim meets the head liner. If the tether clip becomes damaged, it **MUST** be replaced. The illustrations and photos below show the location of the tether clip and how to release it. It is **STRONGLY RECOMMENDED** to use the release tool (p.n. **SOA635147**) specifically designed for tether clip removal. Each Retailer has been supplied with 2 of these tools. If the tool is unavailable, a needle-nosed plier can be used to **CAREFULLY** release the tether clip as shown in the illustration below.

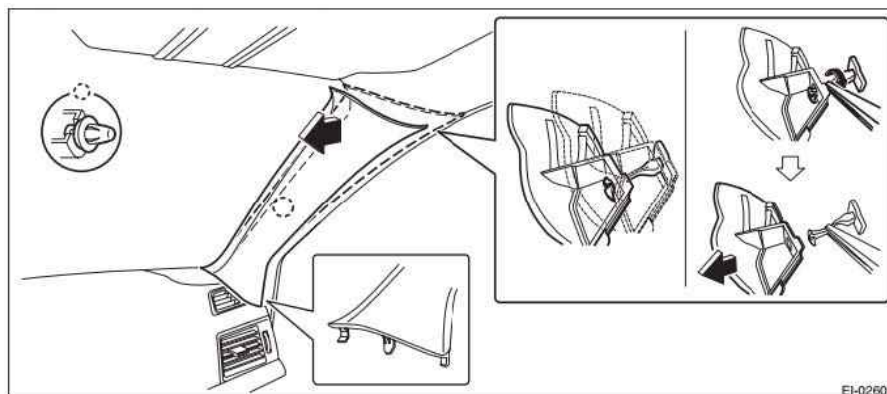
**NOTE:** When removing the “A” pillar trim, be **VERY CAREFUL** not to damage the upper trim retaining (tether) clip. The clip is located just below where the trim panel meets the head liner. If the tether clip becomes damaged, it **MUST** be replaced. The illustrations below show how to release the tether clip and remove the “A” pillar trim. It is **STRONGLY RECOMMENDED** to use the release tool (p.n. SOA635147) specifically designed for tether clip removal. See pg. 8 of this bulletin for more information.

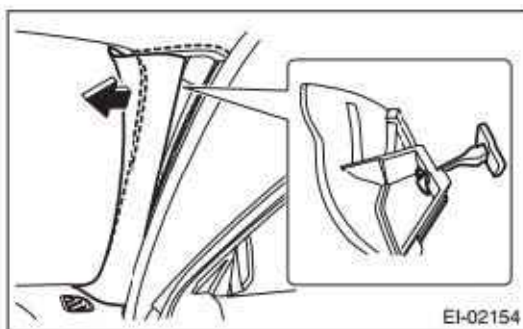
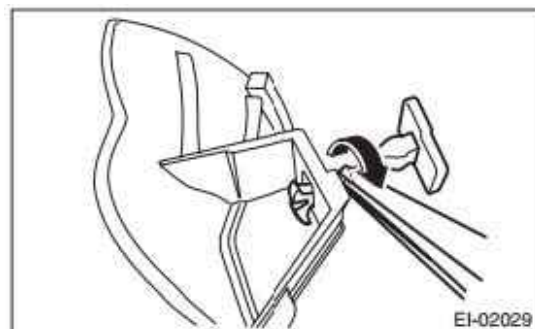
**NOTE:** On **FORESTER** models, when removing the “A” pillar trim, be **VERY CAREFUL** not to damage the upper trim retaining (tether) clip. It is **STRONGLY RECOMMENDED** to use the release tool (p.n. SOA635147) specifically designed for tether clip removal. See pg. 8 of this bulletin for more information. The clip is located just below where the trim panel meets the head liner. If the tether clip becomes damaged, it **MUST** be replaced. The illustrations below show how to release the tether clip and remove the “A” pillar trim.

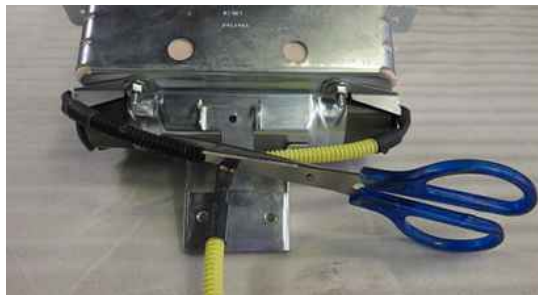
**STEP 4-** Using a scissor or wire cutter (no knives or razors) **CAREFULLY** cut the black harness cover tube (approximately 1 1/2 inches) enough to expose the blue and white wires inside. Provide enough room to install the Electro-Tap (shorting) connector.

**TAKE YOUR TIME AND BE CAREFUL TO NOT CUT THE 2 WIRES!**

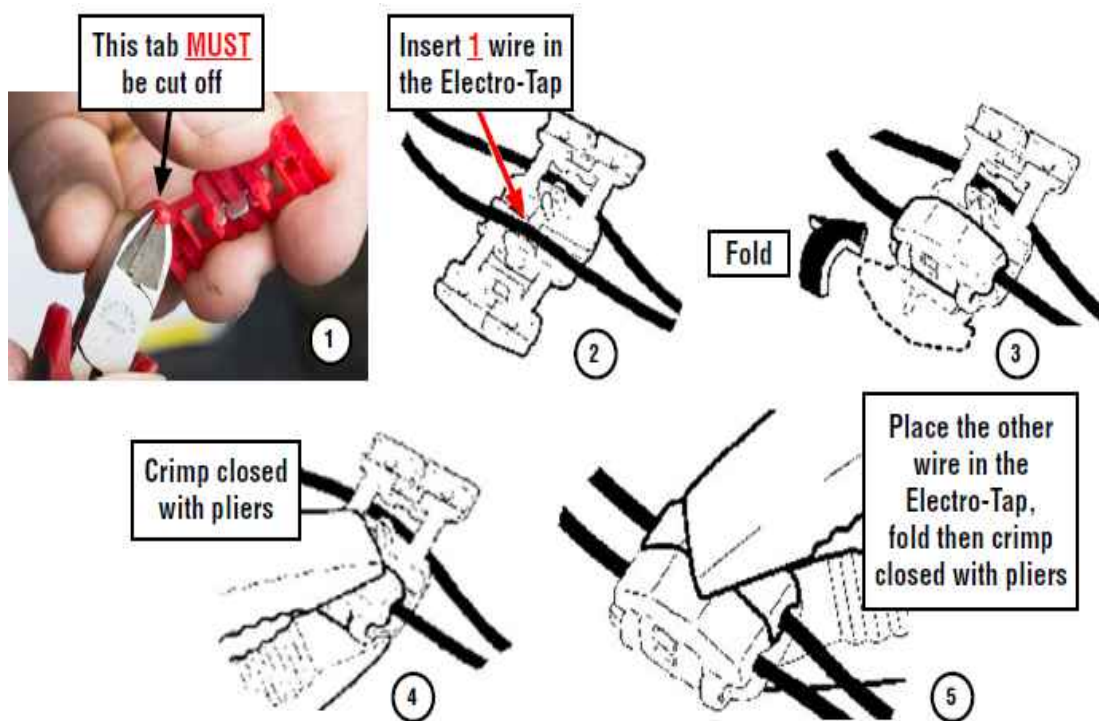
**STEP 5-** Short the blue and white wires together by installing the Electro-Tap connector. The connector creates a short circuit which acts as a safeguard to prevent against static discharge that may deploy the removed inflator. The tab portion of the Electro-Tap connector **MUST** be cut off prior to use to insure a good short-circuit is made as shown in the illustration below. **Follow the sequence below** for installing the Electro-Tap connector. Use pliers to squeeze closed the two sections of the connector together, **one section at a time**.

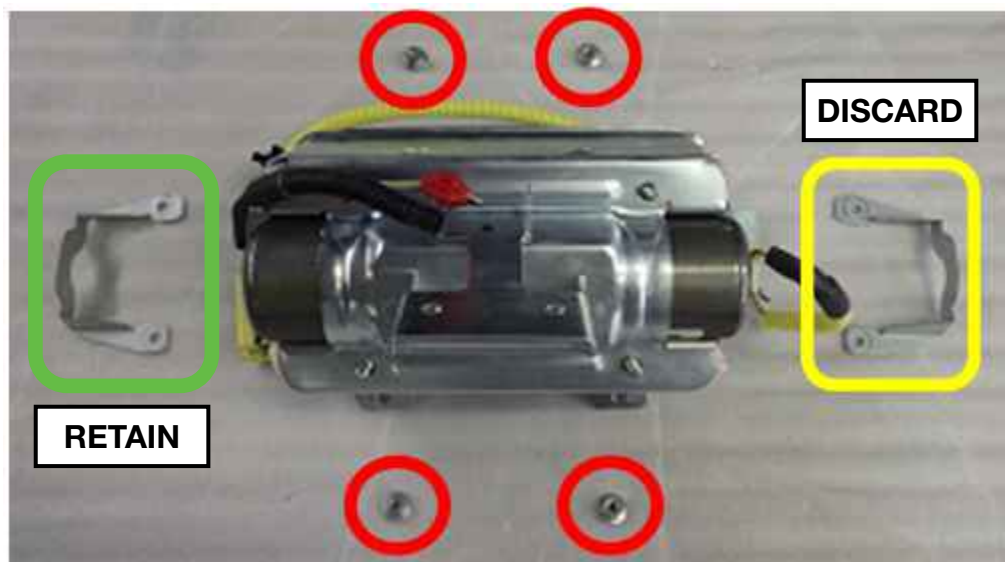
**STEP 7- USING HAND TOOLS ONLY**, loosen and remove the four (4) 10mm self-locking nuts along with both stopper plates. **RETAIN the stopper plate circled in GREEN** (Left-side bracket in image below) as it will be used during reassembly. Discard the removed stopper plate circled in **YELLOW** as it is no longer needed along with the 4 removed 10mm nuts.

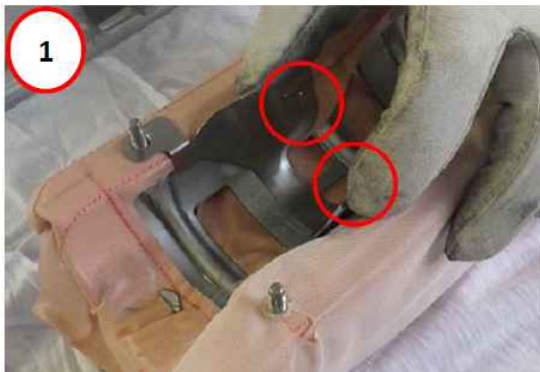
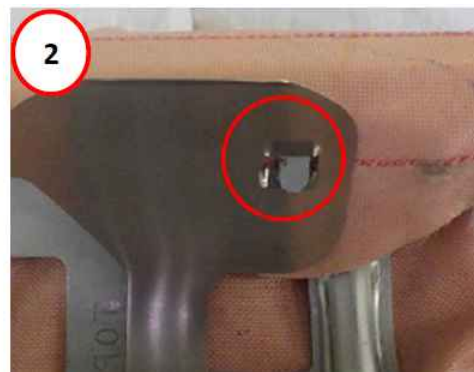
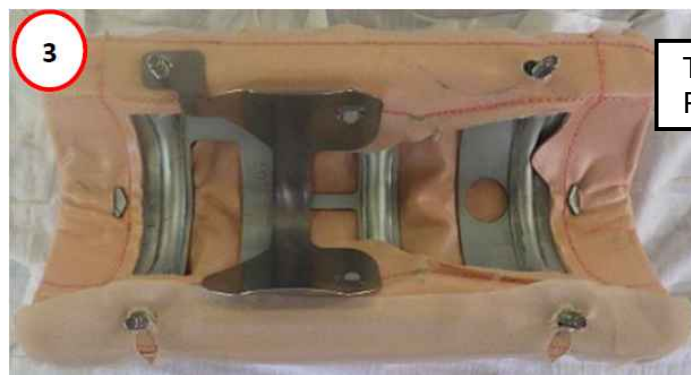
Thermal Insulator Properly Installed

**STEP 11-** CAREFULLY install the black thermal insulator into the back (inflator) side of the airbag as shown in photo 1 below. **CAUTION:** Gloves are recommended when doing this as edges of the thermal insulator can be very sharp. **TAKE YOUR TIME** and do not bend or twist the insulator any more than necessary to make it fit. The insulator can only be installed in one direction as shown in photo 3 otherwise, the airbag will not fit back into the module frame properly. Confirm both retaining claws come through the corresponding insulator holes like the example shown in photo 2.

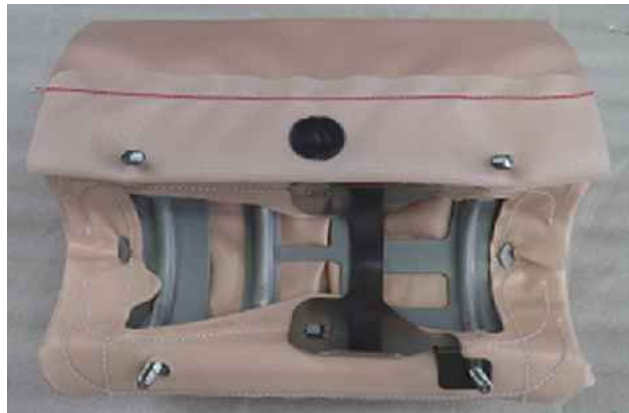
**STEP 12-** Install the protective sheet onto the studs of the airbag with the black mark in the position specified in the photo below. Due to the different spacing of the studs, the protective sheet will only fit properly when installed in this manner.

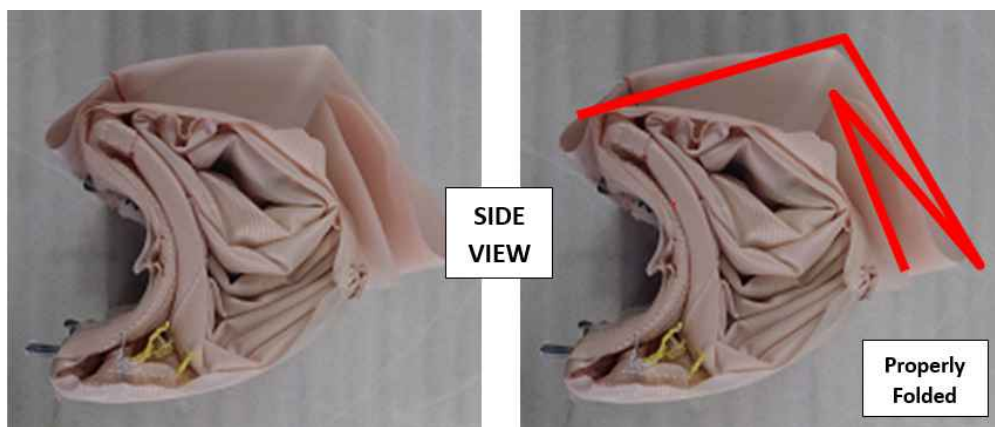
**STEP 13-** The protective sheet is properly installed when: **a)** it fits squarely on the studs, **b)** the black oval-shaped mark is facing up and **c)** the excess is laying over the top of the airbag and folded as shown in the side view photos below.

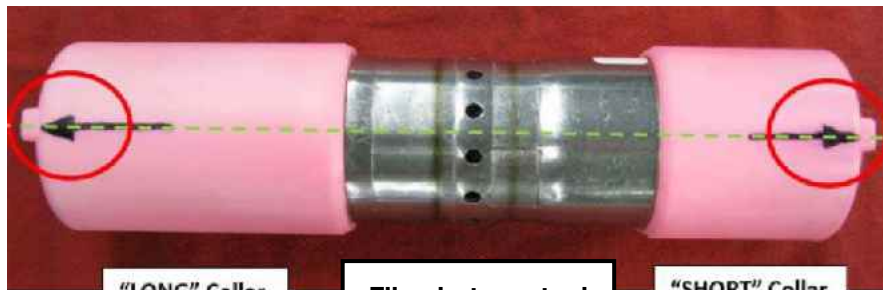
**“LONG” Collar**

**STEP 16-** Inspect the new inflator to confirm the locating protrusions on each of the pink collars are aligned as shown below. The “short” collar can be rotated as needed to align it with the protrusion on the “long” collar if necessary.

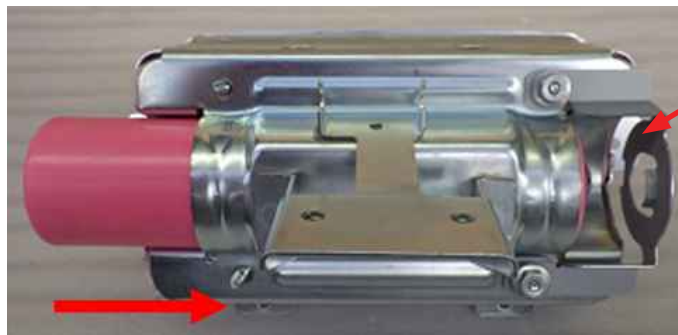
**New Stopper Plate Supplied with Kit.**

**STEP 18-** Slide the new inflator back into the mounting bracket, short collar end first. Align the tab on the new stopper plate with the notch on the end of the collar. When properly installed, the inflator will be tight against the stopper plate with no gap.

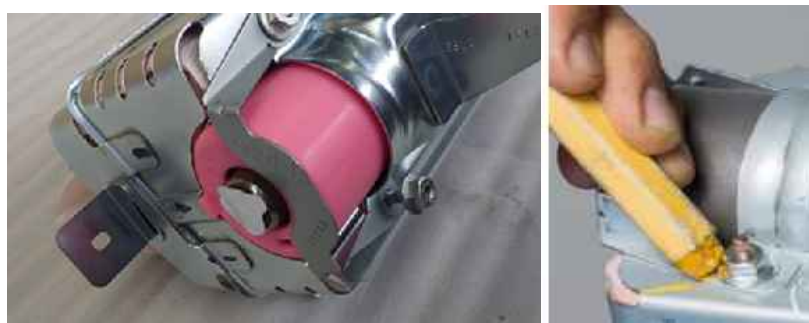
**STEP 19-** Reinstall the original (retained from **STEP 7**) stopper plate and the other 2 **NEW** self-locking nuts. **SLOWLY** tighten (to prevent over-tightening) while making sure both stopper plates stay tight against both ends of the inflator. **HAND TOOLS ONLY!** Torque the nuts to 31-38 inch-pounds. When complete, use a marker to indicate they have been fully tightened.

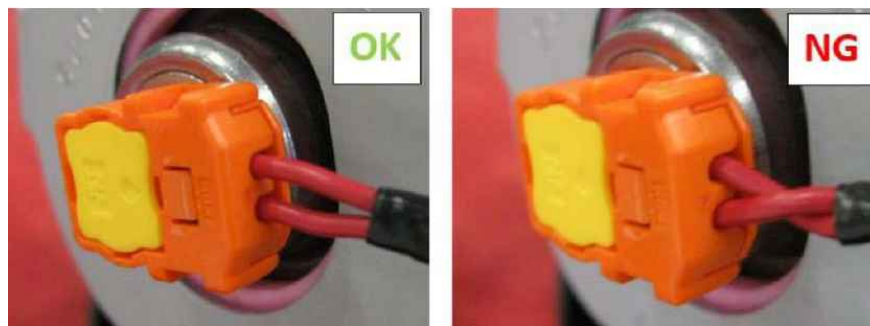
**BEFORE** connecting the harness to the inflator, make sure the harness is not twisted as shown below.

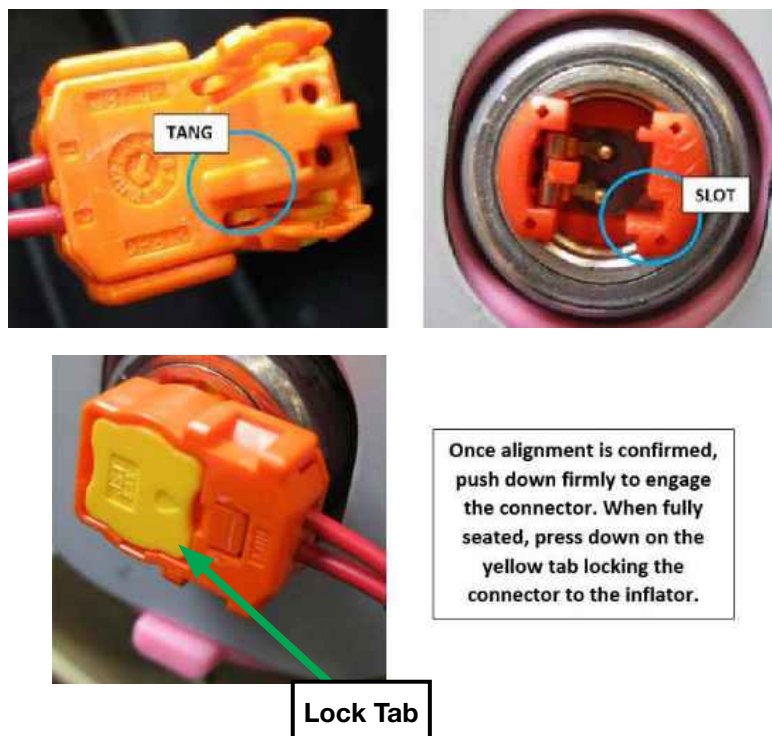
**CAREFULLY** align the tang of the inflator with the slot on the inflator harness connector as shown below. Push down firmly on the yellow lock tab to engage the connector's locking claws into the groove inside the connector boss on the inflator end. Confirm the connector is locked by prying up **LIGHTLY** with a small flat-blade screwdriver. Repeat the procedure on the opposite end.
