Safety Recall Code: 69S8

Subject	Driver Frontal Airbag Inflator (Takata)
Release Date	December 10, 2021
Revision Summary	USA ONLY
	Added Rental Car/Loaner program claiming instructions
	Added Appendix for Rental Car/Loaner program FAQs
Affected Vehicles	U.S.A. & Canada: Certain 2017 MY Audi R8 Spyder and Audi R8 Coupe and Certain 2016- 2017 MY Audi TT Roadster and Audi TT Coupe
	Check Campaigns/Actions screen in Elsa on the day of repair to verify that a VIN qualifies for repair under this action. Elsa is the <u>only</u> valid campaign inquiry & verification source.
	✓ Campaign status must show "open."
	 If Elsa shows other open action(s), inform your customer so that the work can also be completed at the same time the vehicle is in the workshop for this campaign.
Problem Description	The driver airbag may explode in a crash with airbag deployment. Sharp metal fragments can hit people and cause serious injury or death.
Corrective Action	Replace the driver frontal airbag.

Subject: Safety Recall 69S8 – Driver Frontal Airbag Inflator (Takata) Certain 2017 Model Year Audi R8 Spyder and Audi R8 Coupe and Certain 2016-2017 Model Year Audi TT Roadster and Audi TT Coupe

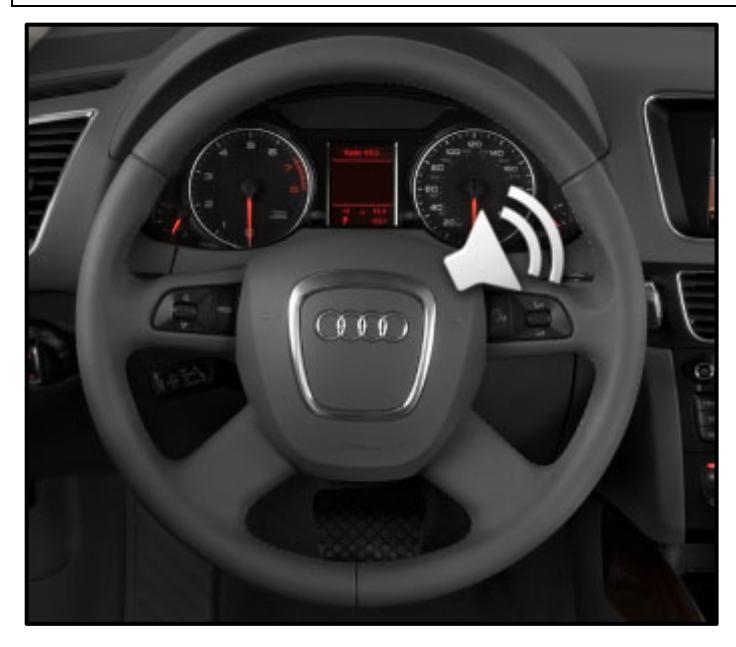
• Prior to beginning repairs, verify the horn is operational.

Diagnosis and repair of an inoperable horn, before or after airbag replacement, will not be covered under this campaign.

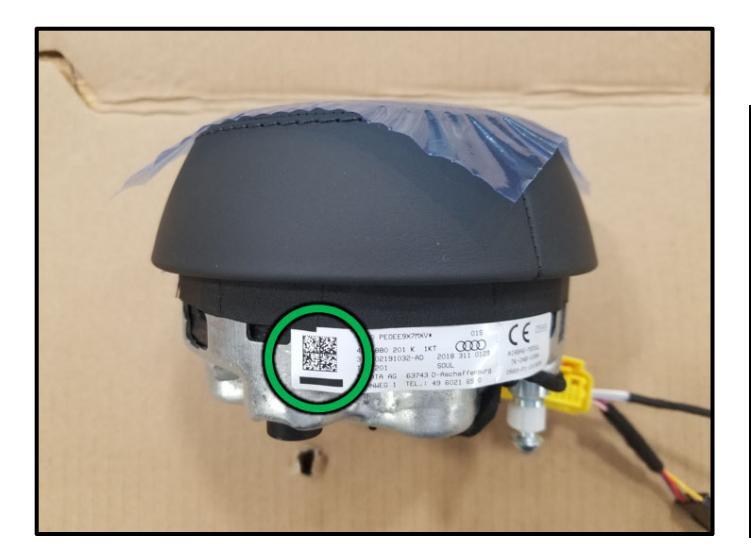
• Scan the data matrix code <circle> of the new airbag at a distance of about 15 cm.

Ensure the correct airbag is scanned and installed into the vehicle.					
Part Number					
4S0.880.201.K DF9					
4S0.880.201.K 1KT					
8S0.880.201.AR 6PS					
8S0.880.201.AT 1KT					
	ect airbag is scanned and installe <u>Part Number</u> 4S0.880.201.K DF9 4S0.880.201.K 1KT 8S0.880.201.AR 6PS 8S0.880.201.AT 1KT

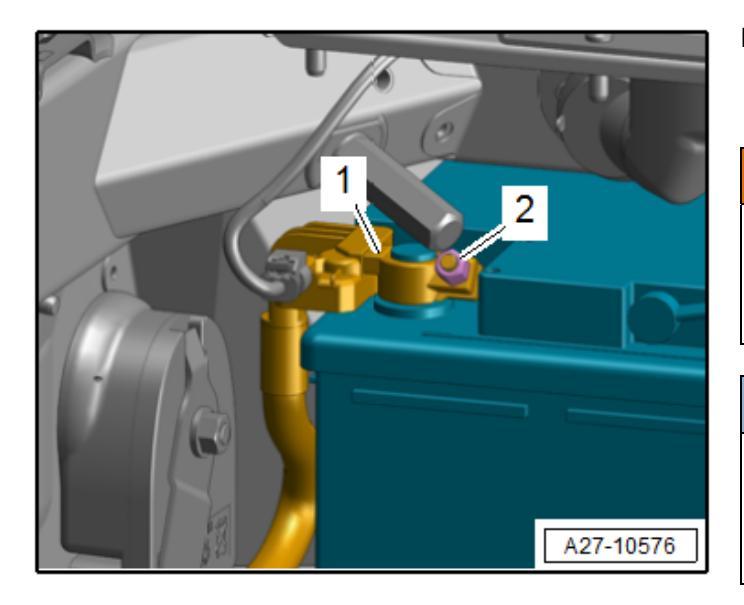
Disconnect battery ground cable:

• Loosen the nut <2> several turns and remove the battery ground cable terminal <1> from the battery terminal.

R8 shown, TT models are similar.

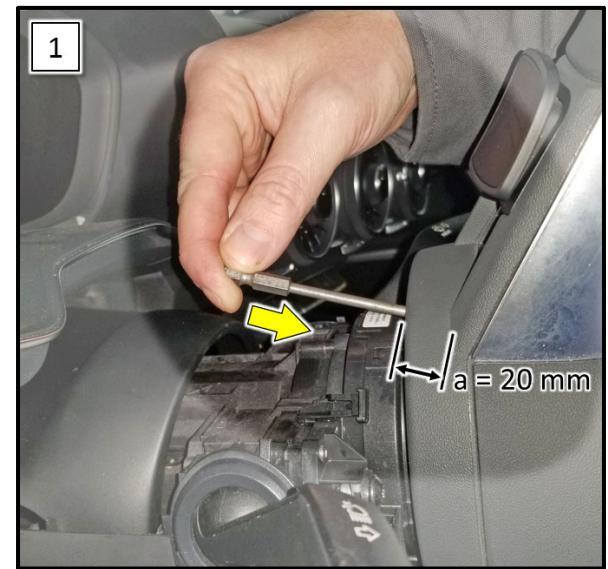
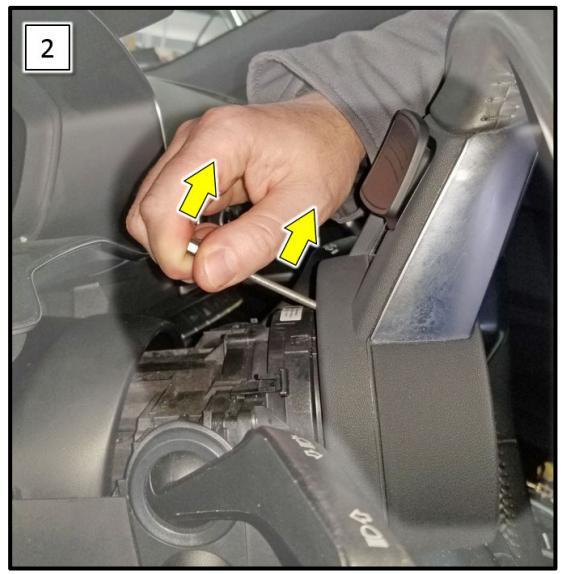
- Move the steering wheel as far to the rear and down as possible. Use the full steering column adjustment range for this.
- Turn the steering wheel 90° from the straight ahead position.
- Insert a TORX or Allen driver into hole on back of steering wheel.
 - Max tool diameter = 3.8 mm.
 - Tool is inserted approximately 20 mm into the steering wheel.
- Release the locking bracket <1> for the driver frontal airbag <2> in direction of <arrow>.
- Turn the steering wheel 180 degrees and release the 2nd locking bracket.

- Photo 1 shows tool positioning after being inserted into back of steering wheel approximately 20 mm <dimension a>
- Photo 2 shows tool positioning after being pulled up to release the locking bracket in the steering wheel.

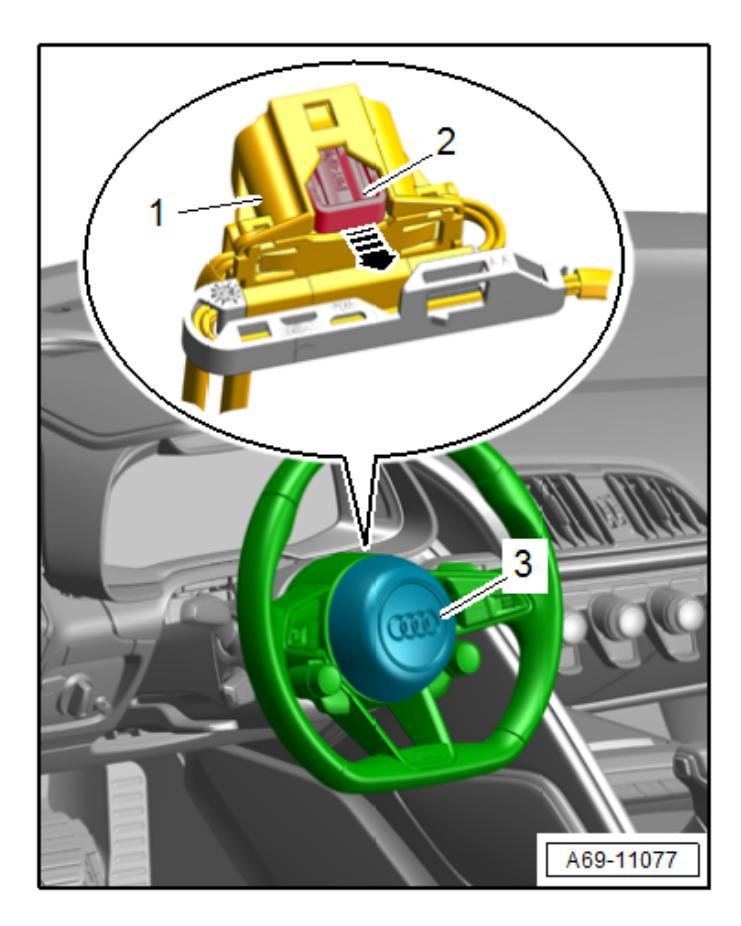
- The battery must be disconnected. •
- Before handling pyrotechnic components (for example, disconnecting the connector), the person handling it must "discharge static electricity". This can be done by touching the door striker, for example.
 - Bring the steering wheel back into the center • position (wheels are straight).
 - Carefully remove the driver frontal airbag <3> slightly from the steering wheel.
 - Pull out the connector lock <2> in direction of <arrow> and press it down, disconnect the connector <1>.
 - Disconnect the connectors for the buttons in the steering wheel.

- Connect the connector <1>. The connector • must click into place.
- Press the connector lock <2> on the connector • <1>.
- Reconnect connectors for steering wheel.
- Position the driver frontal airbag in the steering • wheel and press on it until it audibly engages.

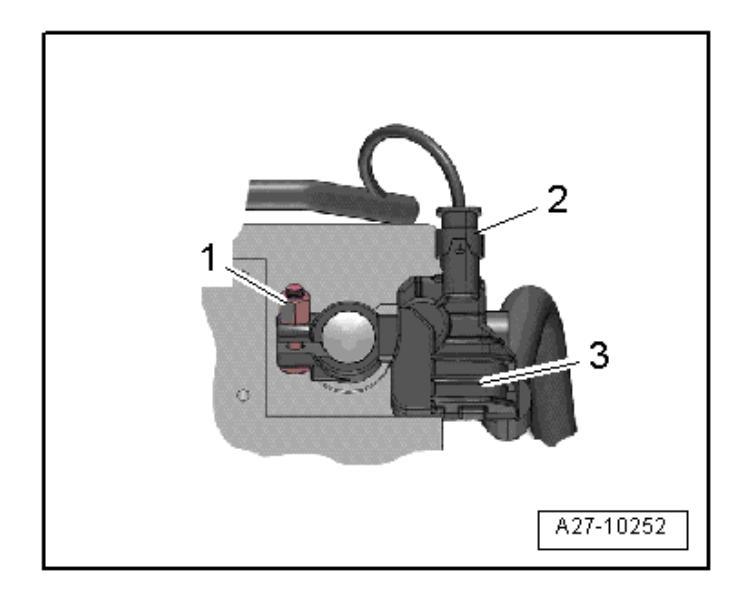
Connect battery:

Ignition must be **ON** when connecting battery. If pyrotechnic components (e.g. airbag, belt tensioner) are not repaired correctly, they may deploy unintentionally after connecting battery. There must not be anyone inside the vehicle when connecting the battery.
