RECALL 19V-015: DRIVER'S FRONT AIR BAG MODULE – PRIOR PARTS REPLACEMENT

This Service Information bulletin replaces SI B65 05 19 **dated January 2019**

SI B65 05 19 - Recall Campaign : Driver's Air Bag Module

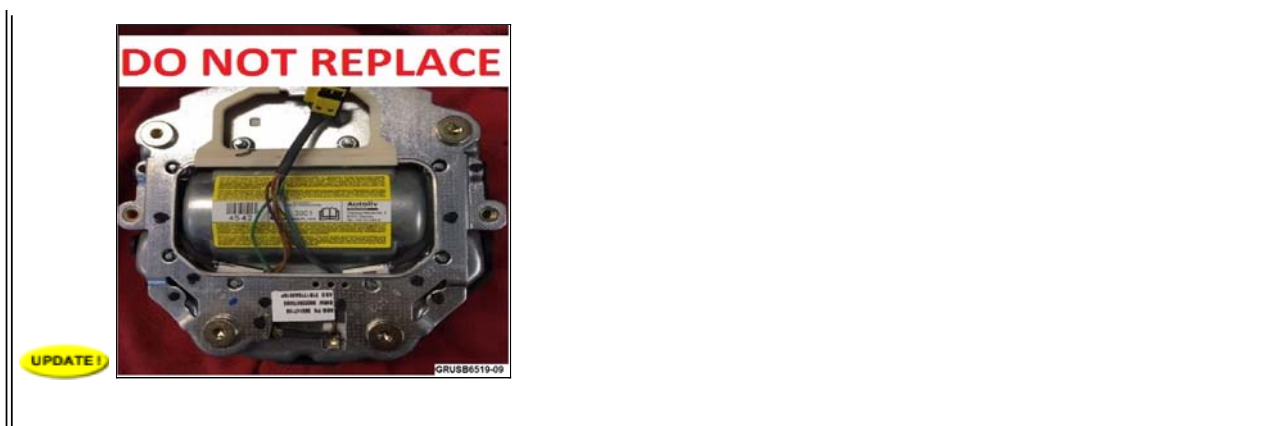
UPDATE! Air bags from other manufacturers (non-Takata, Autoliv), or Takata air bags with different chemical compositions (white label) are not affected by this recall and **DO NOT** need to be replaced. **Reinstall the driver's air bag.**

Note: Before installing the replacement part, the new air bag module's serial number must be

documented by the technician on the repair order so it can also be entered into the warranty claim's comment section.
