**PRODUCT CAMPAIGN BULLETIN**

**APPLICABILITY:** 2019MY Forester and Crosstrek Vehicles      **NUMBER:** WUC-88  
**SUBJECT:** Power Steering Gear Box Inspect/Replacement      **DATE:** 02/12/19  
**NHTSA ID:** 19V-065

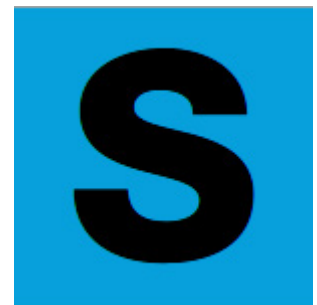
These vehicles can be quickly identified upon receipt by the presence of an "S" label with blue background on the windshield as shown here. While all affected vehicles should have this label installed at the ports, retailers should always check arriving potentially applicable vehicles using vehicle inquiry to confirm if there are any open recalls/campaigns to be completed. In a small number of cases, an "S" written with a glass marker may be found on the windshield in place of the sticker.

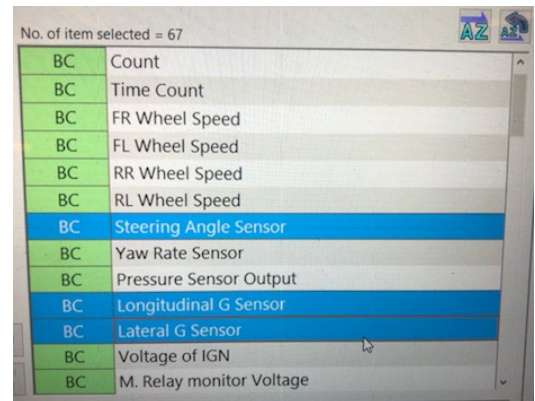
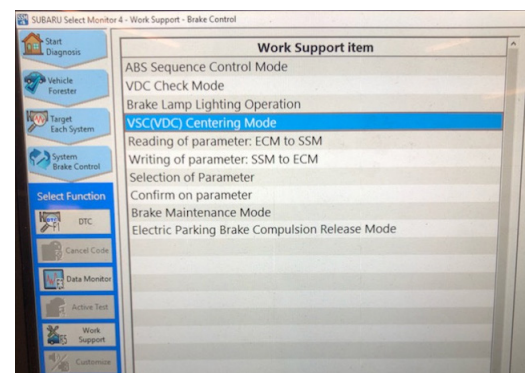
- **Perform VDC Sensor 0 Point Setting Mode:**

10. Check that the output values for the longitudinal G sensor and lateral G sensor are  $-2 \text{ — } 2 \text{ m/s}^2$ . **If the output value is different from the standard value, check the installing condition of the hydraulic unit assembly VDC and the bracket COMPL hydraulic unit VDC.**

11. On [Select Function] screen, select [Work Support].
12. From the work support item list, select [VSC(VDC) Centering Mode], and perform the setting according to the procedure displayed on the Subaru Select Monitor screen.
