May 2019  
INT FL806-01/02  
NHTSA #19V-066  
Transport Canada #19-054  
**INTERIM RECALL BULLETIN**  
THIRD REVISED NOTICE

## **Subject: Freightliner Cascadia Steering Wheel Airbags**

**Models Affected: Specific Freightliner Cascadia vehicles manufactured August 3, 2017, through January 30, 2019.**

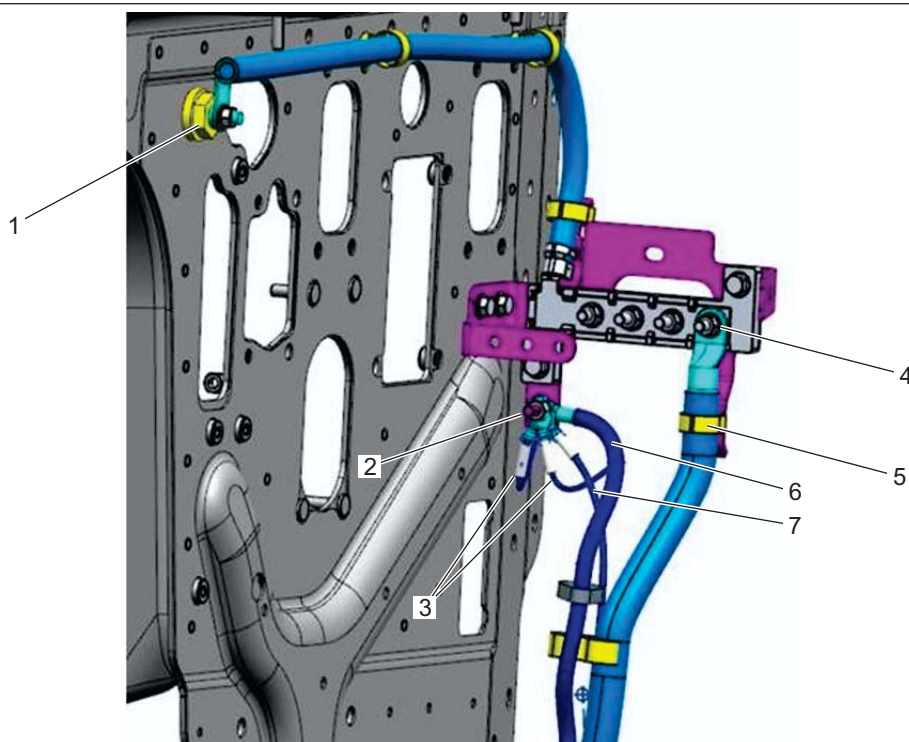
**Fig. 5, MGJB and Frontwall Grounds**

5. GNDE to Battery
6. Cab Skin Ground Cable
7. Chassis Ground Harness to frame rail (mod 2YU)

12. Inspect the GNDE non-isolated stud, located on the lower aft portion of the MGJB bracket. Verify that the GNDE non-isolated stud is clean, configured properly, and torqued correctly. Disassemble and inspect the stud for overspray on the flat surfaces, and in between the ring eyes. Verify there are exactly four (4) circuits on ring eye terminals that attach to the GNDE non-isolated stud on every vehicle. If more or less are found on this stud, combine this inspection step with the next one for GNDE MGJB, separate and group the cables until four GNDE connections are confirmed. Fan these GNDE ring eyes properly on the non-isolated stud and then torque the stud to 16 lbf-ft (21 N·m). Repaint the connection as necessary.
