A. VEHICLE INSPECTION PROCEDURE

B. CROSS MEMBER INSPECTION PROCEDURE 2009-2013 MAZDA6

On certain subject vehicles in salt belt states, it is possible that the front cross member may be corroded due to possible insufficient paint coating. Corrosion may be more severe on the portion just under the air conditioner drain, causing a perforation.

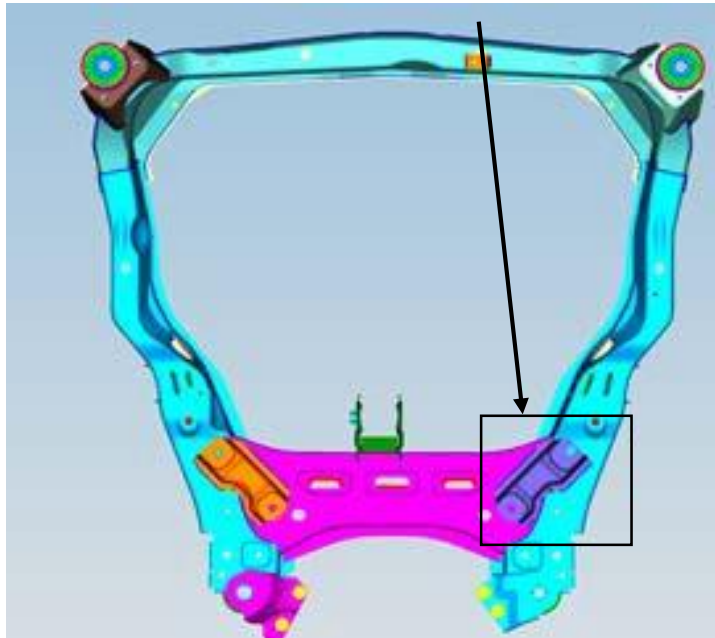
Top View – Area affected (Right Top Side)

**FRONT
OF VEHICLE**

Zone 1 Inspection – Upper Surface/Top side

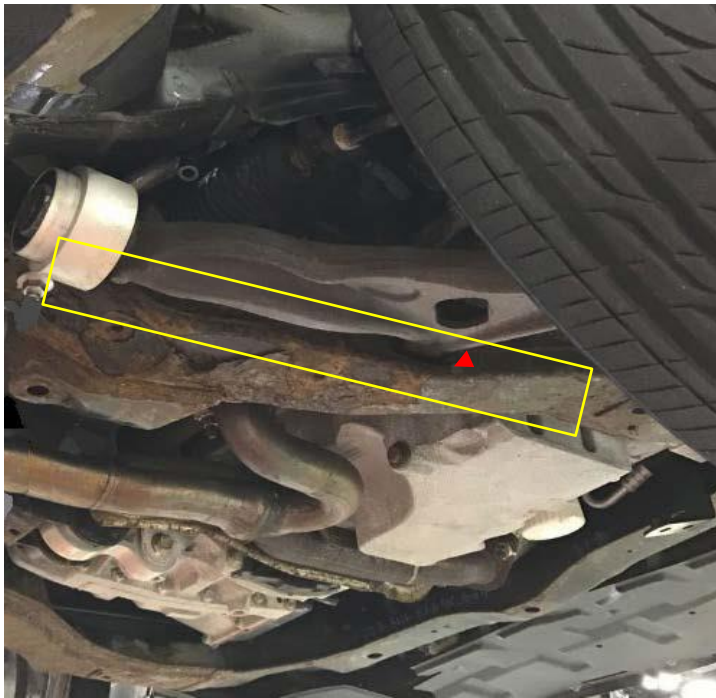
Side View: Non-Damaged Cross member

Zone 3 inspection Area:
Look for perforation especially along the bottom corner ridge line (this area). If perforation or a crack is present the cross member needs to be replaced.
