## SAFETY RECALL CAMPAIGN 2010 - 2013 Front Passenger Seat OCS Campaign 4016 for all Kizashi vehicles (A6B424)

<b>Affected Models:</b>	All 2010 - 2013 Suzuki Kizashi vehicles (A6B424)
<b>Affected Departments:</b>	Management, Service, Warranty, Parts
<b>Attachment:</b>	Customer notification letter
<b>Reference:</b>	Safety Recall Campaign 4015 Bulletin SC-85 (April 3, 2020), & Safety Recall Campaign 4015 Update SC-86 (October 8, 2021) & Campaign 4016 VIN-Parts Support Document (October 22, 2021)

The front passenger seat occupant classification system (OCS) may misclassify adult occupants as child occupants and suppress the front air bag due to the seating posture/position of the adult occupant. In a crash necessitating air bag deployment, the front air bag may not deploy with an adult occupant in the front passenger seat, increasing the risk of injury to the adult occupant.

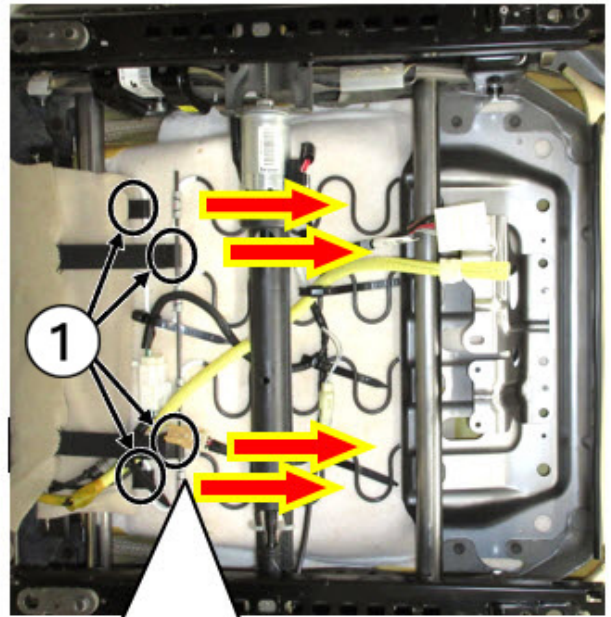
The OCS harness ③ can be damaged if it comes in contact with the edge of the clasp ④.

To prevent this, hang the hook ② in the space between the OCS harness ③ and the clasp ④.
