# Recall Campaign

Daimler Trucks  
North America LLC

NHTSA #19V-444

## Subject: TBB Bendix Air Disc Brake Calipers

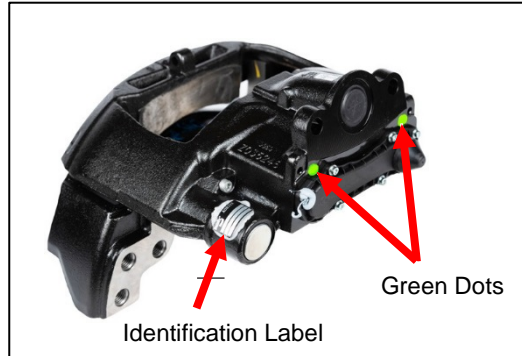
Figure 1: Locating Information on the Caliper

1. For FCCC chassis, check the base label (Form WAR259) for a completion sticker for FL818 (Form WAR260) indicating this work has been done. The base label is usually located above the driver's window. If a sticker is present, no work is needed. If there is no sticker, proceed with the next step. For TBB buses, confirm in OWL that FL818 is still open.
2. Park the vehicle on a level surface, shut down the engine, and set the parking brake. Chock the tires.
3. Drain all reservoirs to 0 psi (0 kPa).
4. Clean the exterior of the Bendix air disc brake assembly.
5. Inspect for the presence of a green dot in either location shown in **Figure 1**.

6. Inspect the identification label on the caliper. (Remove paint coating if necessary.) See **Figures 1, 2, and 3**.

The left rear caliper will be inspected and replaced, if needed, with a new caliper containing an updated clearance adjustment mechanism.

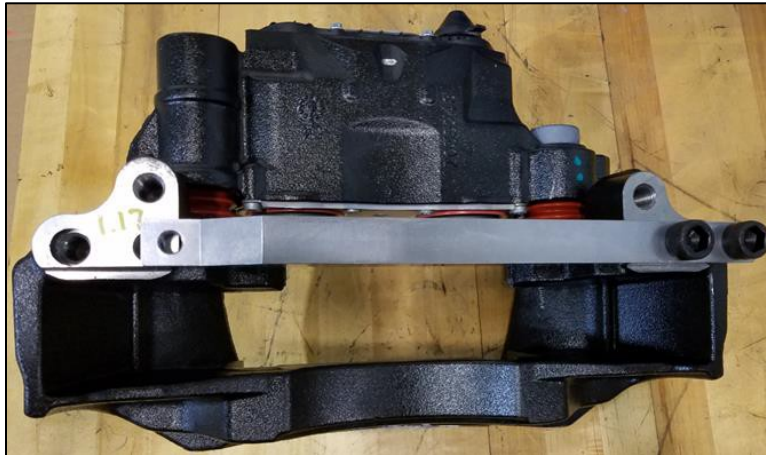
Figure 5: Caliper with Gage Installed

NOTE: A small number of replacement calipers for FL818B may have a defect and should not be used. Calipers that pass this inspection are good and may be used for the FL818 repair. Calipers that fail this inspection should not be used, return them to your facing PDC as defective and use a caliper that passes this inspection.

1. With the caliper sitting on a flat surface, hand tighten the inspection gage to one side of the machined face of the carrier using the two bolts that came with the replacement caliper. See **Figure 5**.
2. Use a metric ruler to measure the gap between the inspection gage and the machined face of the carrier on the opposite side. Note the measurement. See and **Figure 6** and **Figure 7**.
3. Mount the gage on the opposite side and repeat the measurement.
4. Average the two gap measurements (left side gap + right side gap divided by 2).

If the average is **less than 5 mm**, the caliper passes the inspection. Continue with the caliper replacement.

If the average is **5 mm or more**, the caliper fails the inspection. Return the caliper to your facing PDC as defective. Get a new caliper and repeat the inspection. Continue the replacement with a caliper that passes this inspection.
