Thor Motor Coach Recall Repair Instructions

| Description/Title: | MORryde Battery Tray | | |
| Affected Product Line(s): | Certain MY 2019/2020 Magnitude & Omni motorhomes | | |
| Service Campaign # : | RC000171 | Released Date: | 08/5/2019 |

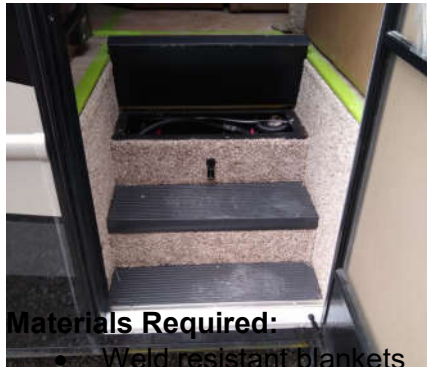
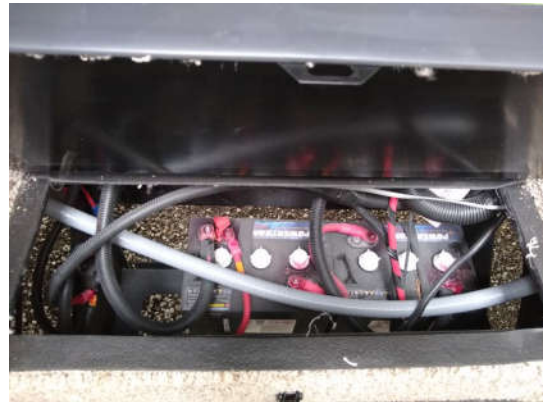
Supplemental Information: The battery tray is located directly under the entry step on the passenger side of the unit. This tray can be accessed by unlatching the top step. It is also accessible underneath the unit behind the sidewall.

OBJECTIVE: Weld on additional support to the battery tray.
