RECALL CAMPAIGN BULLETIN

Classification: EL19-028	Reference: NTB19-077	Date: October 14, 2019
-----------------------------	-------------------------	---------------------------

VOLUNTARY RECALL CAMPAIGN 2019 ALTIMA; AV CONTROL UNIT (INFOTAINMENT) SOFTWARE UPDATE

CAMPAIGN ID #: R1911
NHTSA #: 19V-654
APPLIED VEHICLES: 2019 Altima (L34)

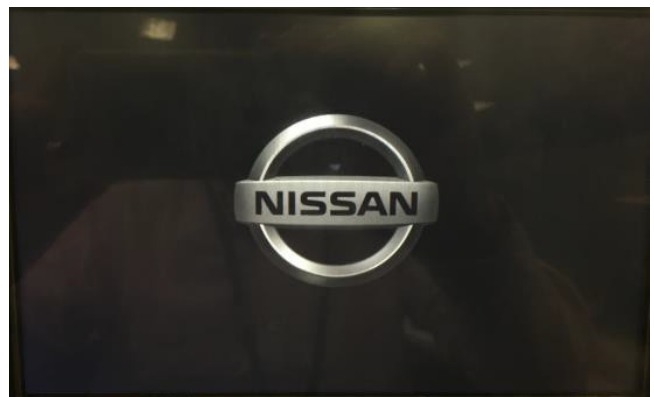
Figure 8

9. Allow the reboot to complete (approximately 30 seconds).
 - The Nissan logo will be displayed during the reboot.
10. Turn the ignition OFF.
